Inspection Report

Property Address:
25 Panavista Cir.
Yerington NV 89447

Clear Choice Home Inspection Services

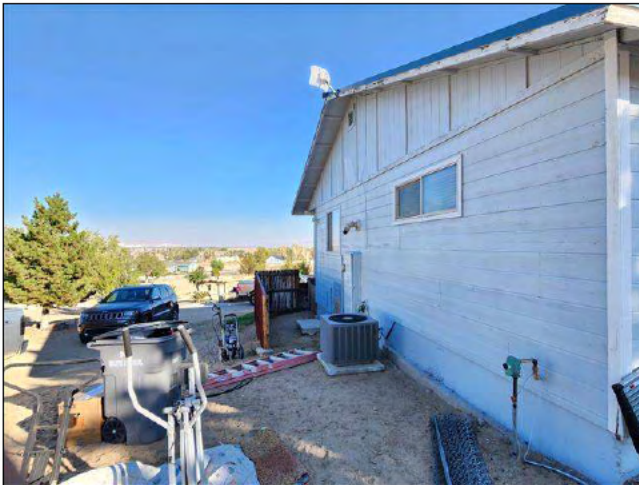
1.0 Item 1(Picture) view of exterior

Exterior, as seen at time of inspection.

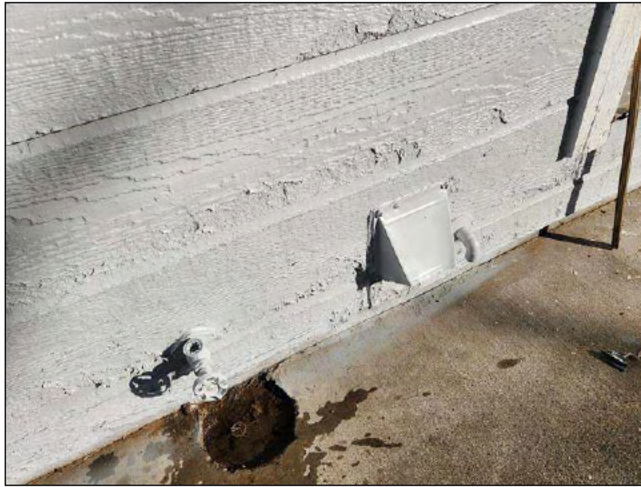
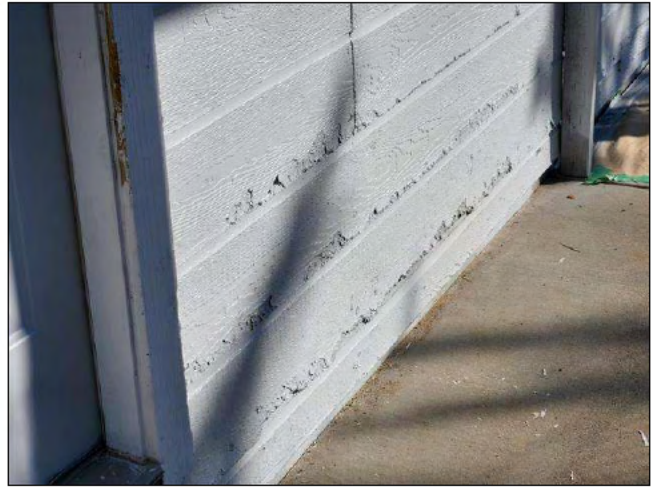
Exterior wall cladding appears original to the home, and is Horizontal lap style compressed board that appears in average condition for the age home. Normal aging and wear was noted, with slight deterioration at the lower edges of South siding boards, possibly from irrigation over-spray or roof run-off splashing on the ground. Recommend maintaining generous paint coverage on siding to protect from weather/moisture. No major problems were noted with the siding materials, and appears properly secured to wall framing.

1.1 Item 1(Picture) south side siding boards

1.1 Item 2(Picture) south side siding boards

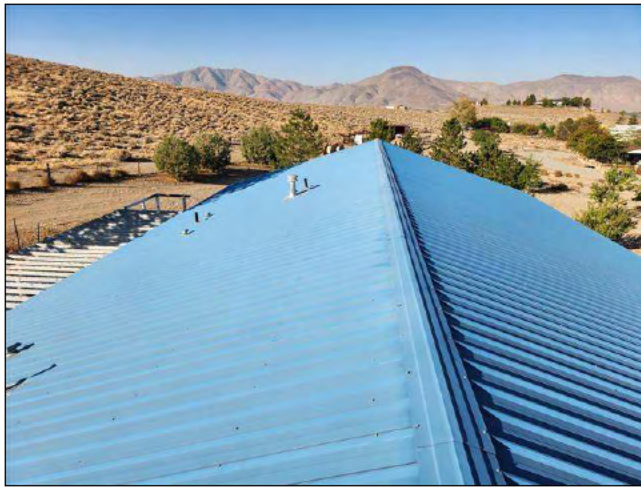
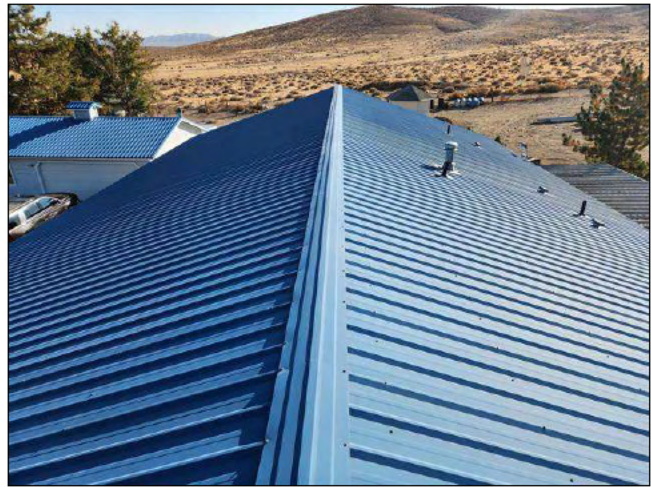
The roof, as seen at time of inspection. Inspected by walking the roof.

2.0 Item 1(Picture) view of roof

2.0 Item 2(Picture) view of roof

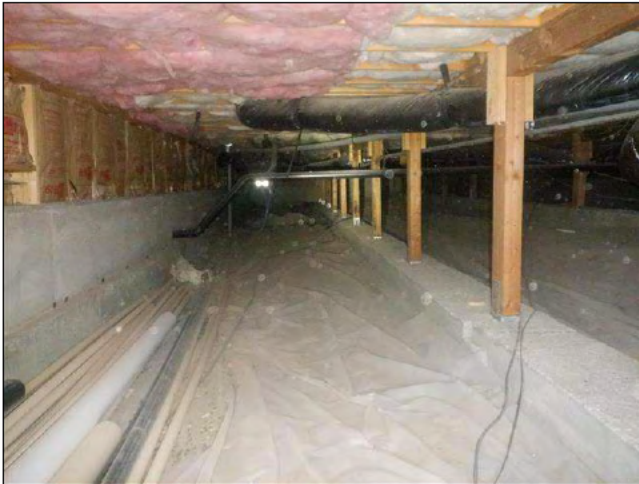
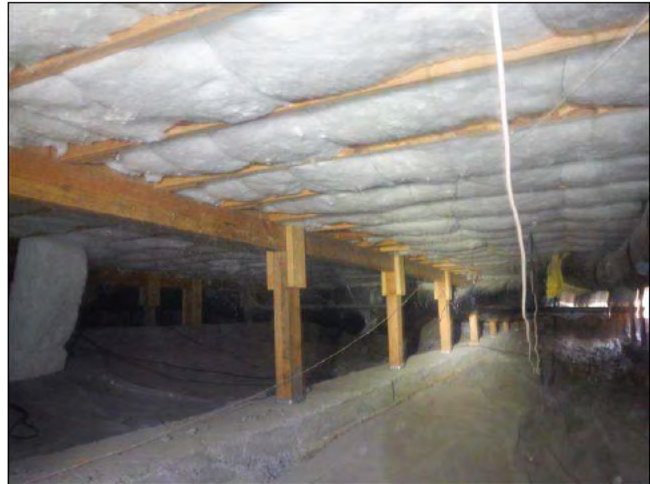
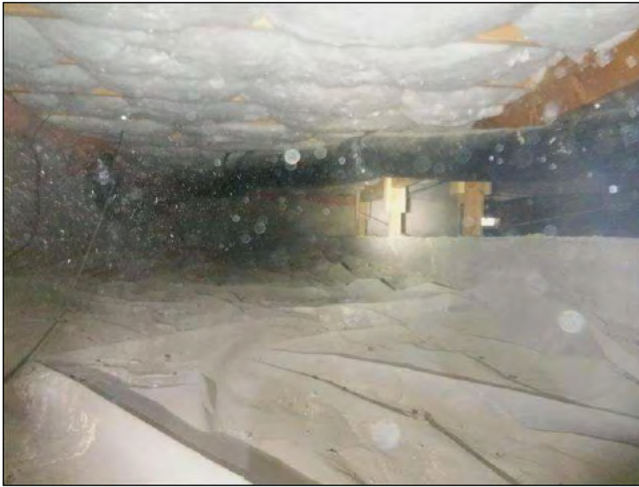
Comments: Inspected
 Crawlspace, as seen at time of inspection.

3.0 Item 1(Picture) view of crawlspace

3.0 Item 2(Picture) view of crawlspace

3.0 Item 3(Picture) view of crawlspace

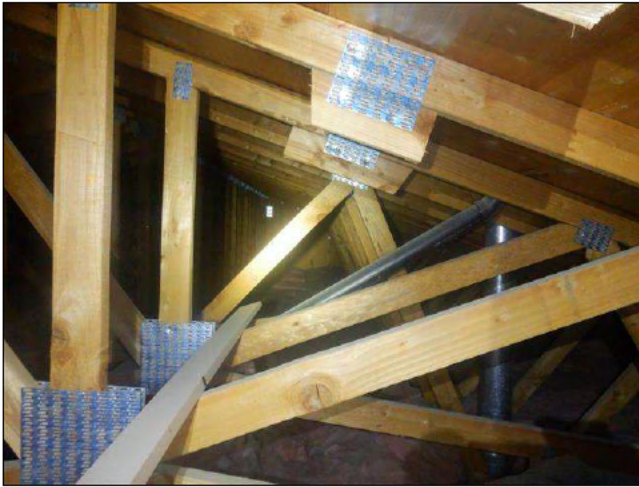
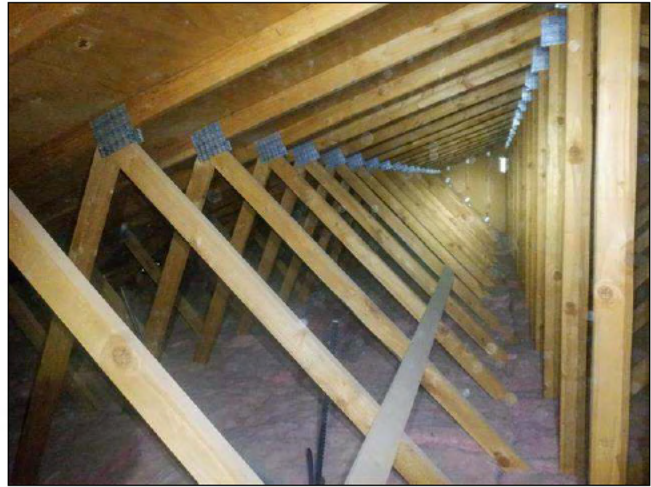
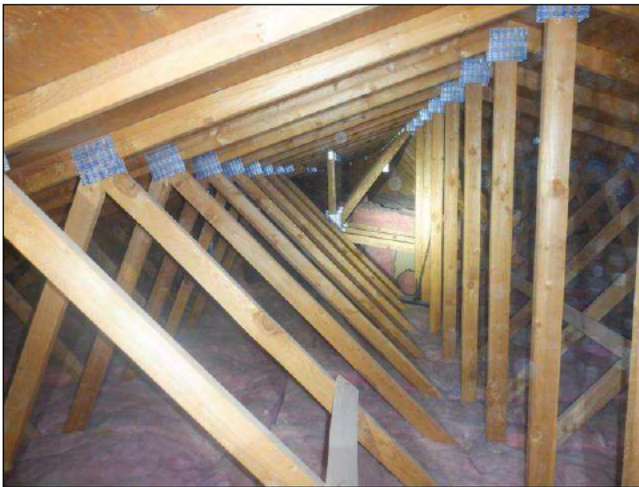
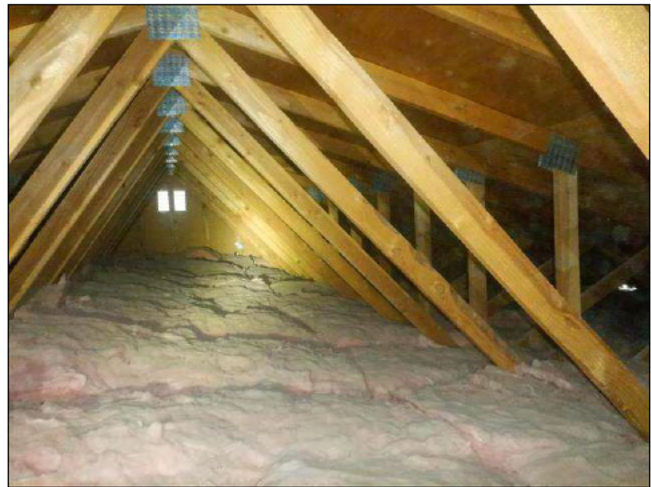
The Attic, as seen at time of Inspection.

3.8 Item 1(Picture) view of attic

3.8 Item 2(Picture) view of attic

3.8 Item 3(Picture) view of attic

3.8 Item 4(Picture) view of attic

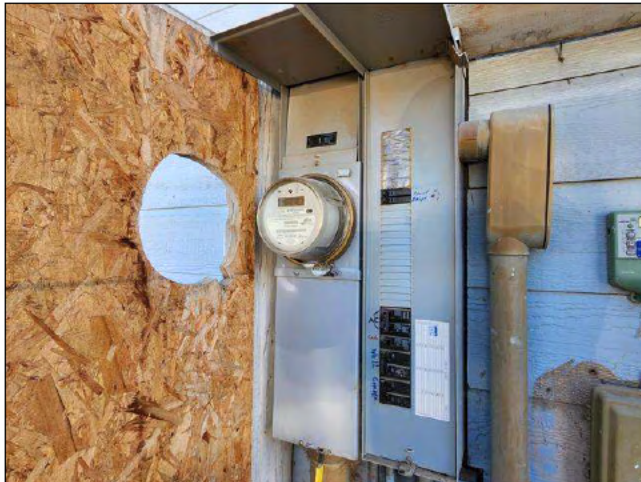
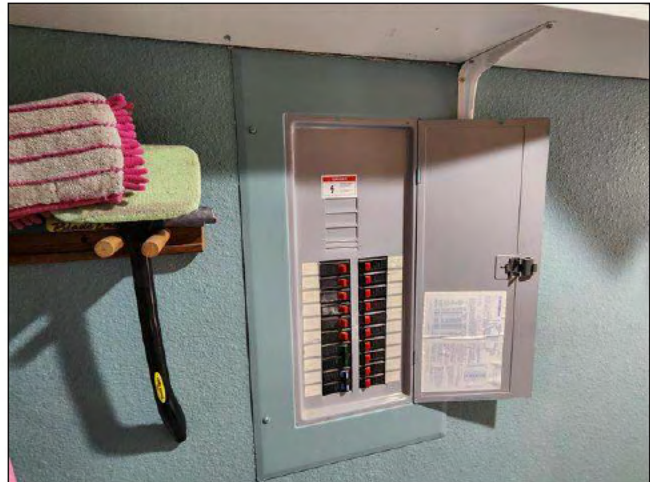
The Main and Distribution Panels are well labeled for circuit identification. "Dead front" cover appears serviceable. No problems noted.

4.1 Item 1(Picture) main electrical panel

4.1 Item 2(Picture) laundry room panel

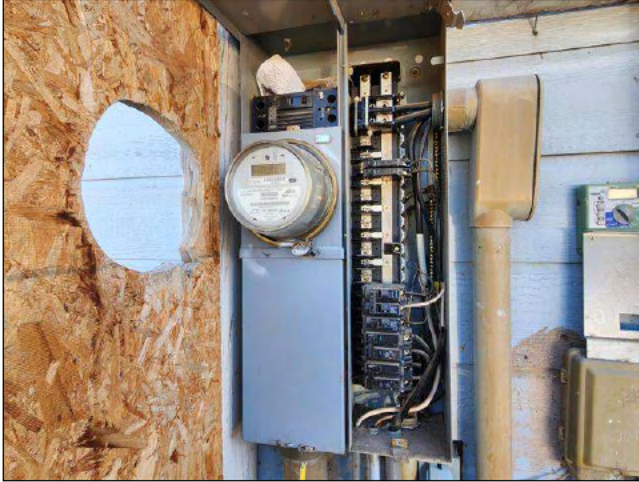
4.4 Item 1(Picture) main panel conductors

(1) The circuit conductors appear in good condition, and are properly sized for their prospective overcurrent devices. No burned connections noted.

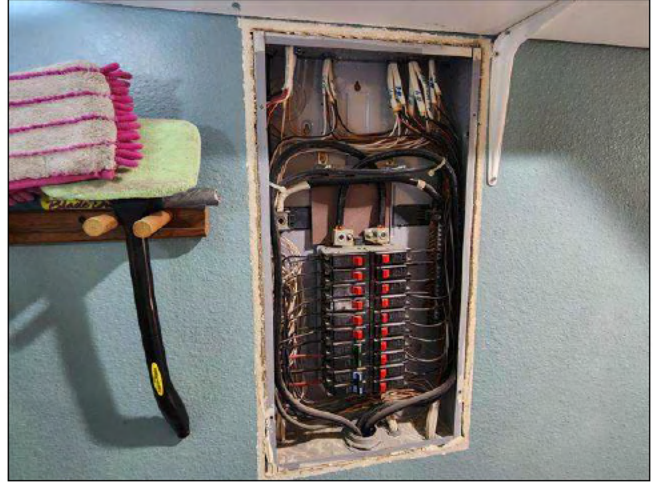
4.4 Item 2(Picture) laundry room panel conductors

(2) Note: There are 5 "double tap" circuit breakers noted inside the Laundry room panel. Each conductor should be wired and connected to separate circuit breakers. Recommend repair by a licensed electrician.

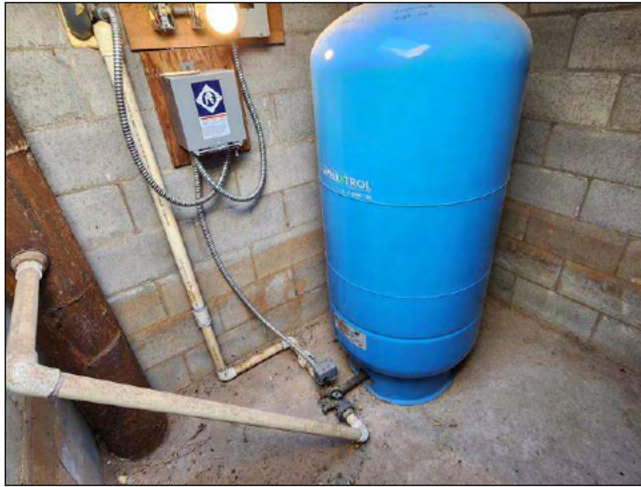
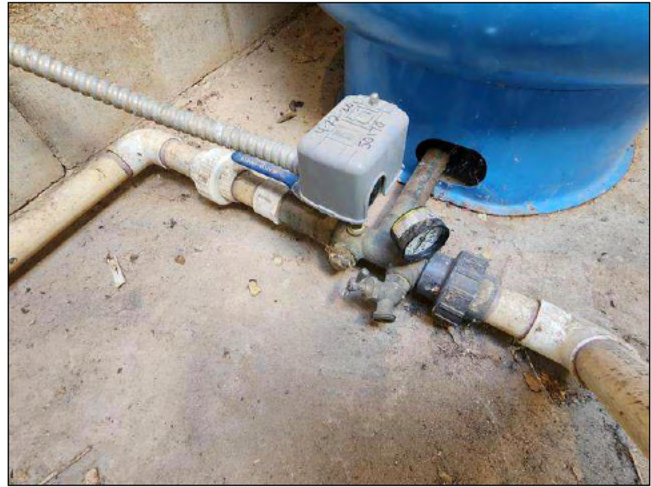
(1) The water supply system was fully operational as intended at time of inspection. The working system pressure fluctuated between 35 and 55 psi during the inspection. Pressure tank is 119 gallon, and the pump controller is for 1-1/2 h.p. pump, which is not visible or accessible.

5.1 Item 1(Picture) well pump equipment

5.1 Item 2(Picture) well pump equipment

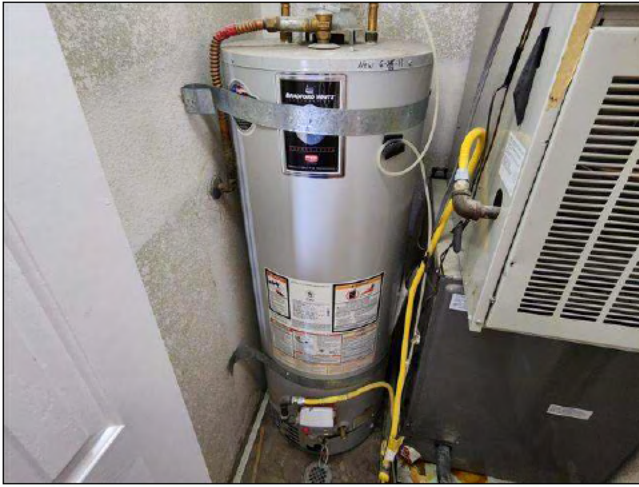
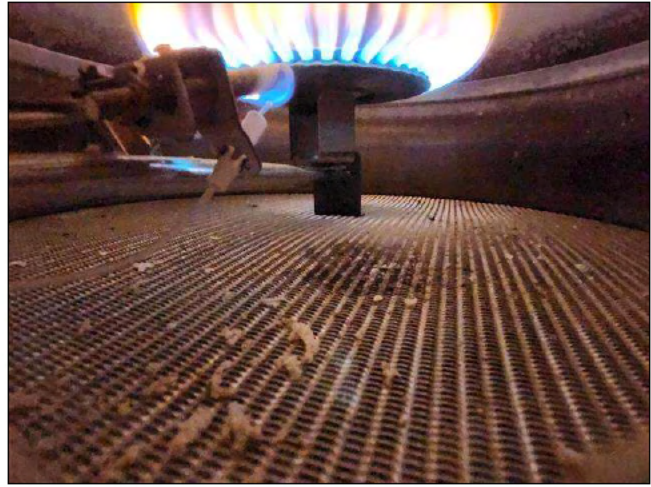
Water heater is located in the hall utility closet, and is strapped to current local codes. Temperature and Pressure Relief Valve is piped to the exterior of the home, or within 6 inches of the floor (for safety reasons). Drip leg has been installed in the gas supply piping, water and fuel shut-off valves are present. Water heater operated as intended with no abnormal noises or leaks noted. Manufactured in February 2011 by Bradford-White.

5.3 Item 1(Picture) water heater

5.3 Item 2(Picture) water heater burner compartment

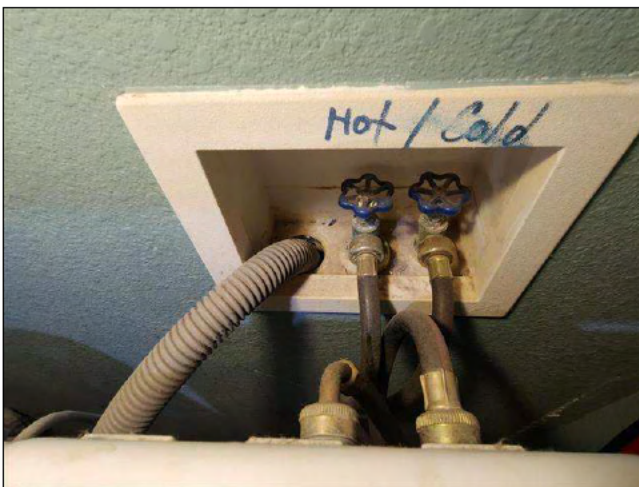
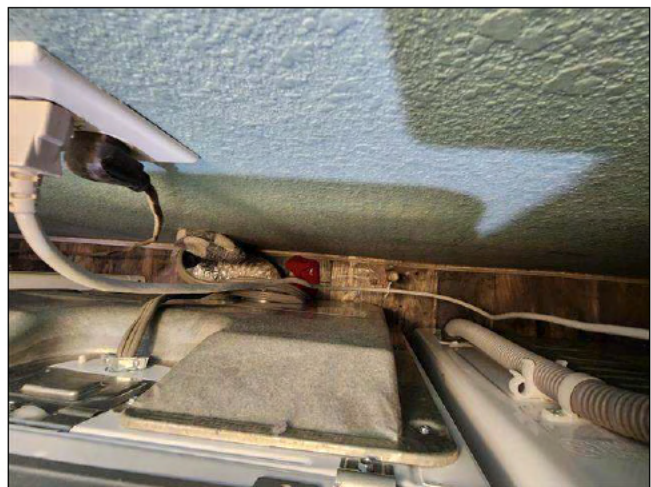
Washer and dryer hook-ups were inspected, with no problems noted. Dryer is electric or gas powered with rigid metal venting installed in the crawlspace. Washer drain is 2" diameter, Hot and Cold hook-ups with no problems noted.

5.5 Item 1(Picture) laundry hook-ups

5.5 Item 2(Picture) laundry hook-ups

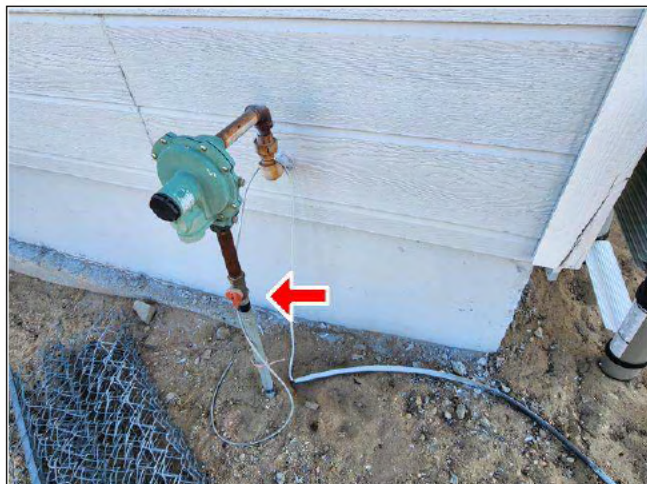
Main tank shut-off for fuel is located on top of the fuel storage tank, at the West side of the house. Main fuel shut-off valve for house is located at the fuel regulator, at the West side of the house. No problems noted.

5.10 Item 1(Picture) main fuel shut-off valve

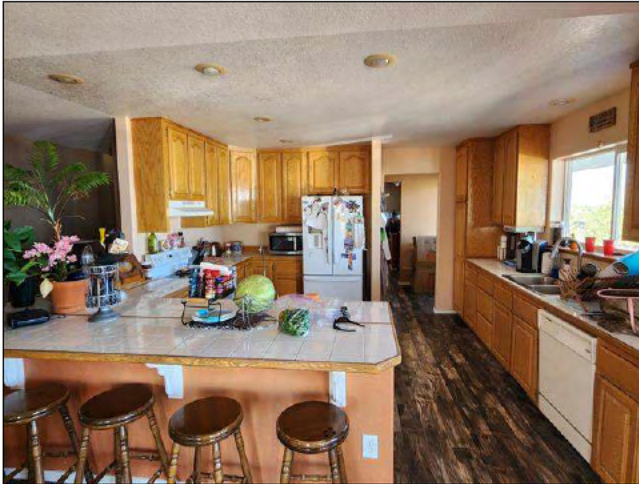
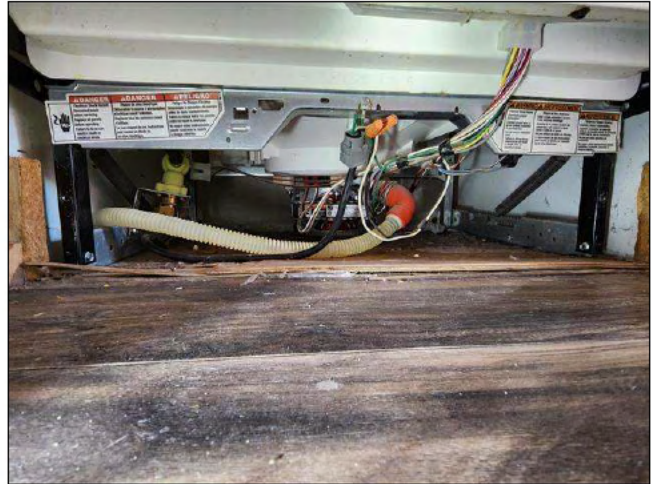
Kitchen, as seen at time of inspection.

6.0 Item 1(Picture) view of kitchen

6.0 Item 2(Picture) dishwasher hook-ups

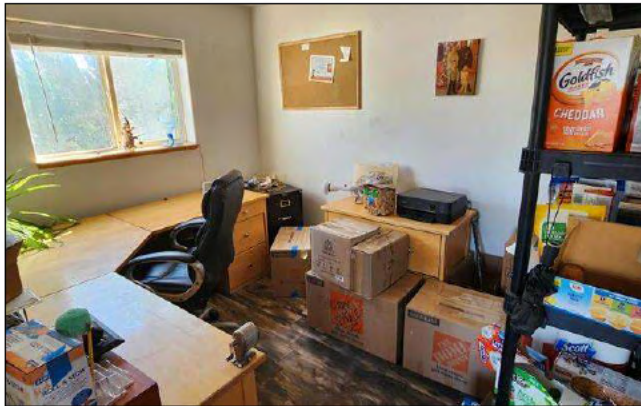
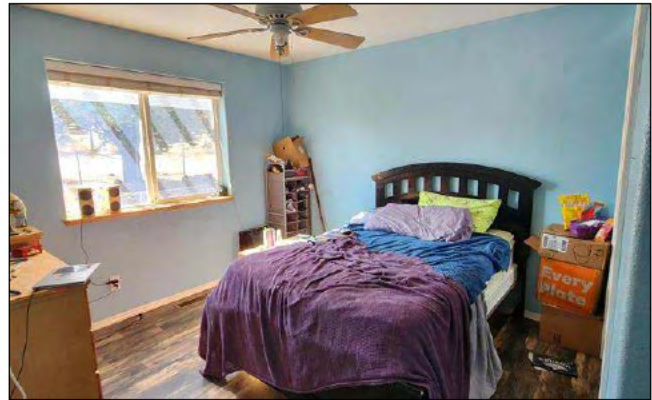
Interior, as seen at time of inspection.

7.0 Item 1(Picture) view of interior

7.0 Item 2(Picture) view of interior

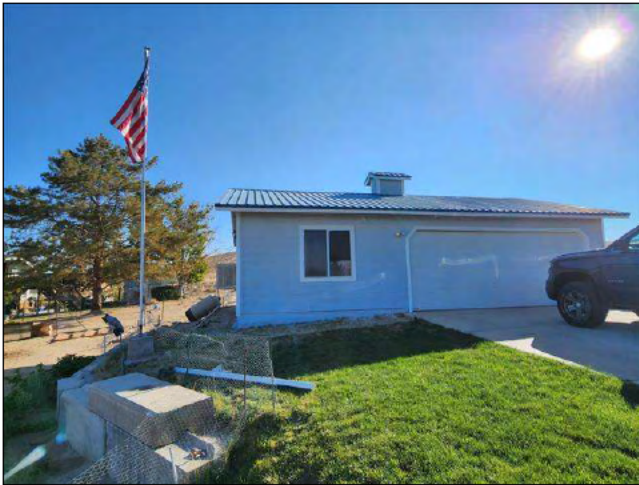
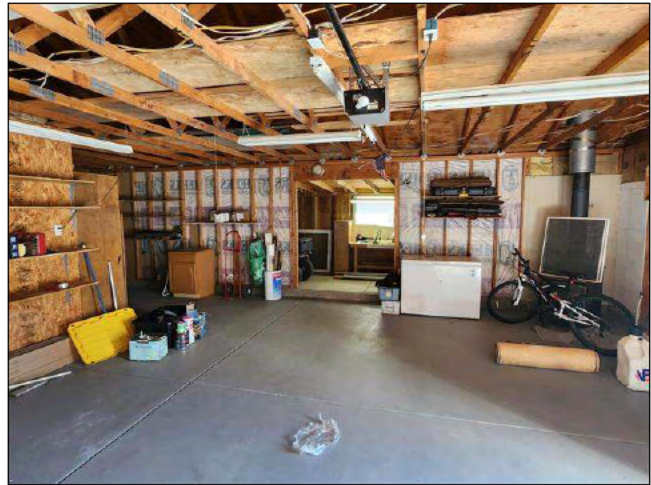
Comments: Inspected
Garage, as seen at time of inspection.

8.0 Item 1(Picture) view of garage exterior

8.0 Item 2(Picture) view of garage interior

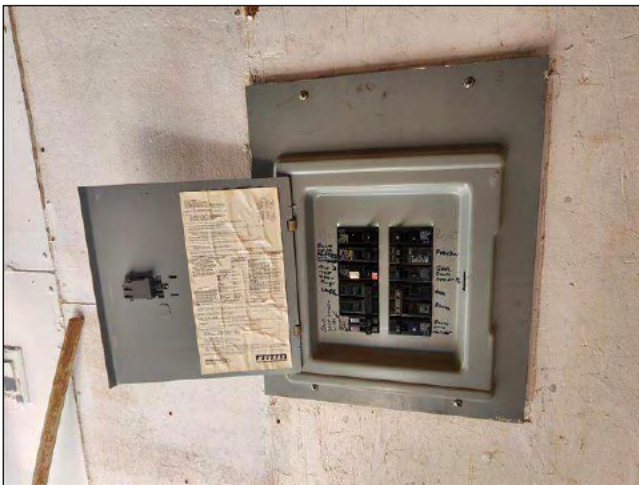
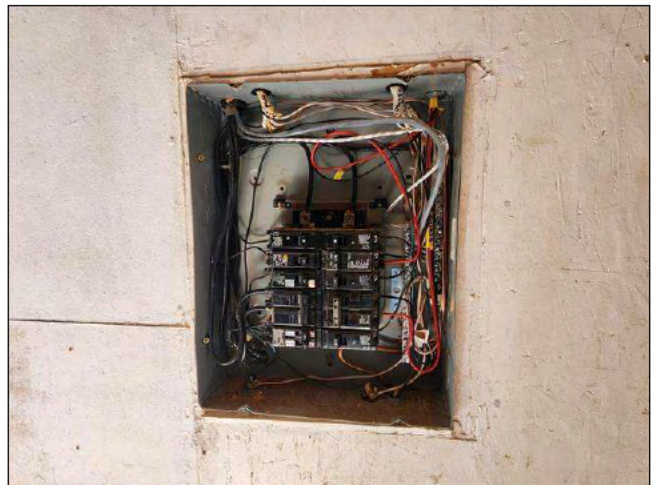
Comments: Inspected
Garage panel is well labeled for circuit identification, The circuit conductors appear in good condition, and are properly sized for their prospective overcurrent devices. No "double tap" circuit breakers or burned connections noted.

8.1 Item 1(Picture) garage panel

8.1 Item 2(Picture) garage panel conductors

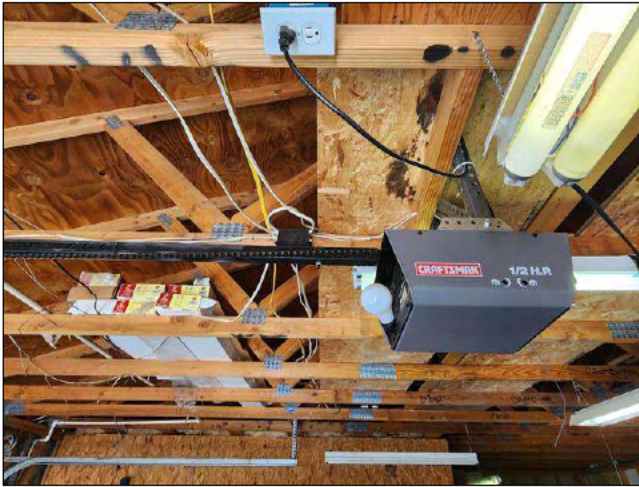
8.9 Item 3(Picture) no obvious problems noted

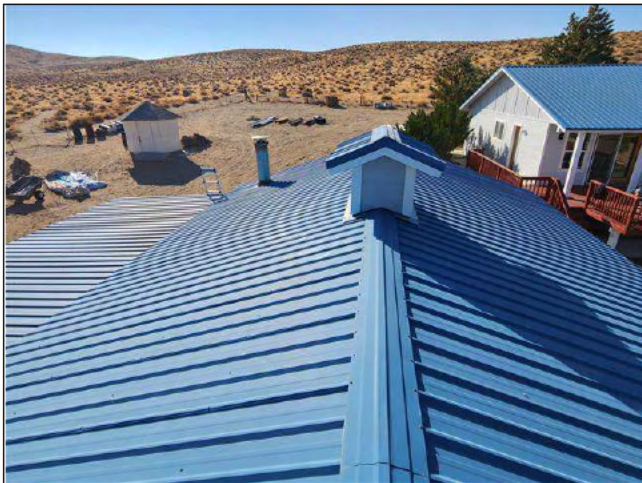
Roofing material is ribbed metal with sealed fasteners. Material is secured well to main structure framing , with proper use of flashings where needed. No problems noted at time of inspection.

8.10 Item 1(Picture) view of garage roof

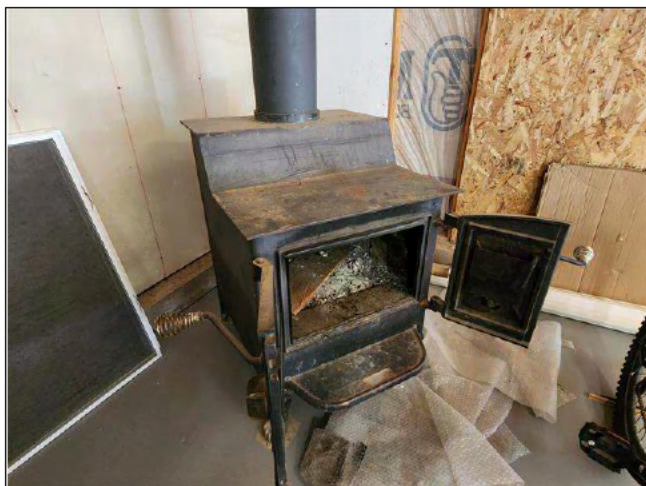
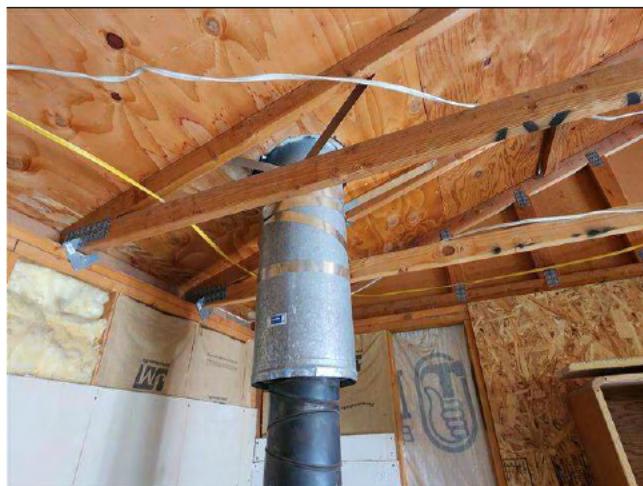
(2) The Garage uses a woodstove for heating. All flue pipes are secured in place, proper clearances to combustible materials at walls and roof penetration appears adequate. No problems noted.

8.14 Item 2(Picture) woodstove in garage

8.14 Item 3(Picture) clearances to combustibles

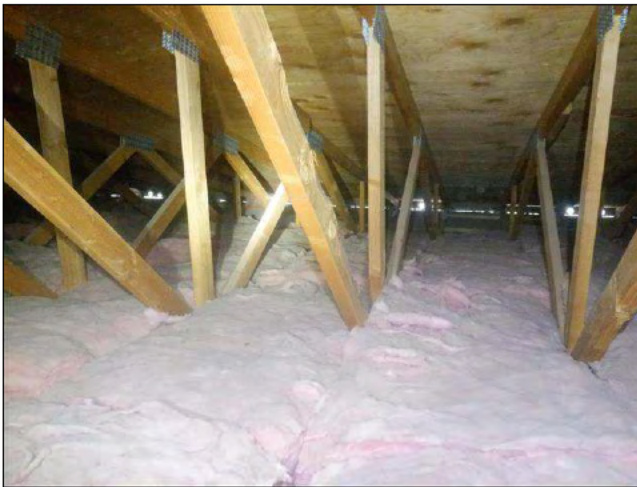
Attic insulation is Fiberglass Batt type approximately 12 inches thick (R38). No problems noted at time of inspection.

9.0 Item 1(Picture) view of attic insulation

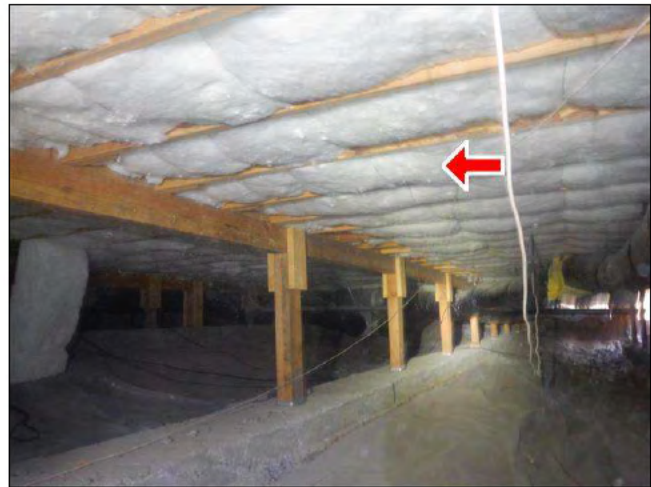
9.0 Item 2(Picture) view of subfloor insulation

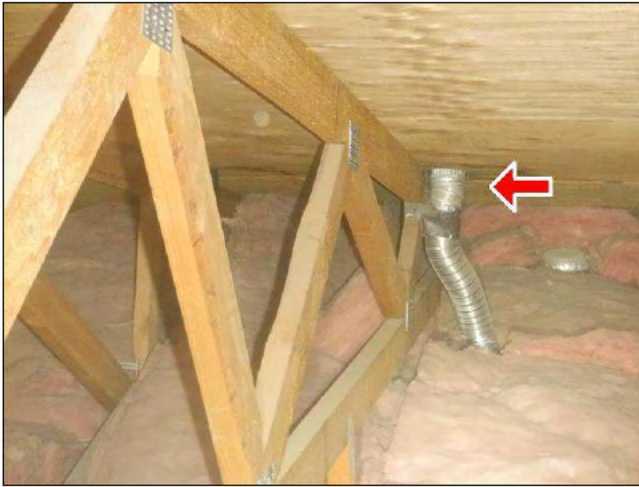
Bathrooms and Laundry vents are properly ducted to the exterior of the home.

9.4 Item 1(Picture) properly vented to exterior

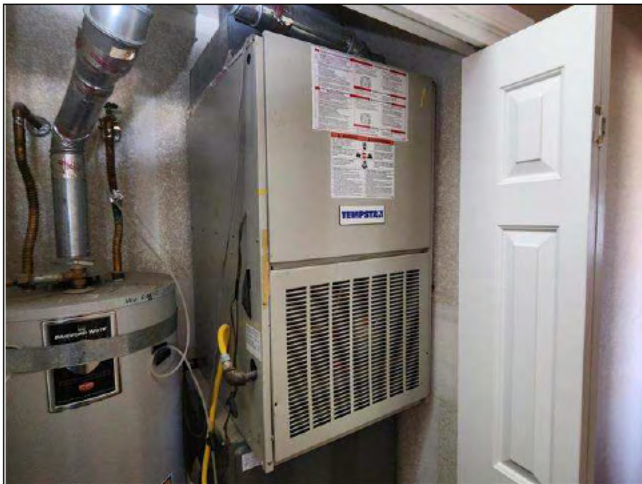
(1) The heating equipment is original (26 years). The furnace is a vertical downdraft propane gas fired forced air unit, Rated at 125,000btu's, that operated as intended with normal operating controls. The burners have an even blue flame. Manufactured in 1996 by Tempstar.

10.0 Item 1(Picture) forced air furnace

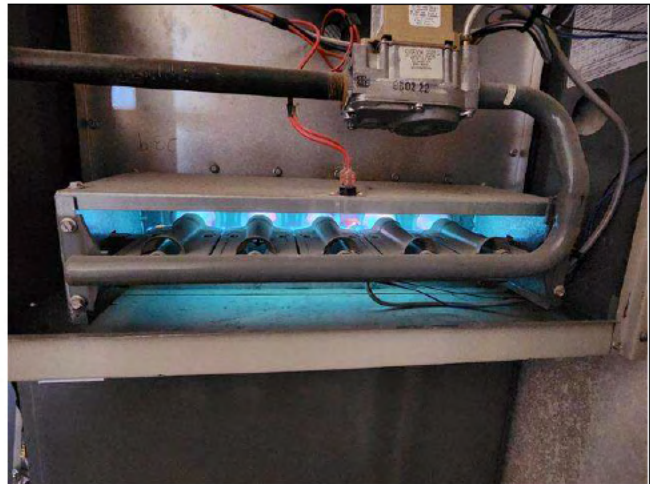
10.0 Item 2(Picture) furnace burners

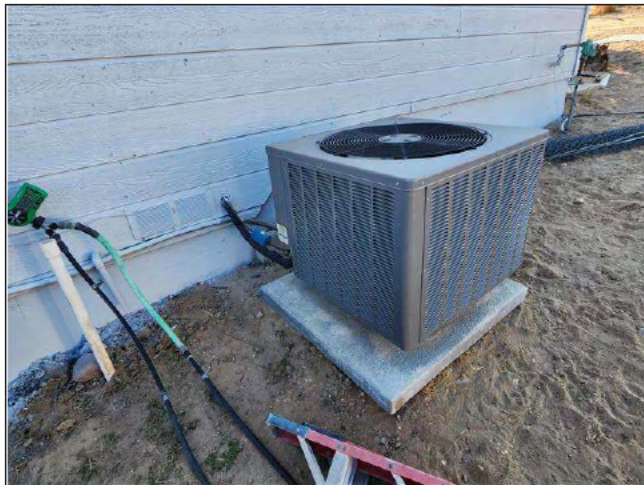
The ambient air test was performed by using thermometers on the air handler of Air conditioner to determine if the difference in temperatures of the supply and return air are between 14 degrees and 22 degrees which indicates that the unit is cooling as intended. The supply air temperature on your system read 56 degrees, and the return air temperature was 71 degrees (a/c cabinet temperature measured 62 degrees). This indicates the range in temperature drop is normal. Condensing unit operated as intended with normal operating controls, and no abnormal noises noted. Unit was manufactured in 2014 by Rheem.

10.5 Item 1(Picture) condensing unit

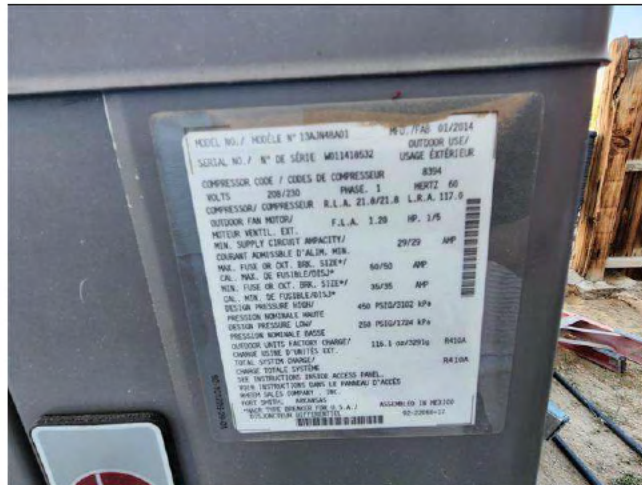
10.5 Item 2(Picture) manufacturer's label

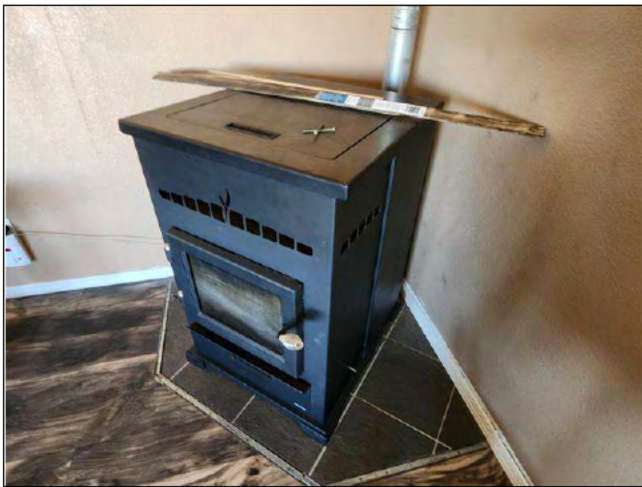
Pellet-stove appears operational, with proper clearances to combustibles. Flue pipe is fastened securely, door and seals appear serviceable. No obvious problems noted. Combustion compartment appears Serviceable.

11.3 Item 1(Picture) living room pellet stove
