Home Inspection Report

PROPERTY INSPECTED:
6249 Dawson Drive
Billings, MT 59105

Date of Inspection: 08/22/2024

Inspection No. 45957-1-1126

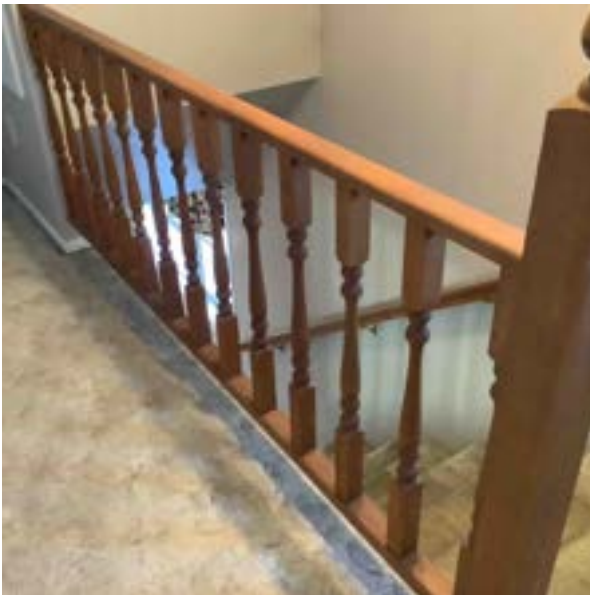
11.6.2 Caution is advised. Railing poses potential safety hazards due to design. Spindle span in greater than 4". **(2nd Floor Hallway)**
