# Inspection Report

**Property Address:**  
4018 Southpointe Dr  
Carson City NV 89701

**Clear Choice Home Inspection Services**

| <b>Date:</b> 8/4/2026 | <b>Time:</b> 09:00 AM | <b>Report ID:</b> PRO401 |

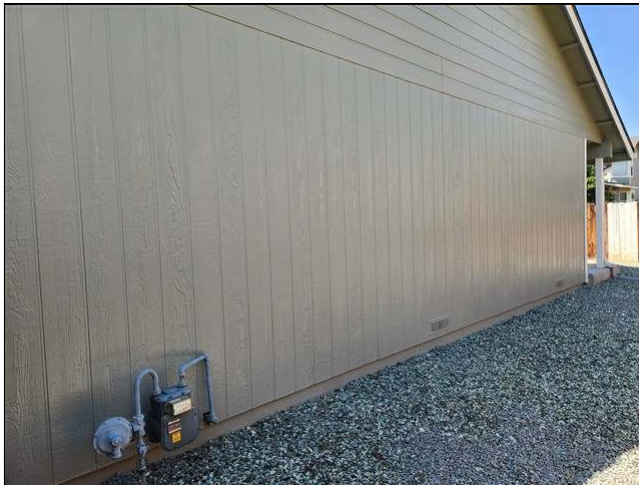
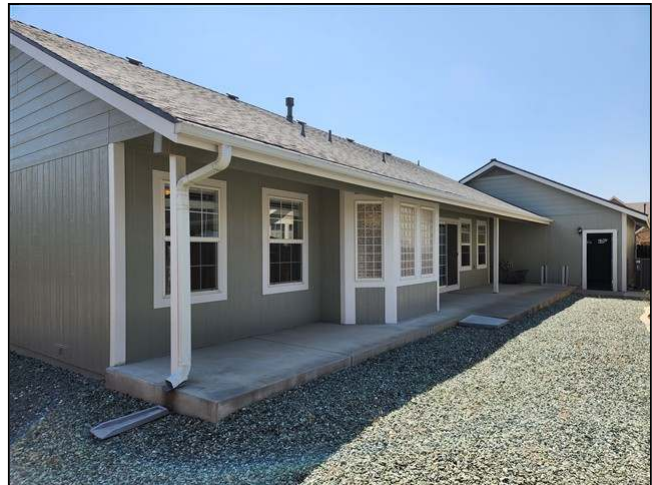
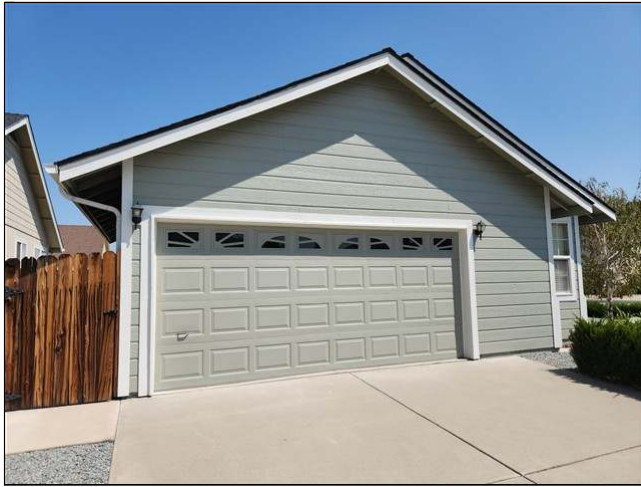
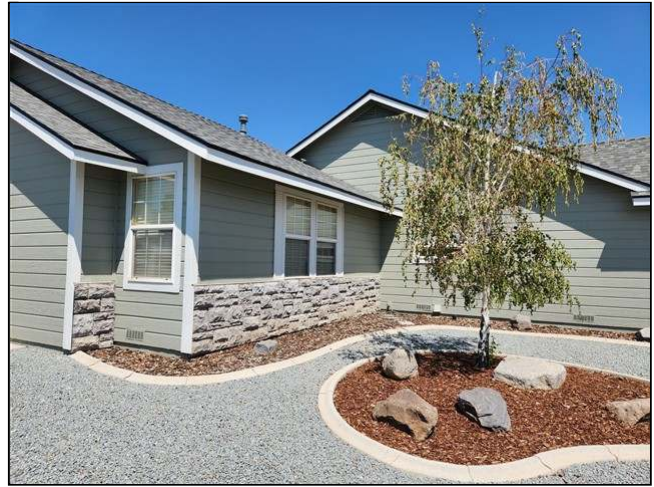
1.0 Item 1(Picture) view of exterior

Exterior, as seen at time of inspection.

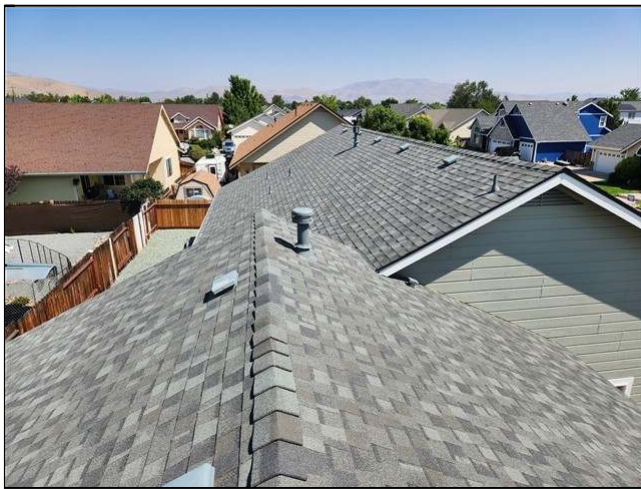
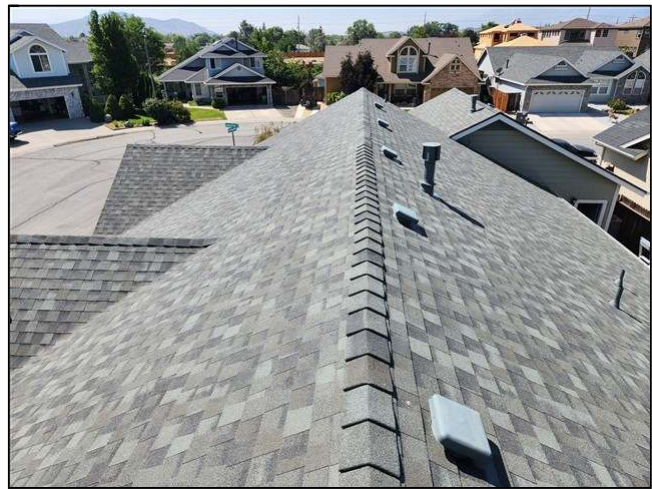
2.0 Item 1(Picture) view of roof

The roof, as seen at time of inspection. Inspected by walking the roof.

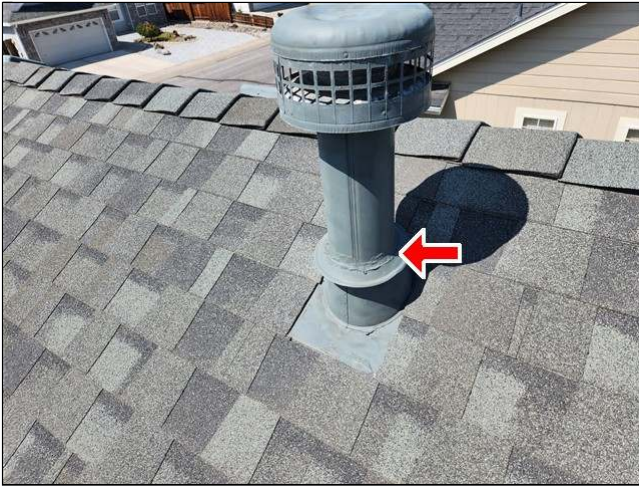
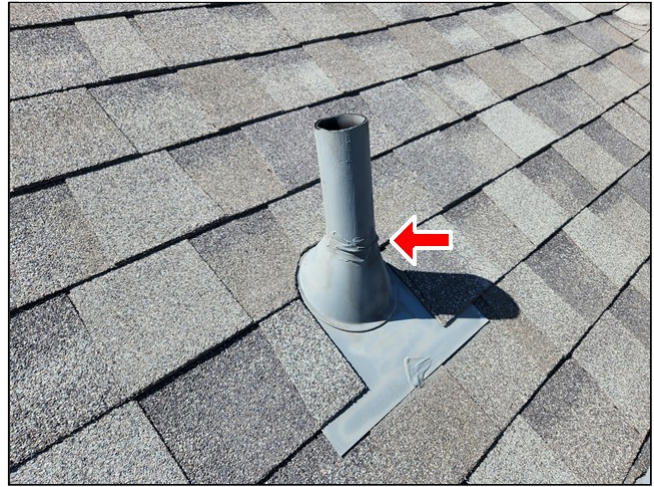
Plumbing and furnace vent pipes are sealed well against flashings to prevent moisture intrusion into attic framing areas.

2.3 Item 1(Picture) Plumbing and furnace vent pipes are sealed well

2.3 Item 2(Picture) Plumbing and furnace vent pipes are sealed well

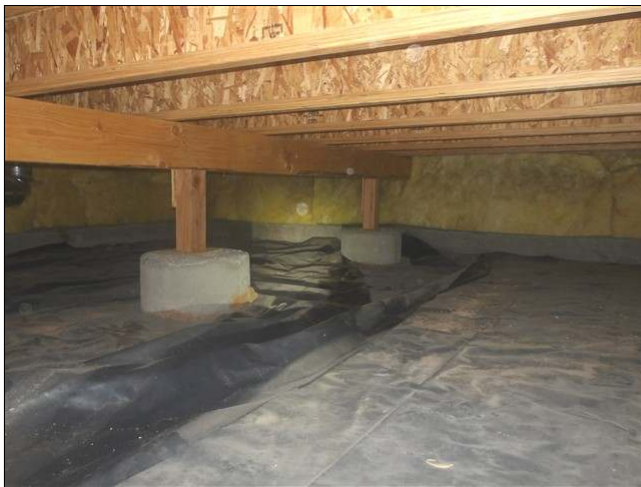
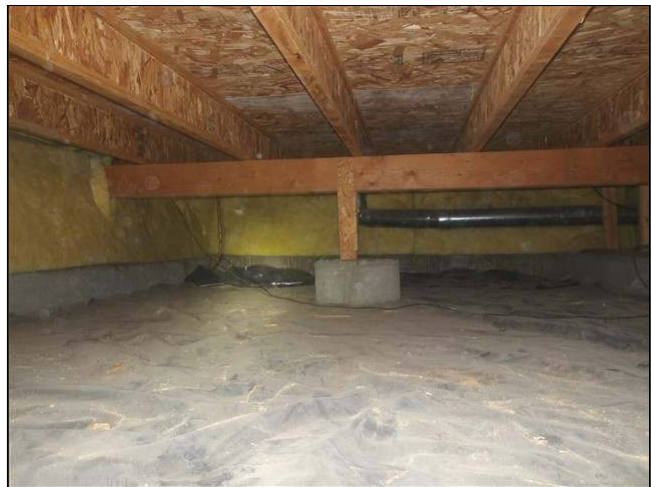
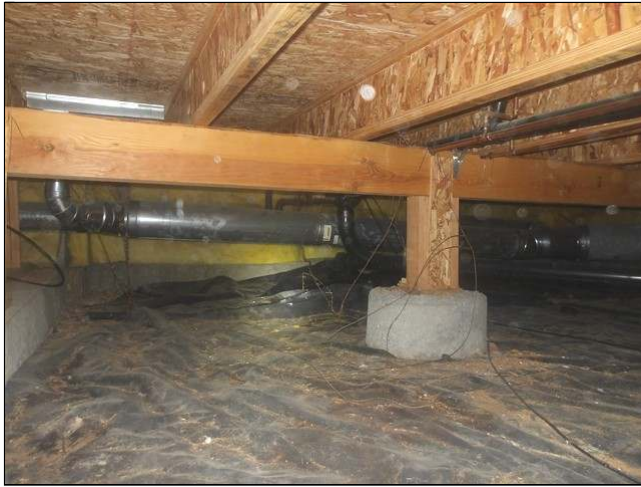
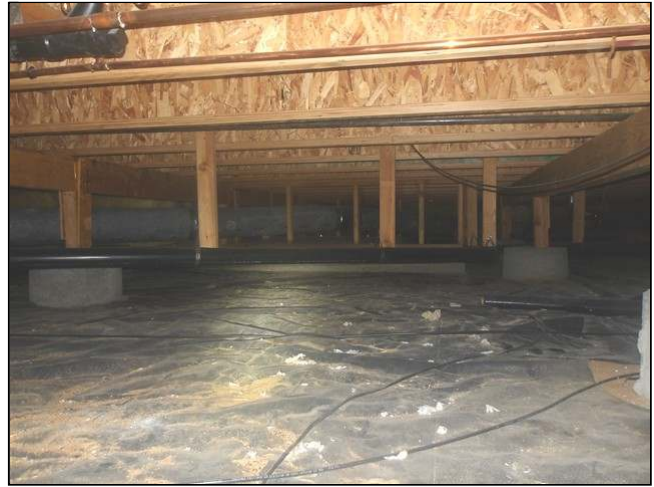
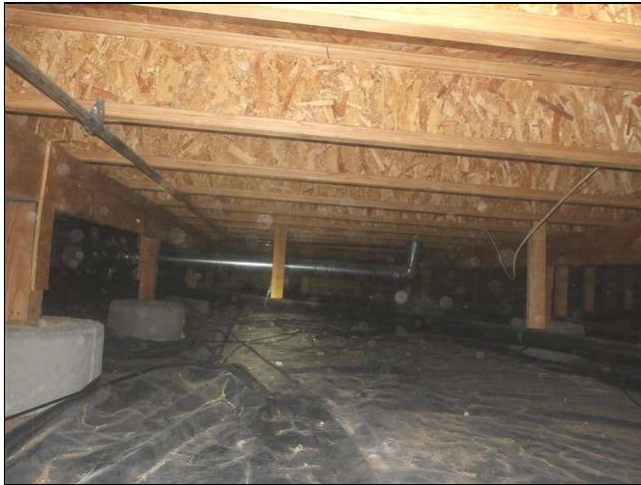
3.0 Item 1(Picture) view of crawlspace

Crawlspace, as seen at time of inspection.

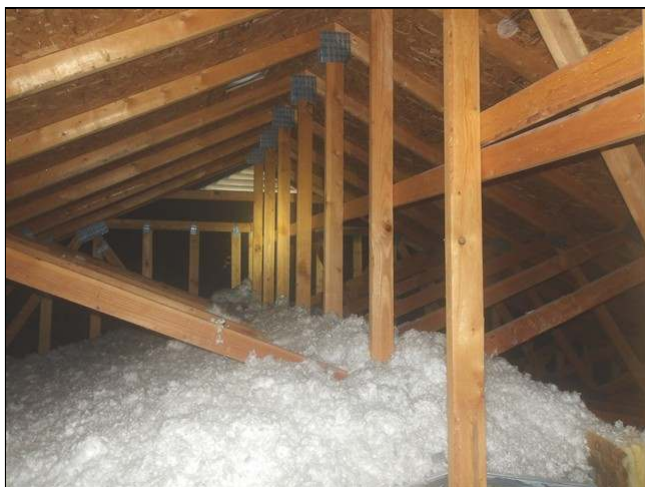
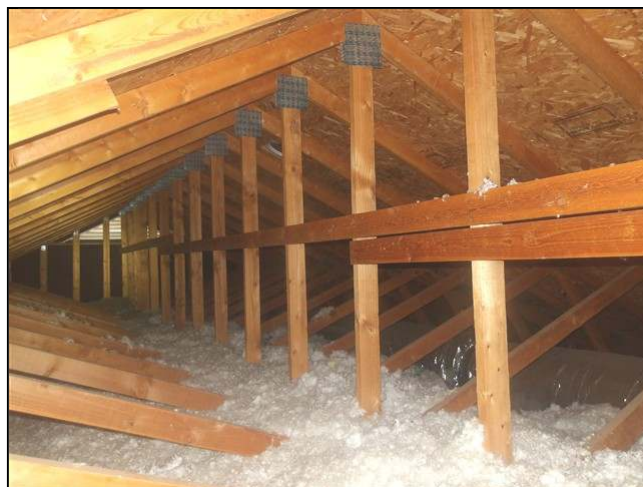
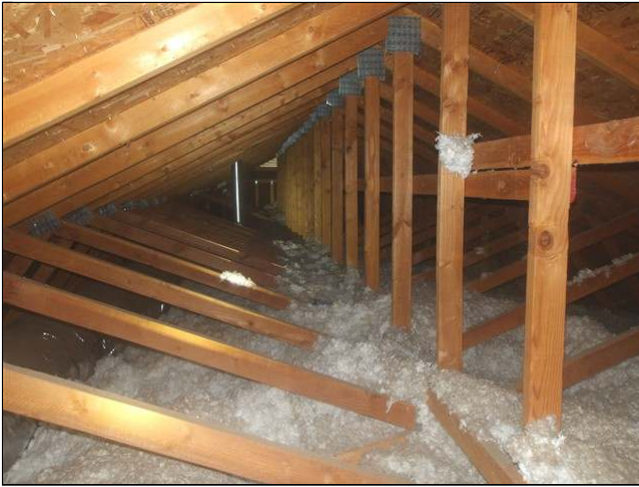
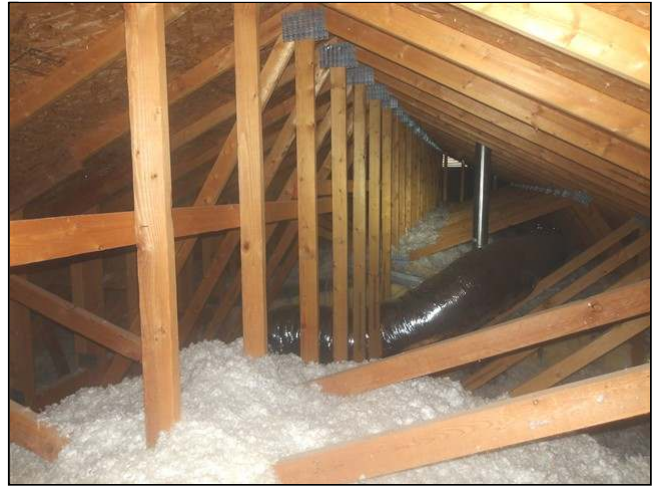
3.8 Item 1(Picture) view of attic

The Attic, as seen at time of Inspection.

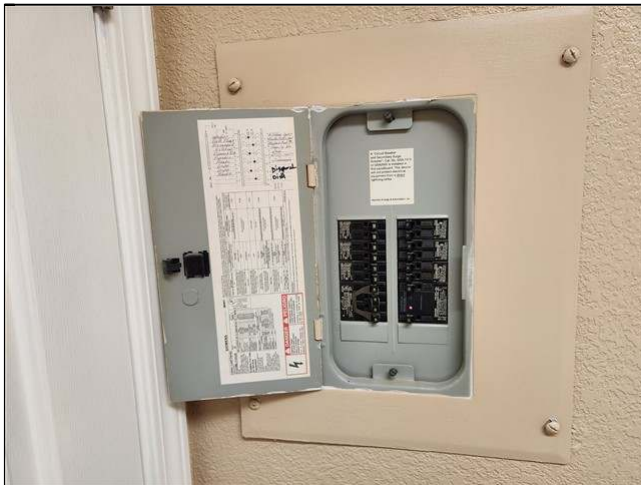
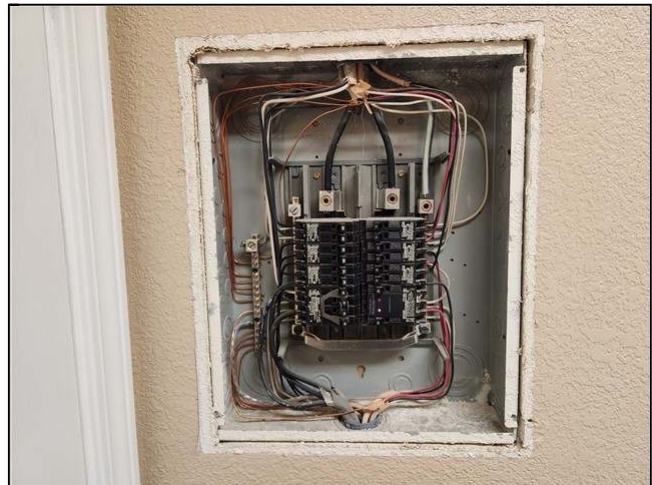
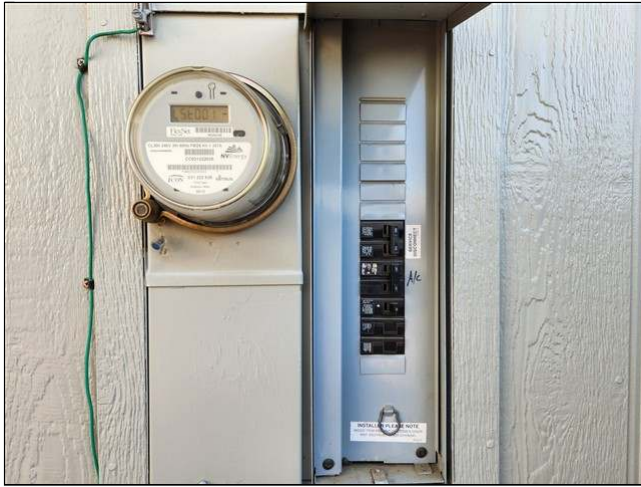
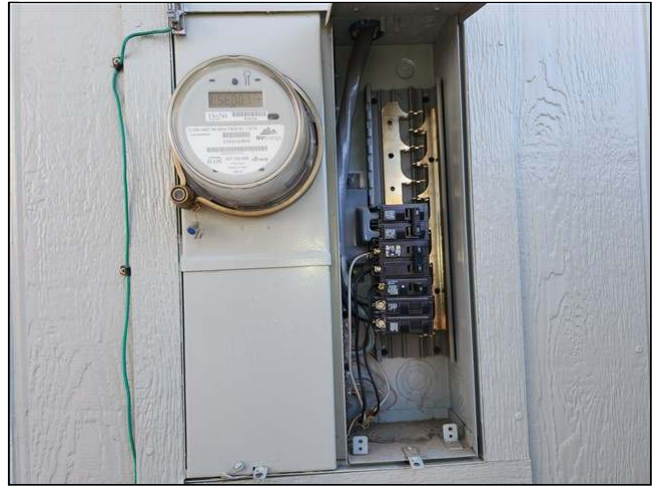
4.1 Item 1(Picture) laundry room panel

The Main and Distribution Panels are well labeled for circuit identification. "Dead front" cover appears serviceable. No problems noted.

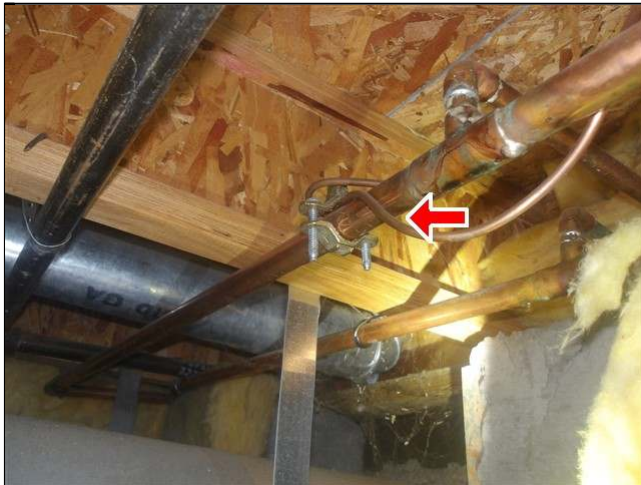
The Grounding system for the Main Service Panel is not visible due to construction materials. However, there is a Grounding wire present in the Panel, and there is a Bonding wire present at the cold water pipe, which are important for proper grounding (safety) of the home.

4.3 Item 1(Picture) bond to plumbing

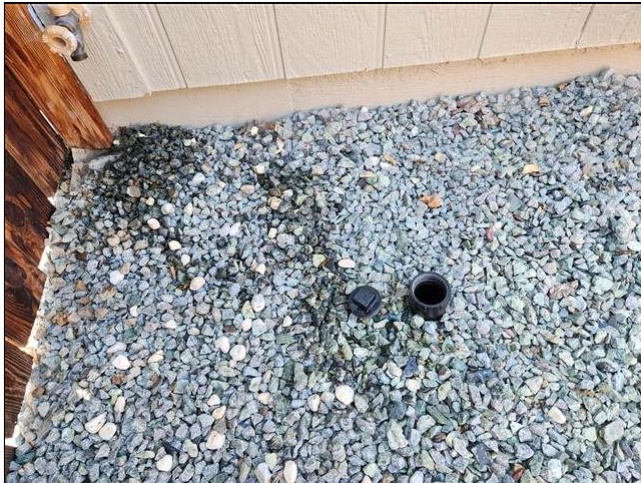
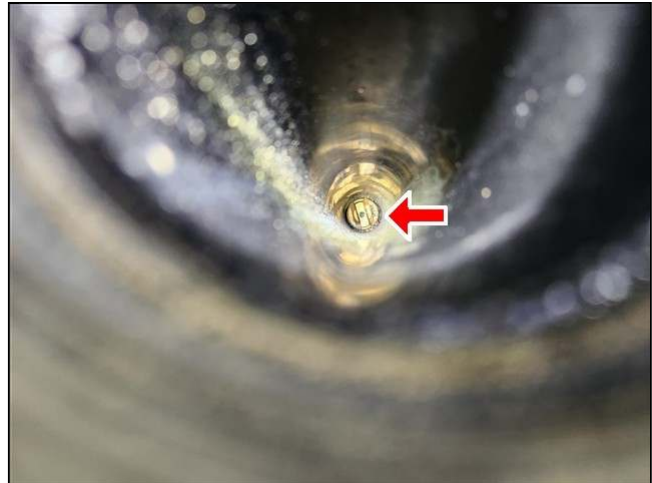
There are a couple main water shut-off locations. With the water meter at front of property (for emergencies), and at side yard to right of house. Note: Both of these locations will require a water key tool to operate. No obvious problems noted.

5.0 Item 1(Picture) main water shut-off valve location

5.0 Item 2(Picture) main water shut-off valve

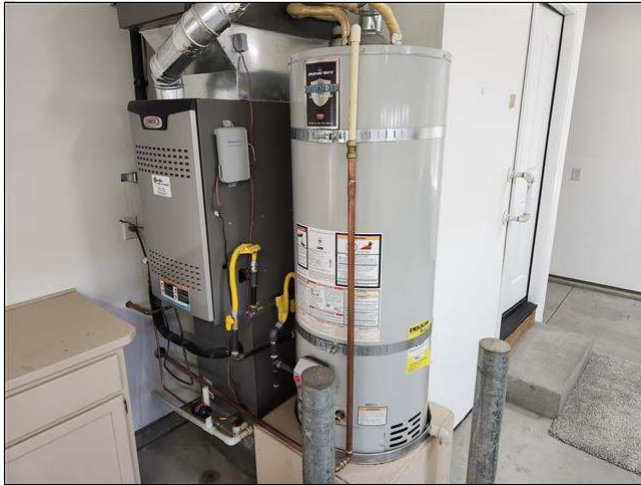
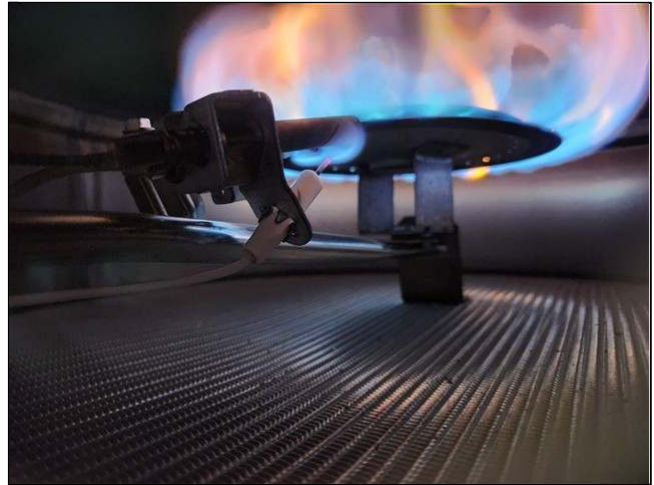
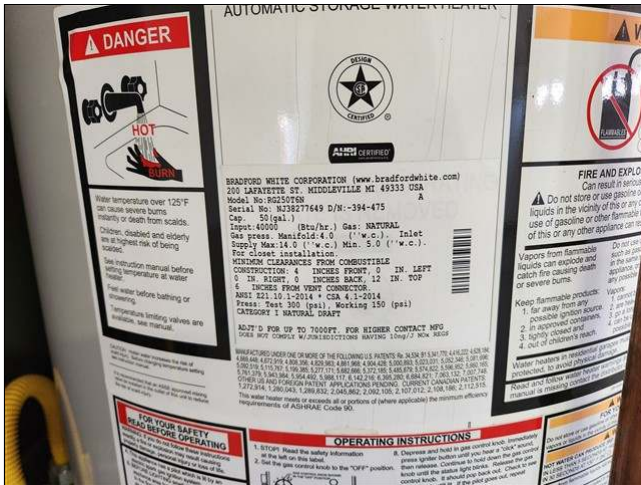
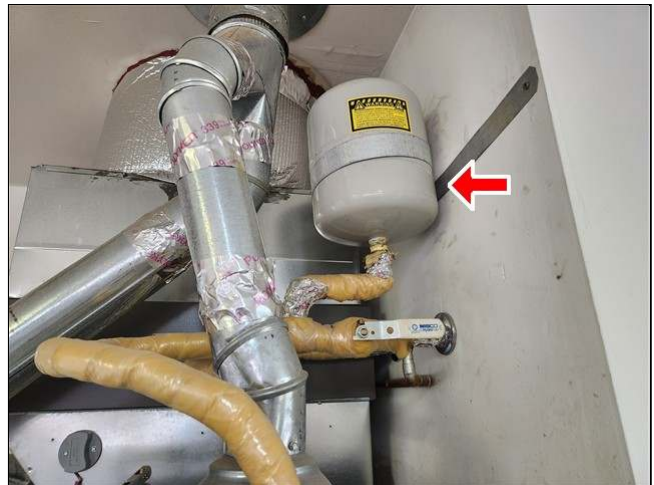
5.4 Item 1(Picture) water heater

(1) Temperature and Pressure Relief valve is piped to the exterior of the house, or within 6 inches of the floor (for safety). Water Heater is strapped with approved strapping material, and is setting on a pedestal minimum of 18" above the garage floor. Drip leg is installed in the gas line, water and fuel shut-off valves are present. Water heater operated as intended with no abnormal noises or leaks noted. No problems noted at time of inspection... Manufactured in 2016 by Bradford-White.

5.4 Item 4(Picture) Thermal Expansion tank

(2) Your water heater does have a "Thermal Expansion tank" installed to prevent a possible leak at the Temperature and Pressure relief valve, or "pop-off" valve, by absorbing the excessive pressure built-up in the water heater.

Temperature and Pressure Relief (TPR) valve should be checked Bi-Monthly for proper operation. A "sticking" valve could cause excessive pressure to build-up in the Water Heater, possibly causing damage to water heating unit. A valve that will not reseal when testing, is faulty as well. Recommend valve replacement by a qualified person if not operating properly.

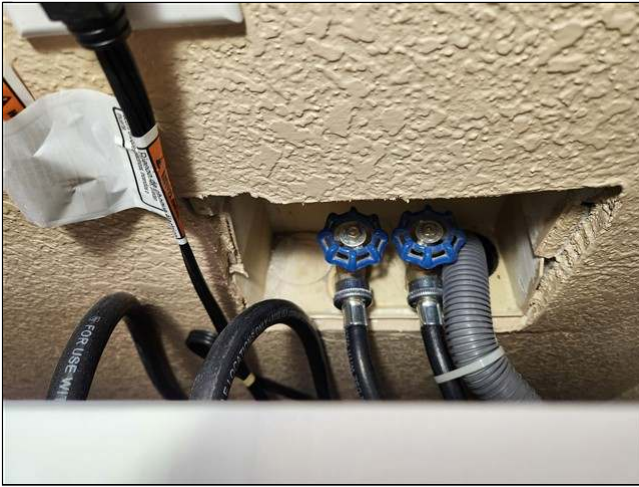
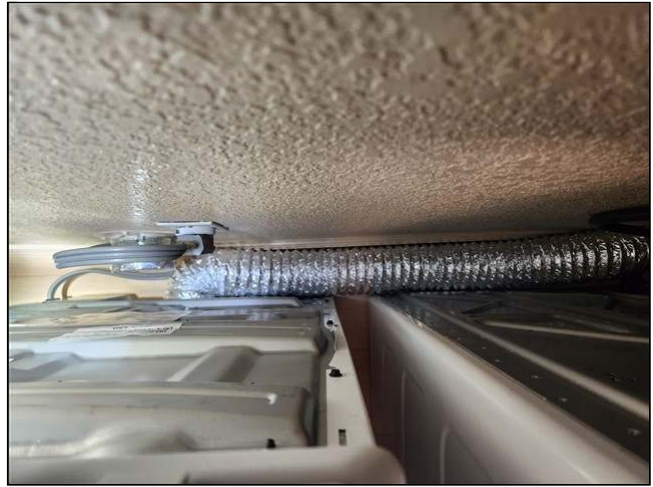
Washer and dryer hook-ups were inspected, with no problems noted. Dryer is electric powered with rigid metal venting installed through the wall and crawlspace area. Washer drain is 2" diameter, Hot and Cold hook-ups with no problems noted.

5.6 Item 1(Picture) Washer and dryer hook-ups

5.6 Item 2(Picture) Washer and dryer hook-ups

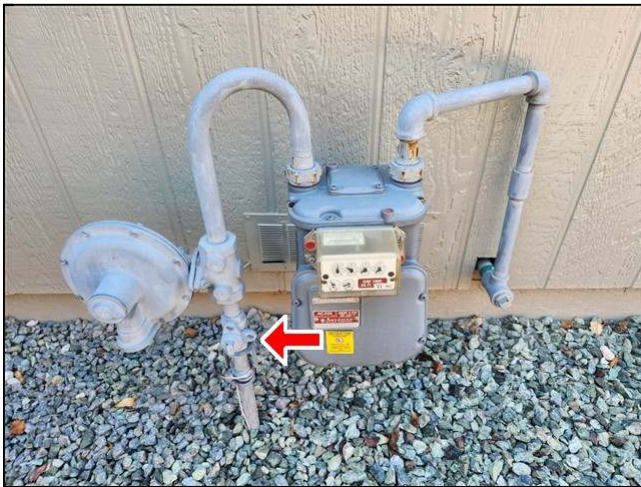
Located at the North side of the house with the gas meter. No problems noted.

5.11 Item 1(Picture) main fuel shut-off valve

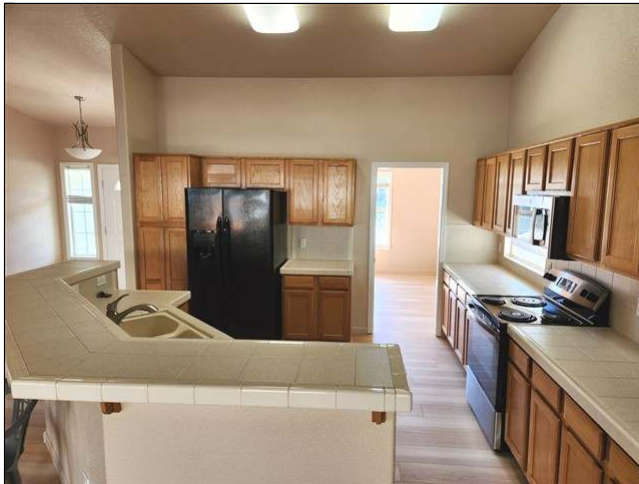
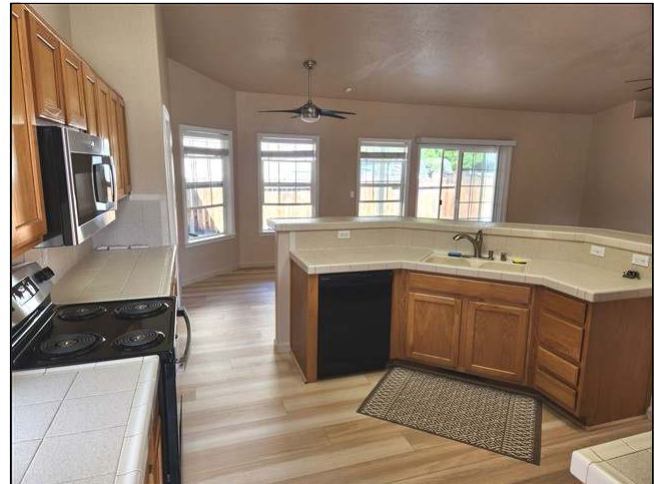
6.0 Item 1(Picture) view of kitchen

Kitchen, as seen at time of inspection.

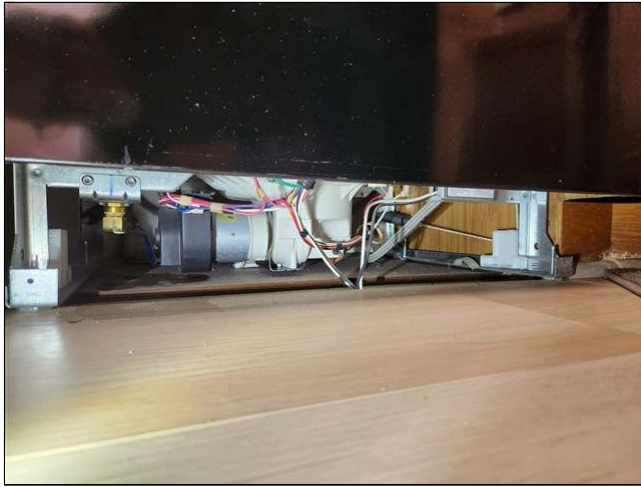
The Dishwasher was run through a complete cycle, with no leaks or abnormal noises noted. Inspection cover was removed to view the Dishwasher electric/plumbing hook-ups, Door seals and dish racks appear in serviceable condition. Mounted securely to under countertop. Drain hose is routed to a high loop prior to connecting to drain, as required to prevent backflow/siphon of waste into dishwasher.

6.1 Item 1(Picture) dishwasher hookups

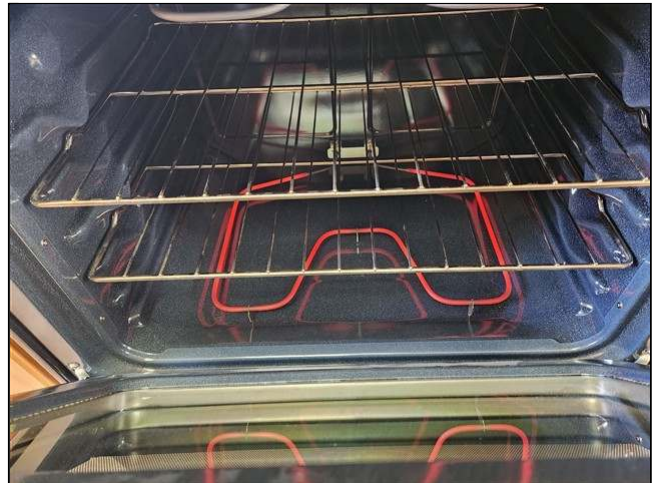
6.2 Item 2(Picture) oven operation

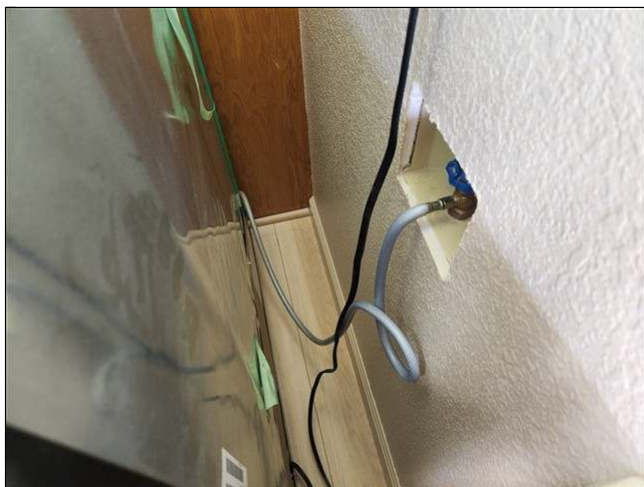
Refrigerator was operating at time of inspection. Door seals appear to be in good condition. The Fridge and Freezer temperatures were 49 and 24 degrees respectively at time of inspection.

6.6 Item 1(Picture) behind refrigerator

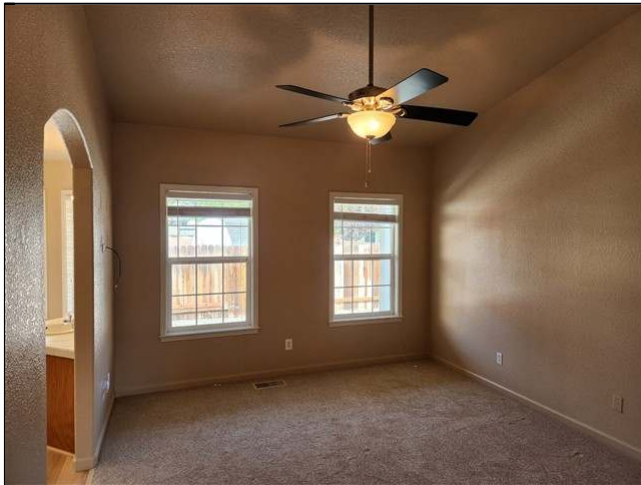
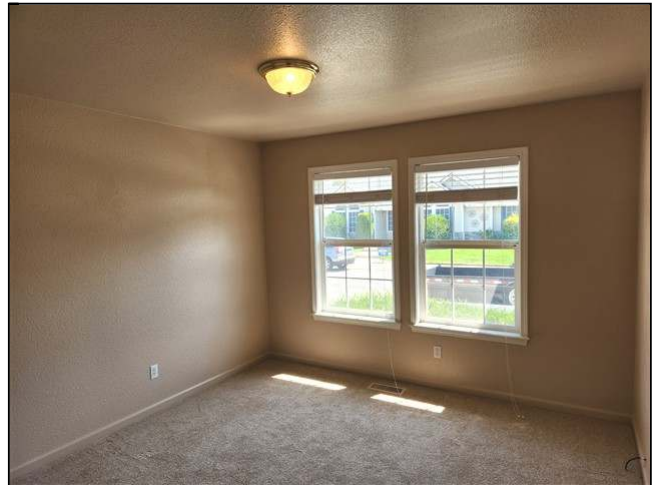
7.0 Item 1(Picture) view of interior

Interior, as seen at time of inspection.

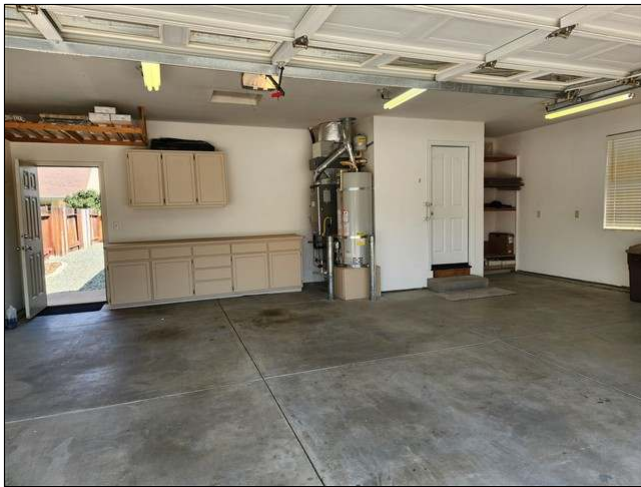
8.0 Item 1(Picture) view of garage

Garage, as seen at time of inspection.

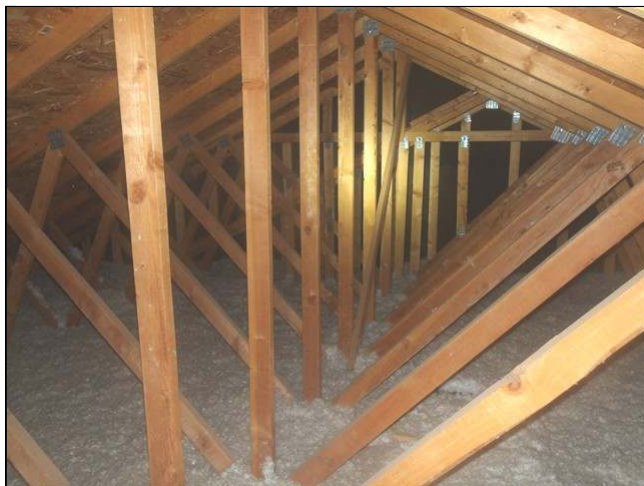
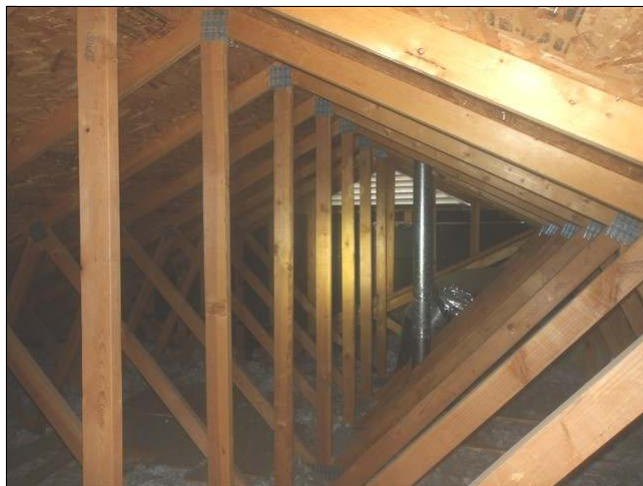
8.11 Item 1(Picture) view of garage roof structure

Garage attic area as seen at time of inspection. NOTE: Garage ceiling is insulated with R19 loose-fill fiberglass.

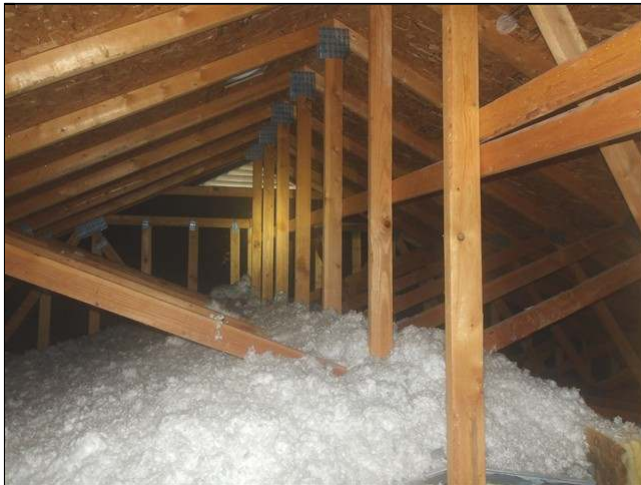
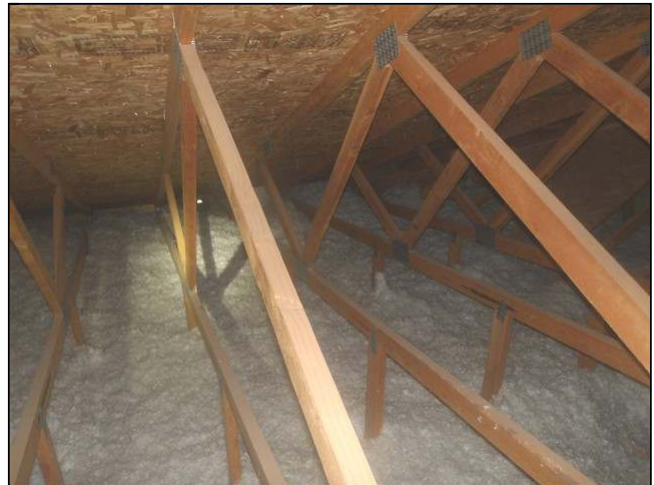
9.0 Item 1(Picture) view of attic insulation

(1) The attic insulation is blown-in, loose-fill, and is approximately 10 to 12 inches deep (R-30), with a few thinner areas noted. No major problems noted.

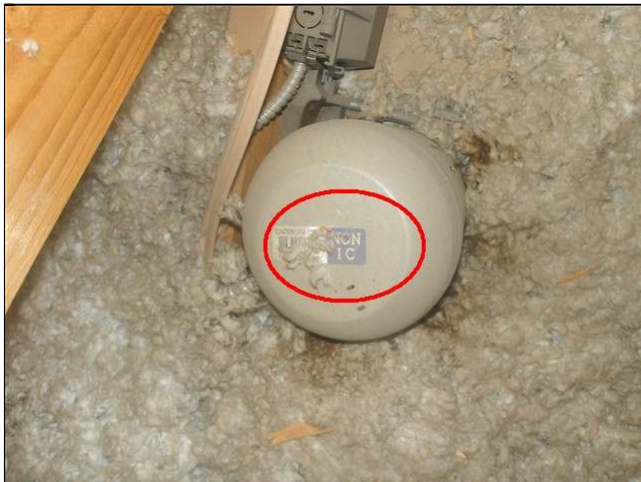
(2) NOTE: Ceiling "can" lighting uses "non-insulation contact" type, which shouldn't make contact with the ceiling insulation due to heat created by the light fixture. There are several can lights currently with insulation contact in various locations throughout the attic area, and should be cleared to eliminate contact.

9.0 Item 3(Picture) "non-insulation contact" type

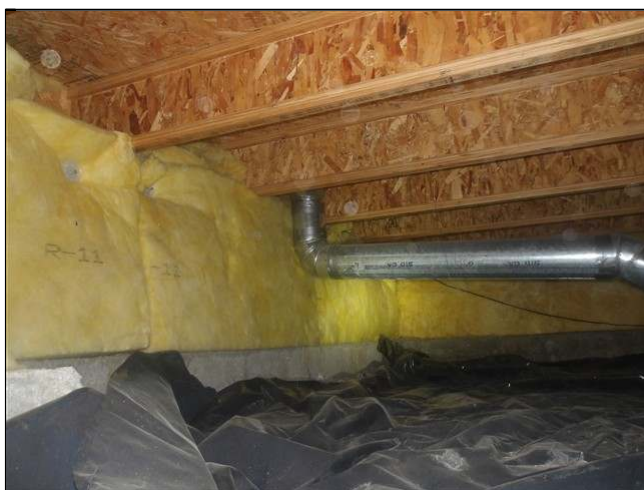
9.1 Item 1(Picture) view of crawlspace insulation

The crawlspace area is insulated on the perimeter of the foundation using R11 fiberglass Batts, no problems noted.

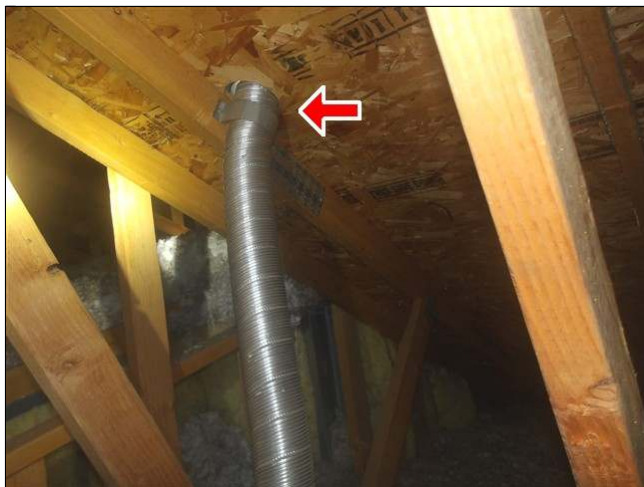
(1) Most Bathrooms and Laundry vents are properly ducted to the exterior of the home... Kitchen uses a recirculation type of range hood.

9.4 Item 1(Picture) properly ducted to the exterior

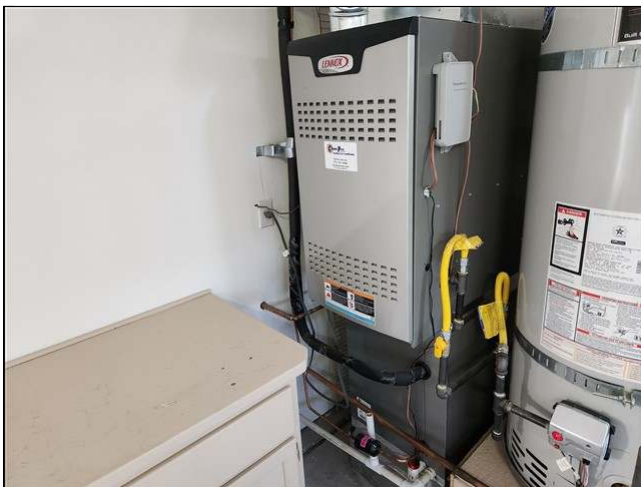
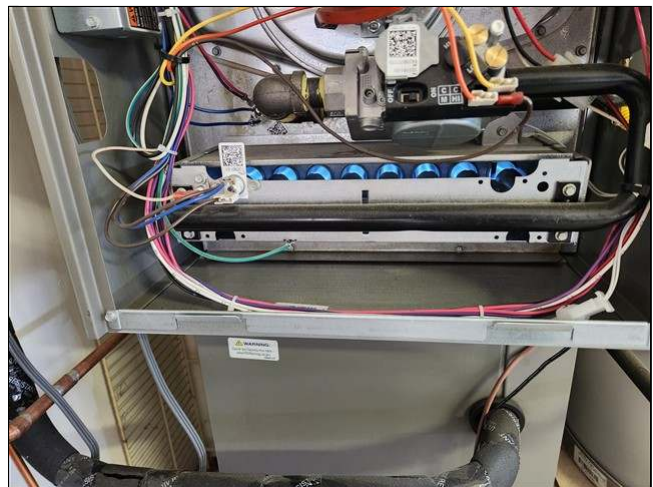
10.0 Item 1(Picture) forced air furnace

The heating equipment is NOT original (3 years). The furnace is a vertical downdraft natural gas fired forced air unit, Rated at 88,000btu's, that operated as intended with normal operating controls. The burners have an even blue flame. Manufactured in 2023 by LENNOX heating.

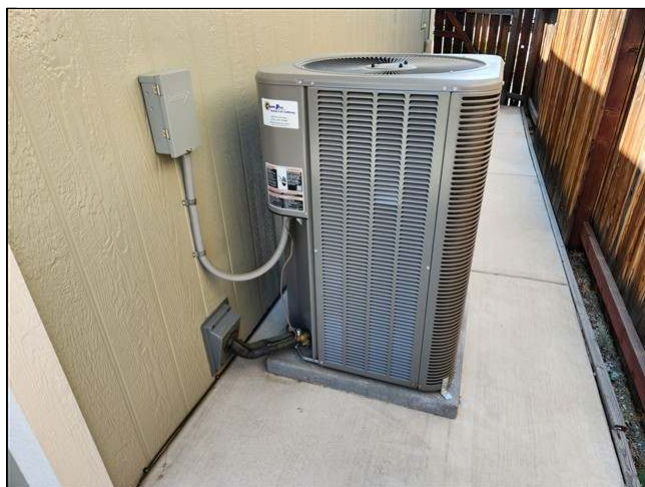
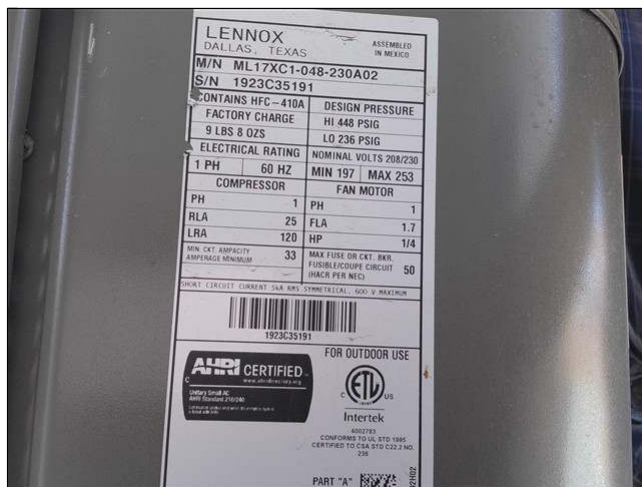
10.5 Item 1(Picture) condensing unit

The ambient air test was performed by using thermometers on the air handler of Air conditioner to determine if the difference in temperatures of the supply and return air are between 14 degrees and 22 degrees which indicates that the unit is cooling as intended. The supply air temperature on your system read 56 degrees, and the return air temperature was 71 degrees (a/c cabinet temperature measured 82 degrees). This indicates the range in temperature drop is normal. Condensing unit operated as intended with normal operating controls, and no abnormal noises noted. Unit was manufactured in 2023 by LENNOX.

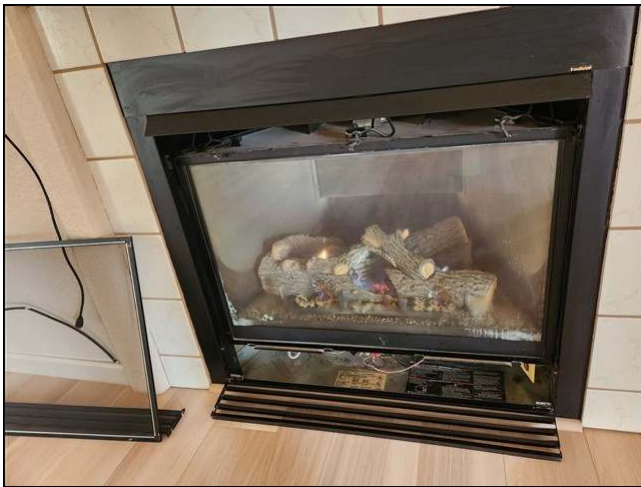
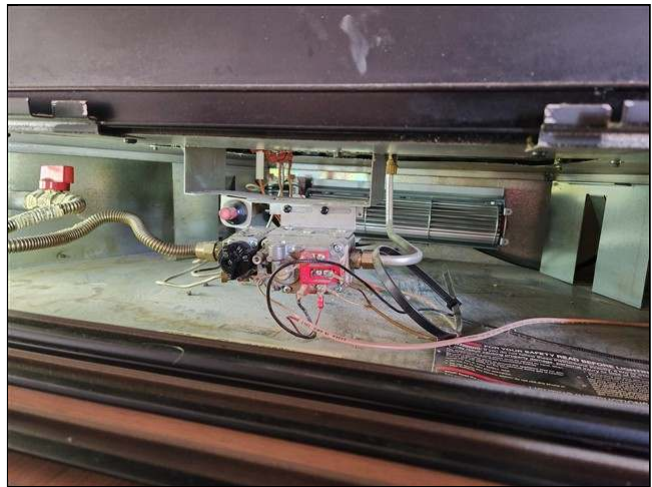
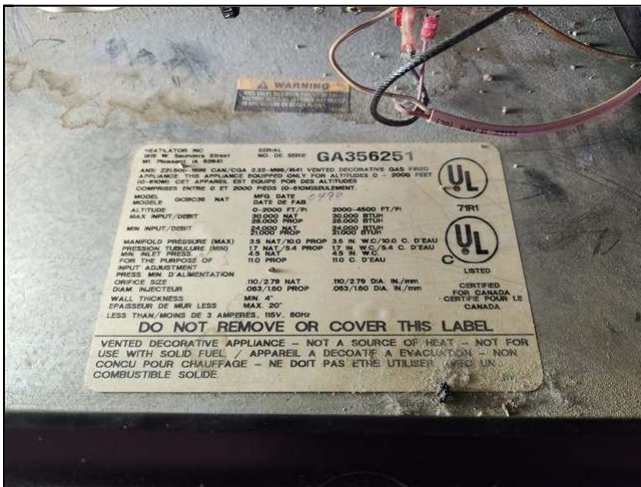
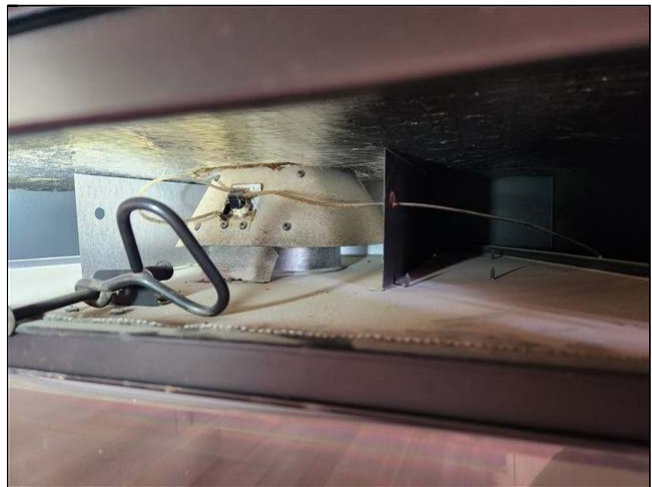
11.0 Item 1(Picture) Fireplace unit in Living room

Fireplace unit in Living room was turned off upon arrival for inspection. Pilot light was ignited using normal operating controls. Firelogs ignited, and blower fan operated using the wall mounted control switches located to right of f/p unit. No problems noted at time of inspection.

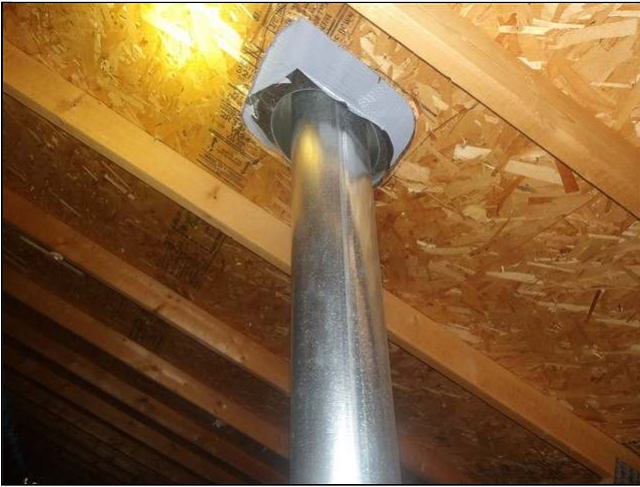
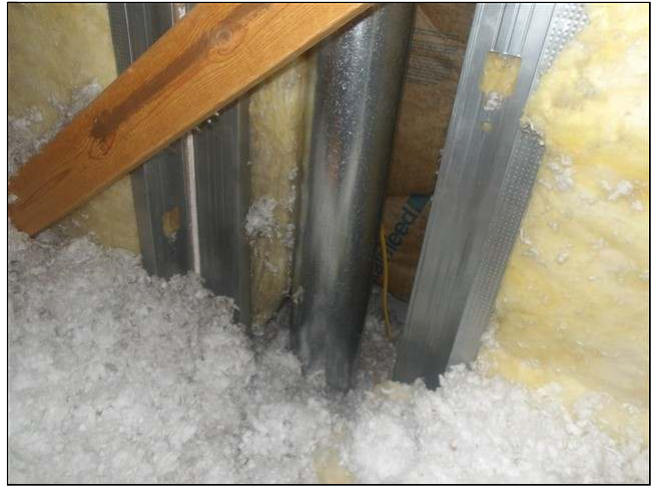
Chimney pipe has proper clearances from combustible materials at ceiling and roof penetrations.

11.1 Item 1(Picture) proper clearances from combustible materials

11.1 Item 2(Picture) proper clearances from combustible materials
