Inspection Report

Property Address:
1926 Currant Ct.
Gardnerville NV 89410

Clear Choice Home Inspection Services

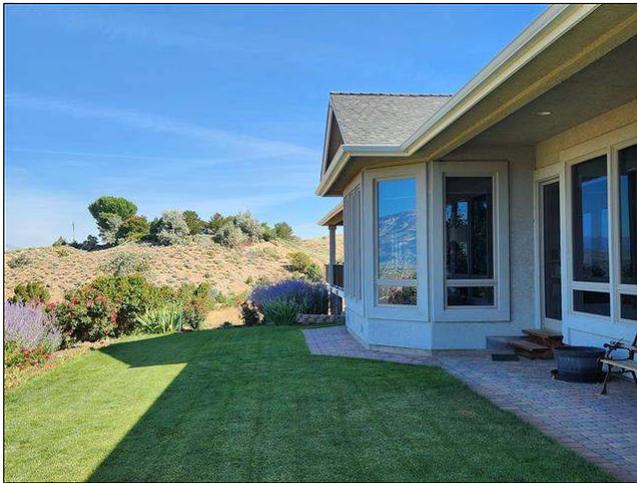
1.0 Item 1(Picture) view of exterior

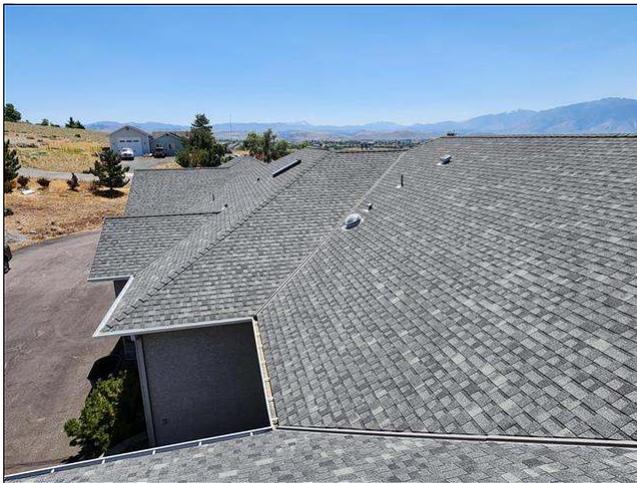
2.0 Item 1(Picture) view of roof

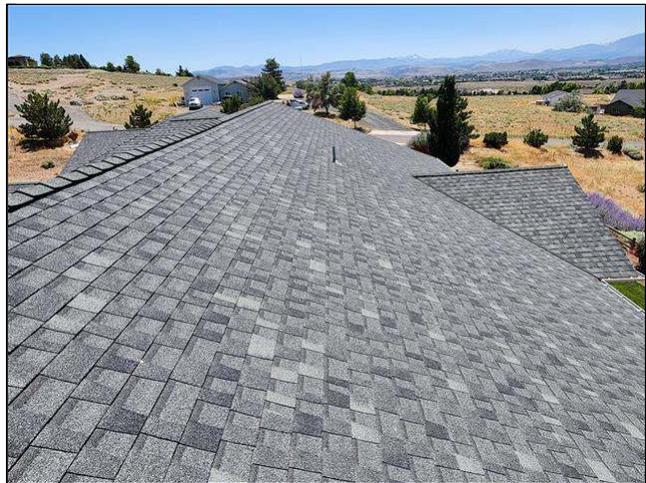
2.0 Item 2(Picture) view of roof

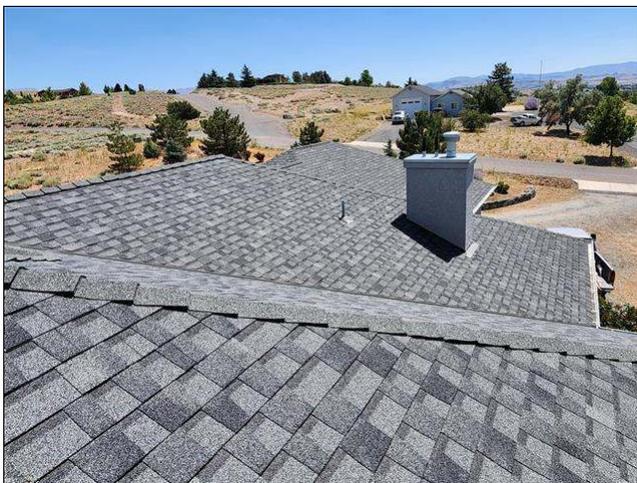
2.0 Item 3(Picture) view of roof

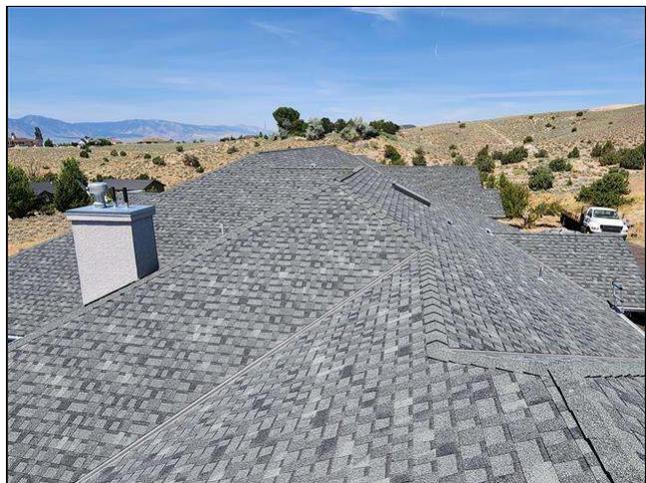
2.0 Item 4(Picture) view of roof

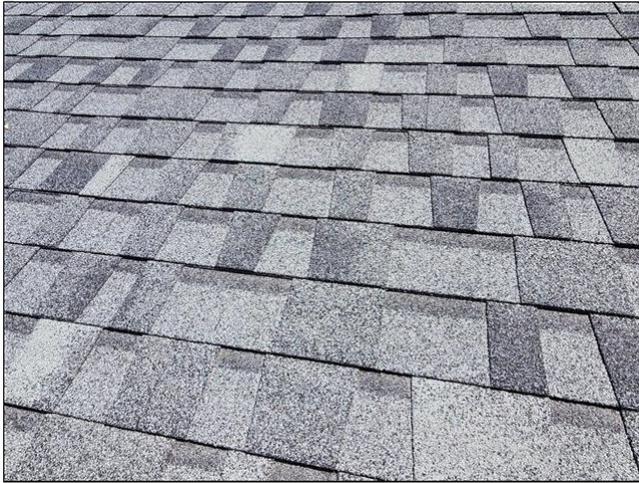
The roof covering appears to be original (16 years) and is a 30/40 year architectural, asphalt/fiberglass Composition shingle with much of it's life remaining. Typical loss of granules noted from shingles. No problems noted at time of inspection.

2.1 Item 1(Picture) condition of roof shingles

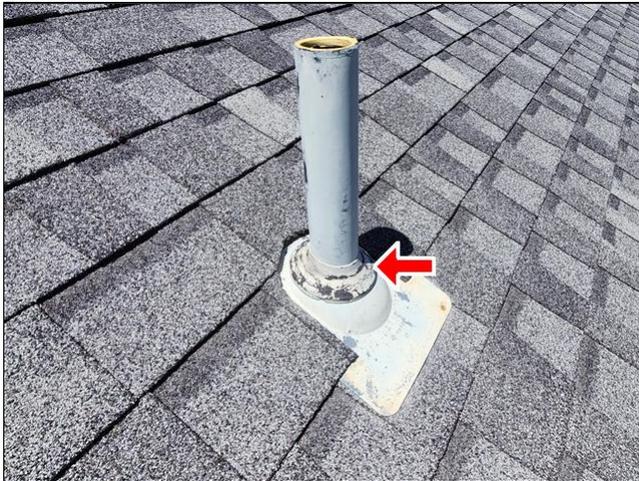
(1) Plumbing and furnace vent pipes are sealed well against flashings to prevent moisture intrusion into attic framing areas.

2.3 Item 1(Picture) plumbing vent pipes sealed well

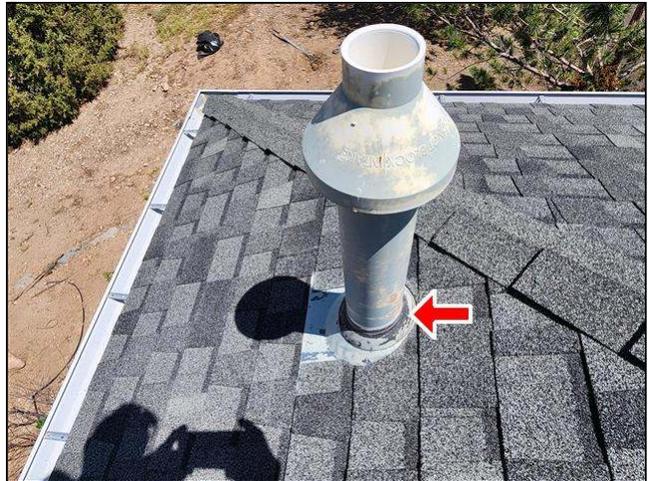
2.3 Item 2(Picture) flue pipe sealed well

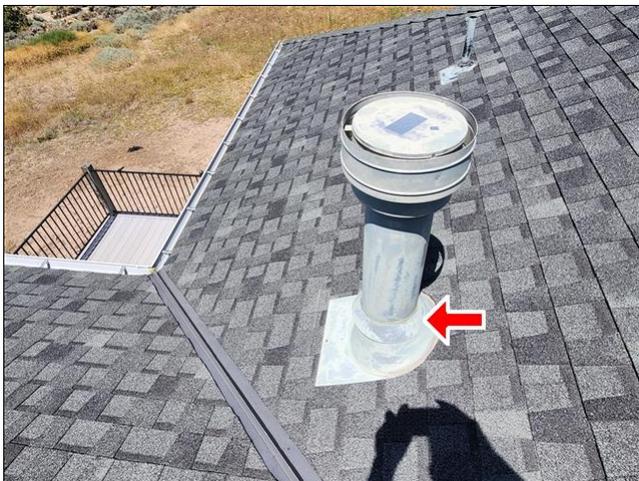
2.3 Item 3(Picture) chimney flue pipe sealed well

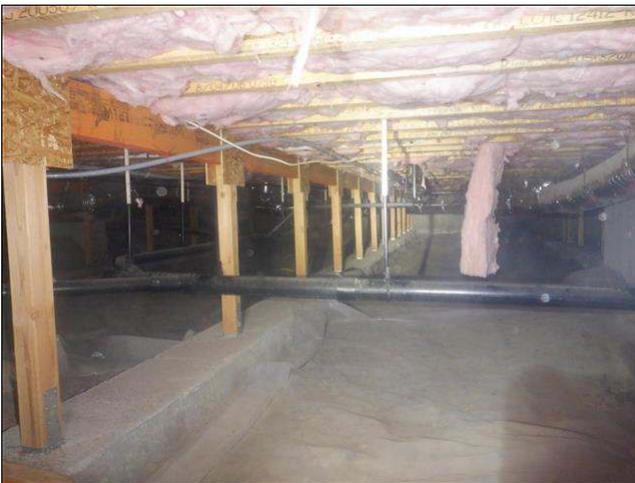
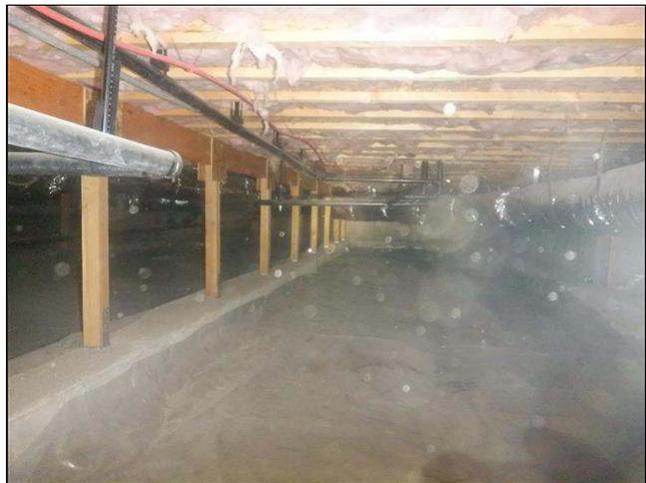
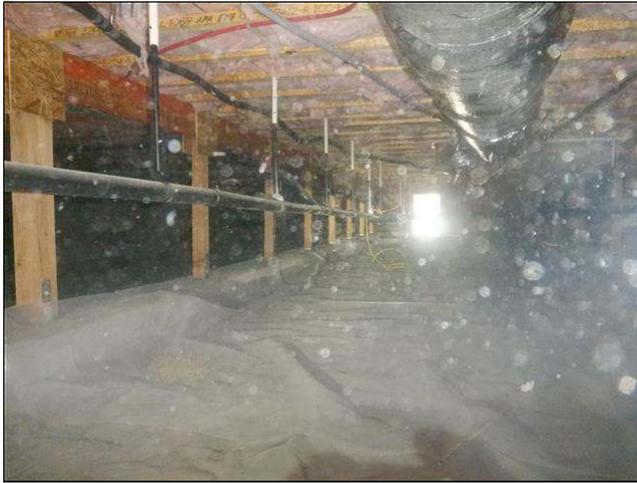
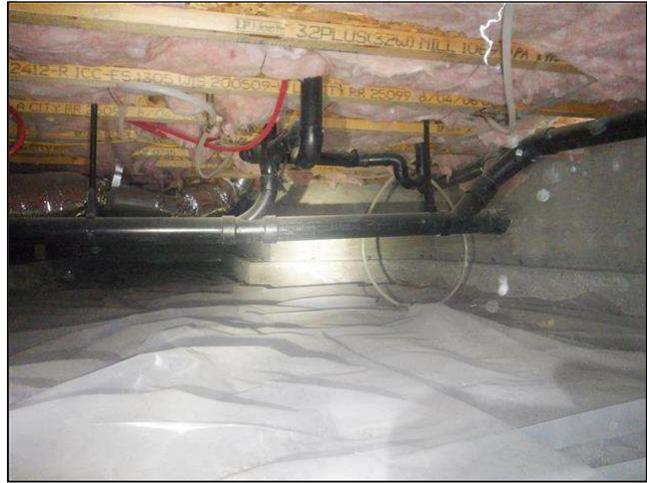
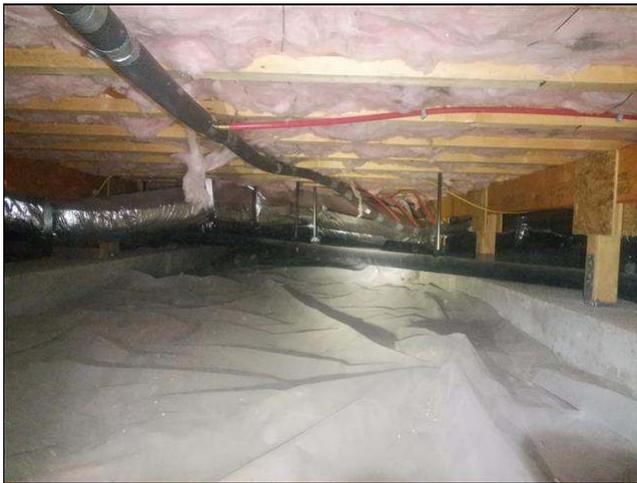
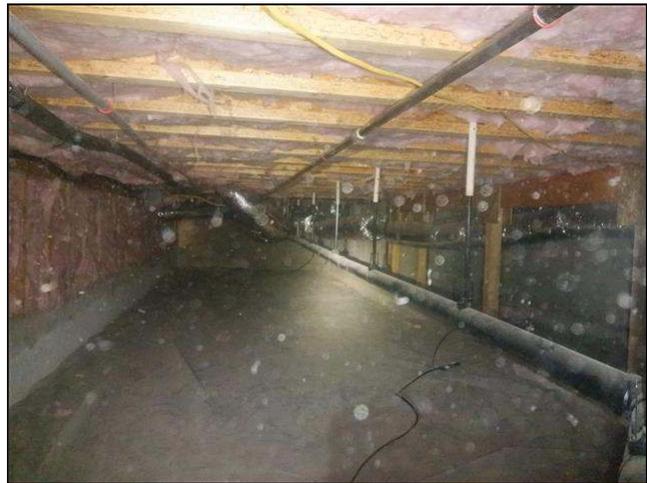
Comments: Inspected
Crawlspace, as seen at time of inspection.

3.0 Item 1(Picture) view of crawlspace

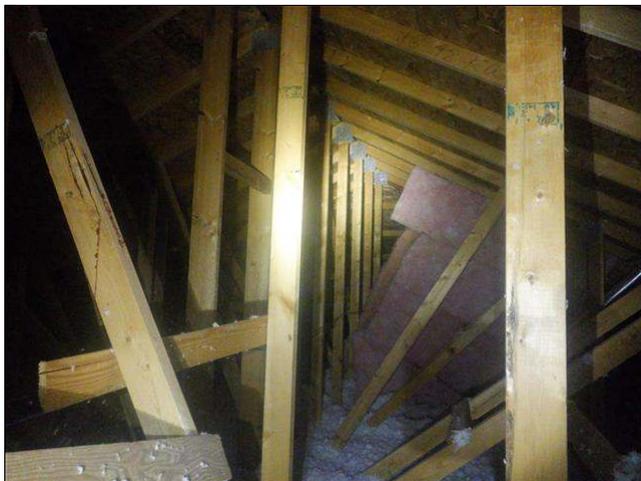
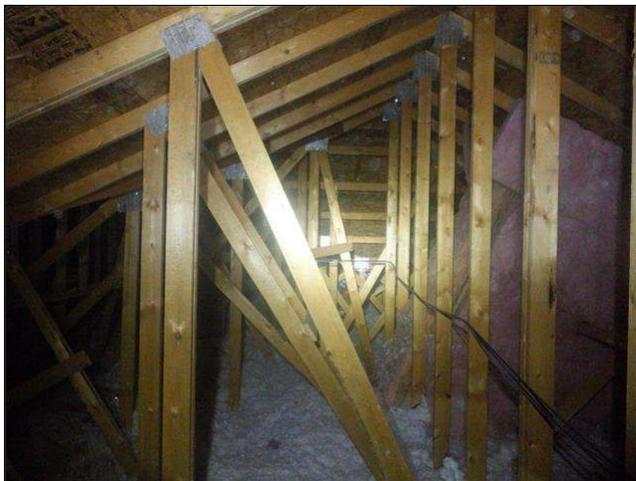
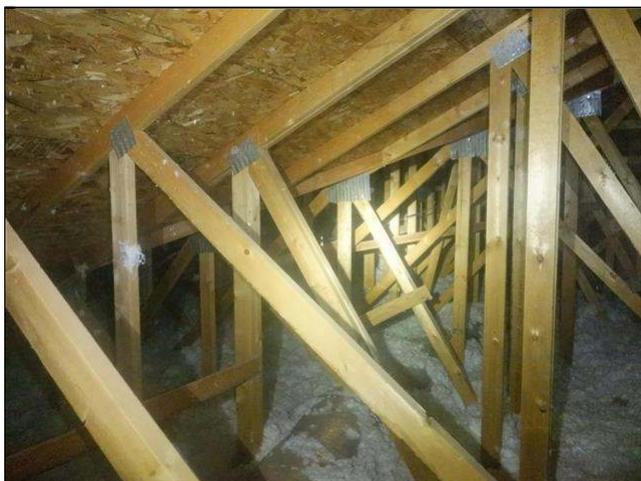
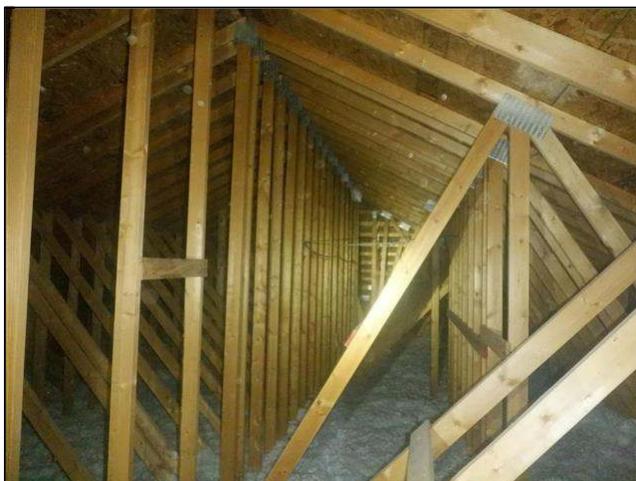
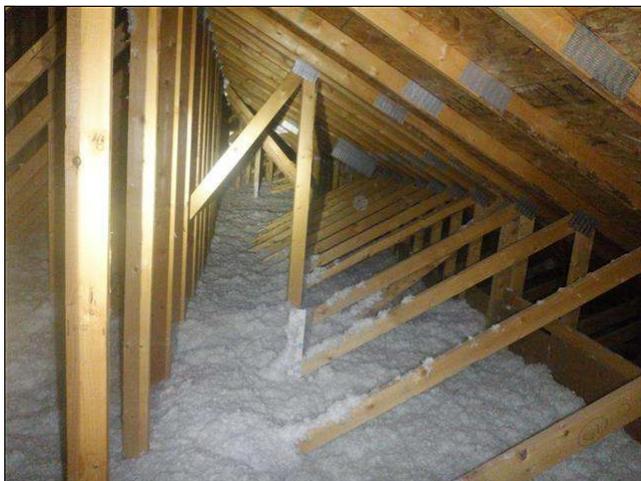
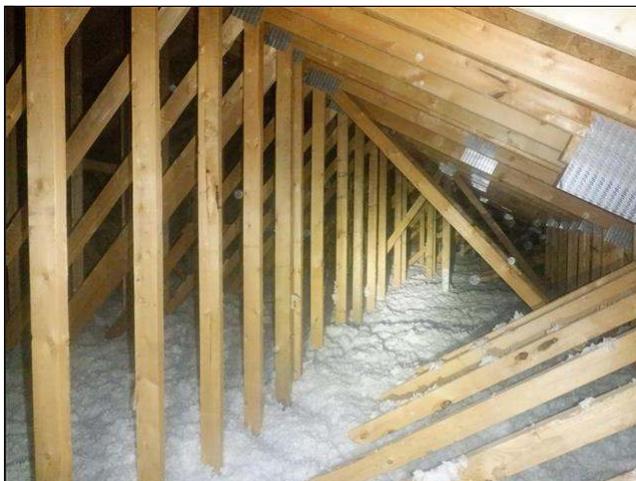
The Attic, as seen at time of Inspection.

3.8 Item 1(Picture) view of attic

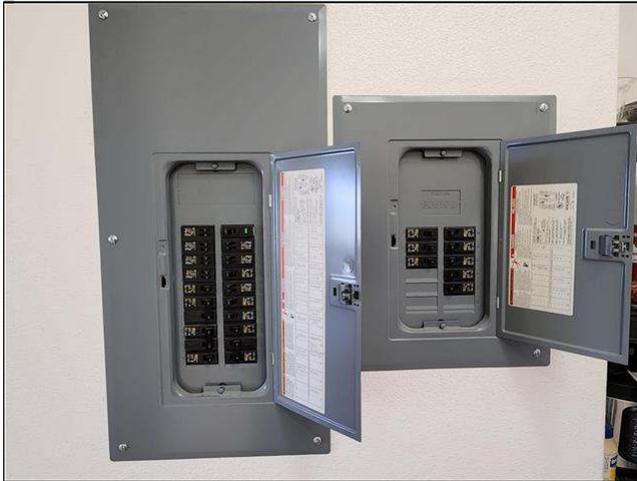
(1) The Distribution Panels are well labeled for circuit identification. "Dead front" cover appears serviceable. No problems noted.

4.1 Item 1(Picture) laundry room panels

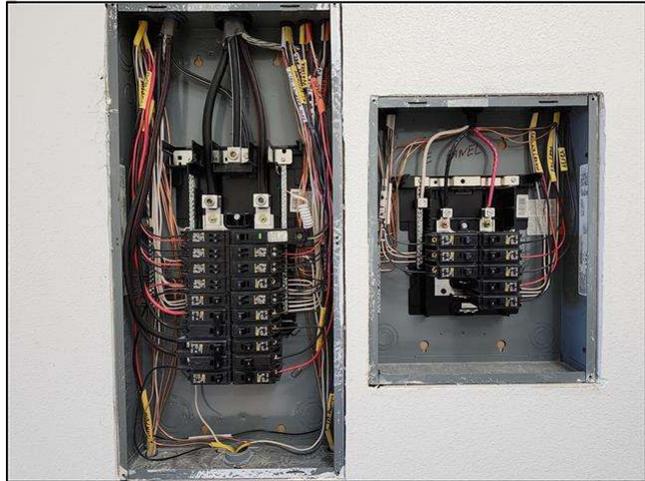
4.1 Item 2(Picture) panel conductors

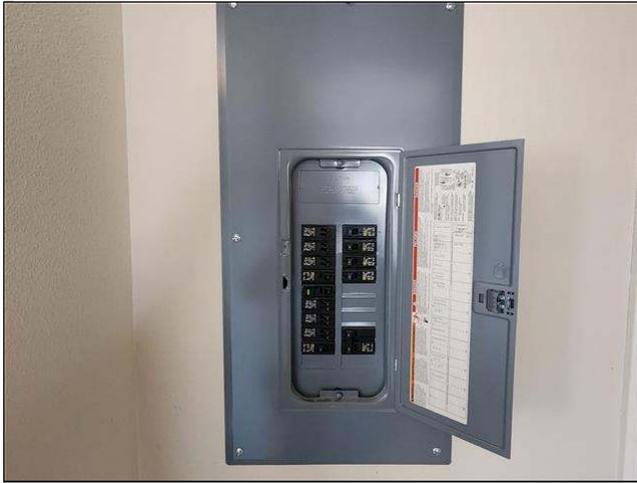
4.1 Item 3(Picture) hallway panel

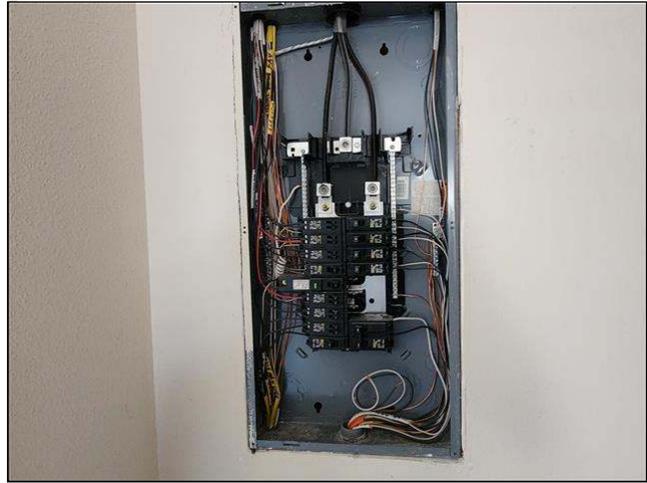
4.1 Item 4(Picture) panel conductors

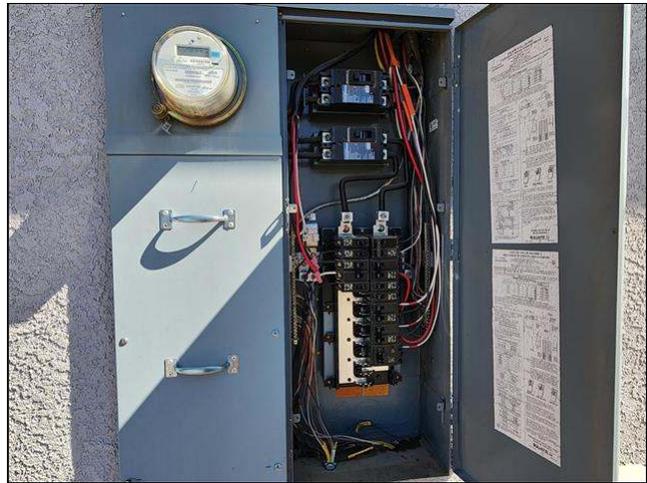
4.1 Item 6(Picture) main panel conductors

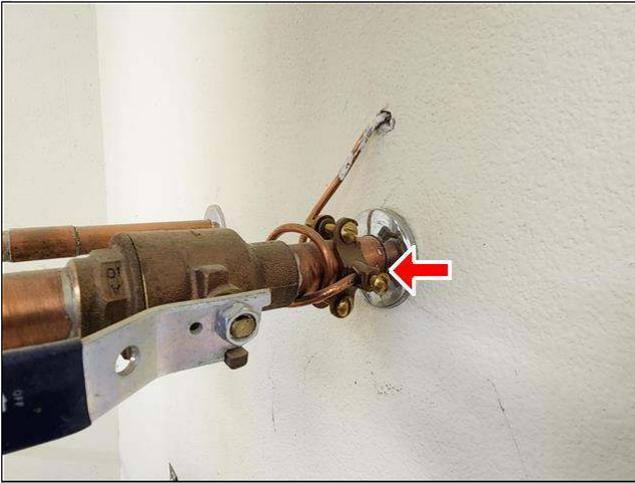
The Grounding system for the Main Service Panel is not visible due to construction materials. However, there is a Grounding wire present in the Panel, and there is a Bonding wire present at the cold water pipe, which are important for proper grounding (safety) of the home.

4.3 Item 1(Picture) bond to plumbing

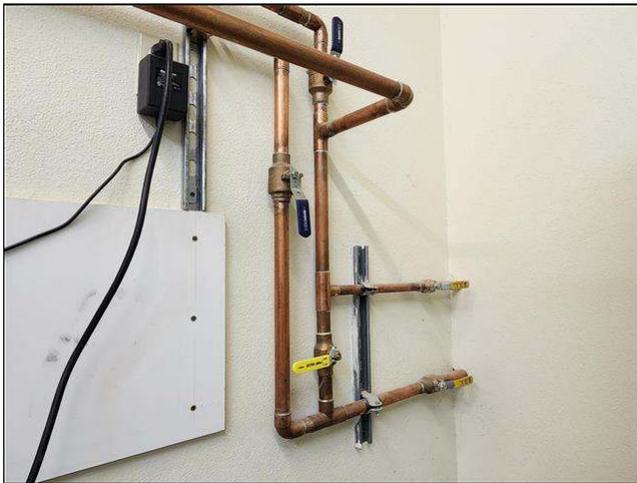
The main water shut-off valve for the house is located in the garage, with the well pump equipment. Function as intended.

5.0 Item 1(Picture) water shut-off valves for home

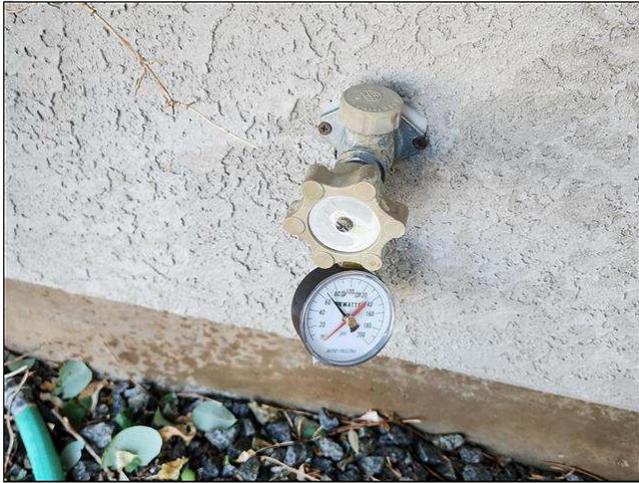
(1) The water pressure was tested at the West hose bib, pressure was 65 psi at time of inspection.

5.2 Item 1(Picture) water pressure at west hose bib

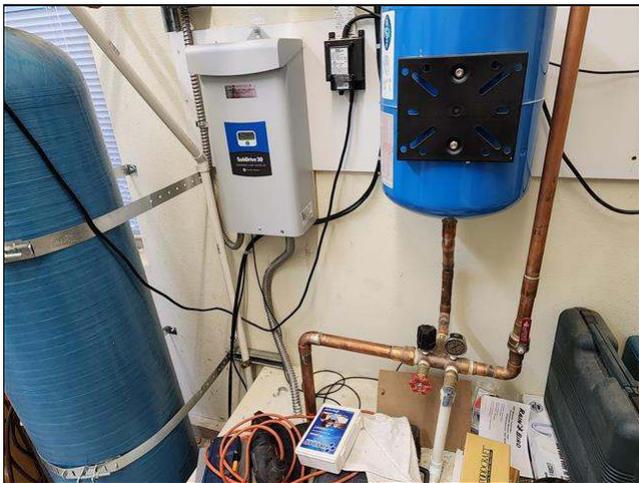
(3) The water supply system was fully operational as intended at time of inspection. The working system pressure fluctuated between 55 and 65 psi during the inspection. Pressure tank is 125 psi, and the pump controller is for a submersible type pump, which is not visible or accessible. No obvious problems noted.

5.2 Item 3(Picture) well pump equipment

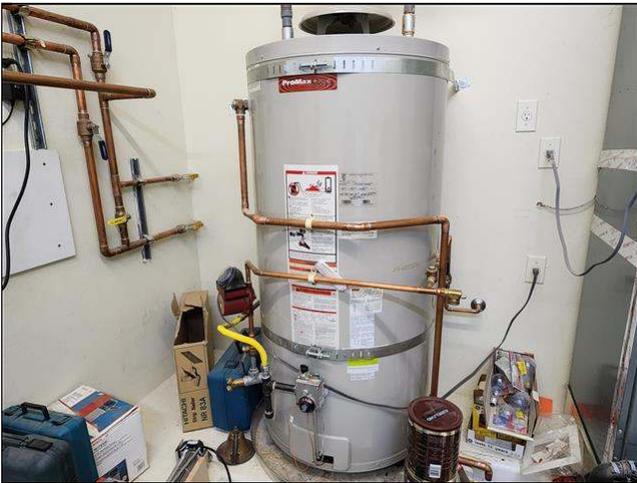
(1) Temperature and Pressure Relief valve is piped to the exterior of the house, or within 6 inches of the floor (for safety). Water Heater is strapped with approved strapping material, and is setting on a pedestal minimum of 18" above the garage floor. Drip leg is installed in the gas line, water and fuel shut-off valves are present. Water heater operated as intended with no excessive noises or leaks noted. No problems noted with w/h operation at time of inspection... Manufactured in 2007 by A.O. Smith. NOTE: Slight "Knocking" noise heard coming from water heater while unit was heating. This condition is often caused by calcium build-up at the bottom of the water heater tank, being "pushed up" by boiling water. Flushing of the water heater can sometimes eliminate the noise, Recommend consulting a licensed plumber for further evaluation as necessary.

5.4 Item 1(Picture) water heater

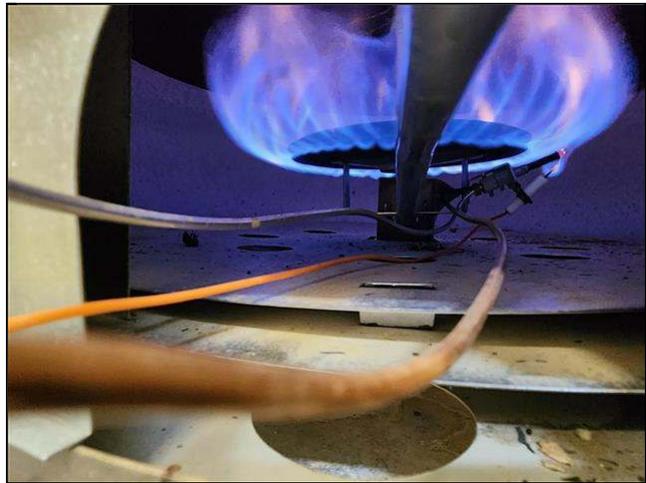
5.4 Item 2(Picture) w2ater heater burner compartment

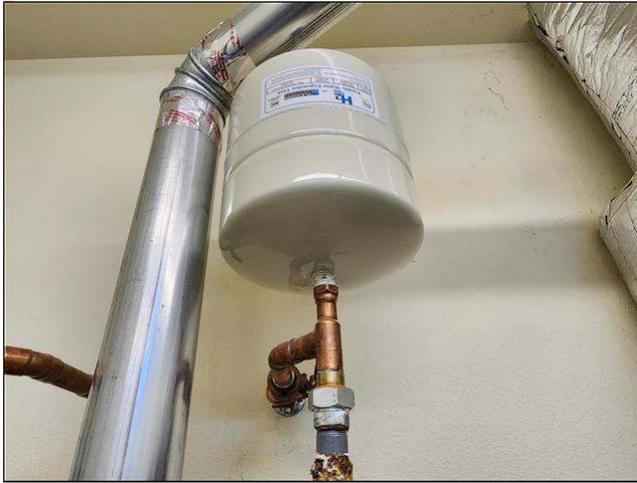
(2) Your water heater does have a "Thermal Expansion tank" installed to prevent a possible leak at the Temperature and Pressure relief valve, or "pop-off" valve, by absorbing the excessive pressure built-up in the water heater.

5.4 Item 3(Picture) thermal expansion tank

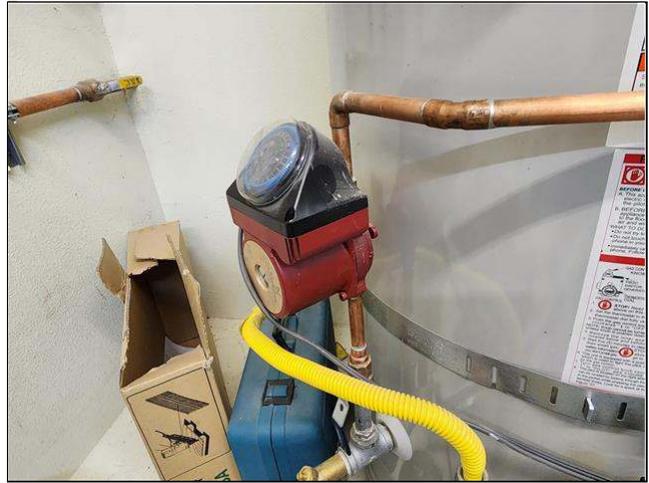
Recirculation pump for hot water is present, and operating as intended at time of inspection. No problems noted.

5.4 Item 4(Picture) recirculation pump

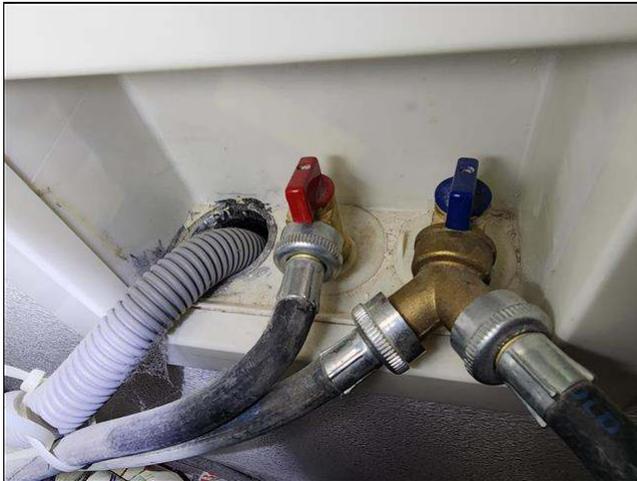
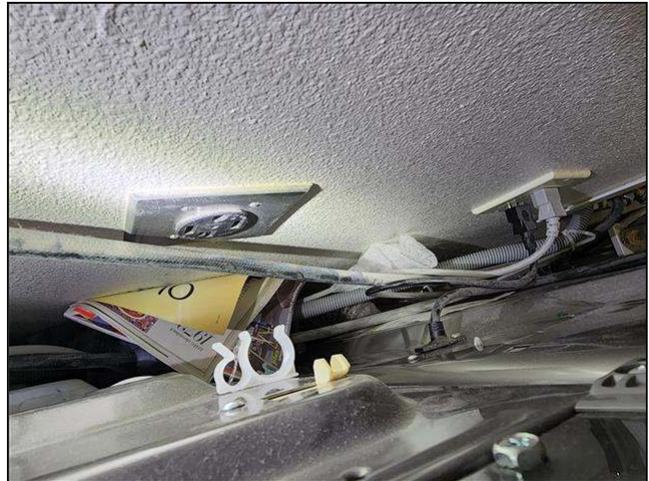
Washer and dryer hook-ups were inspected, with no problems noted. Dryer is electric or gas powered with rigid metal venting installed in the crawlspace. Washer drain is 2" diameter, Hot and Cold hook-ups with no problems noted.

5.6 Item 1(Picture) laundry hook-ups

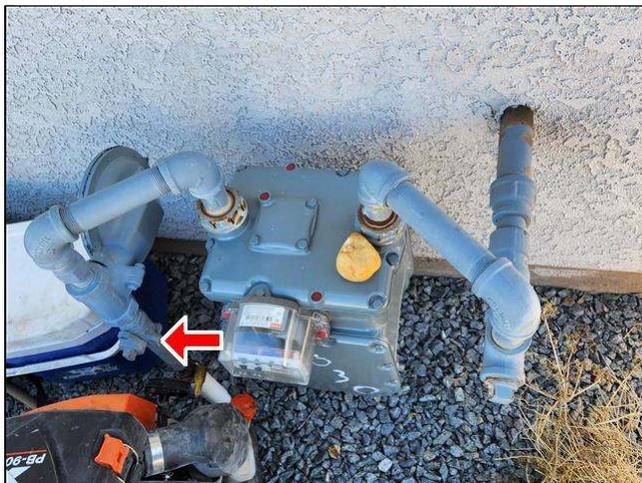
Located at the West side of the house with the gas meter. No problems noted.

5.11 Item 1(Picture) main fuel shut-off valve

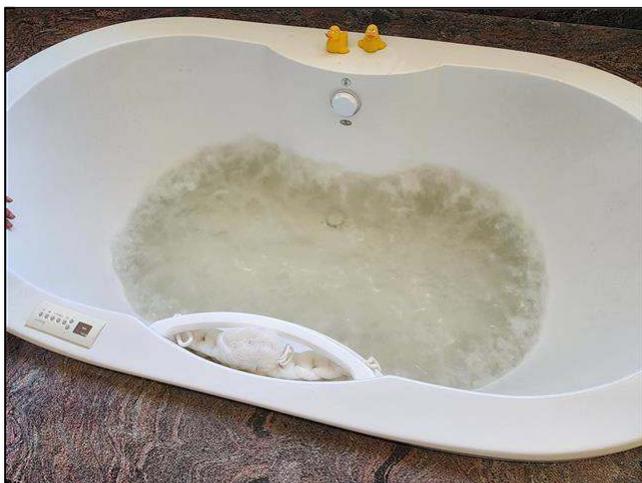
Master Bathroom jetted tub was filled, and jets where checked for proper operation. No problems noted.

5.13 Item 1(Picture) master bathroom jetted tub

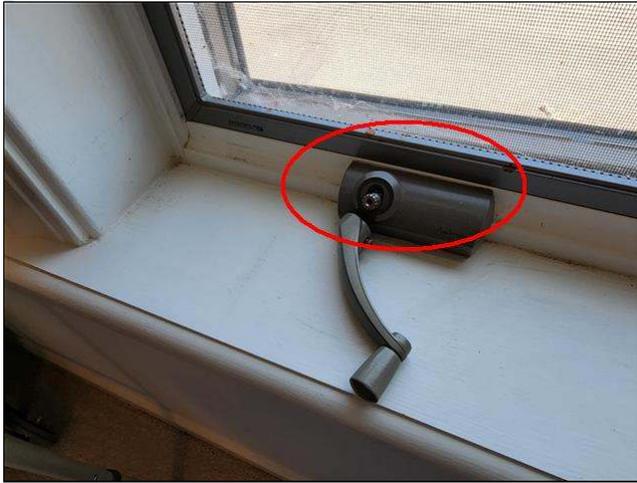
7.5 Item 2(Picture) SE guest bedroom window

(2) Window opening mechanism is stripped at the Southeast guest bedroom.

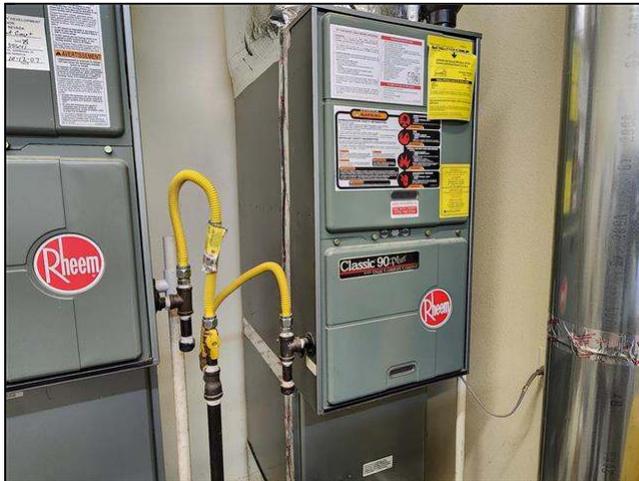
10.0 Item 1(Picture) smaller south furnace

(1) South Smaller Unit... The heating equipment is original (17 years). The furnace is a vertical downdraft natural gas fired forced air unit, Rated at 75,000btu's, that operated as intended with normal operating controls. The burners have an even blue flame. Manufactured in 2006 by Rheem Heating.

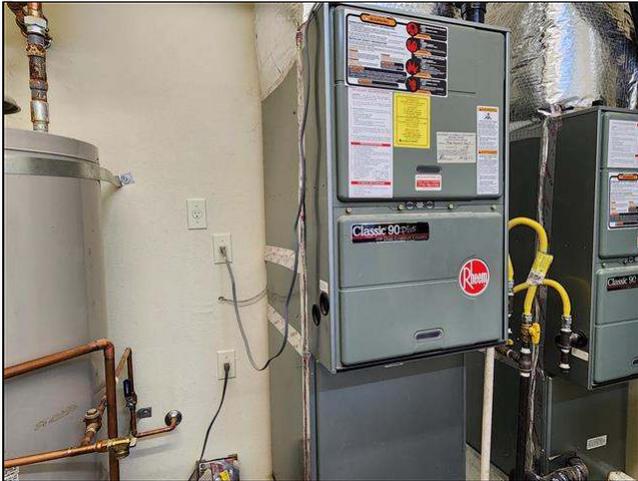
10.0 Item 3(Picture) south main furnace

(2) South Main Unit... The heating equipment is original (16 years). The furnace is a vertical downdraft natural gas fired forced air unit, Rated at 105,000btu's, that operated as intended with normal operating controls. The burners have an even blue flame. Manufactured in 2007 by Rheem Heating.

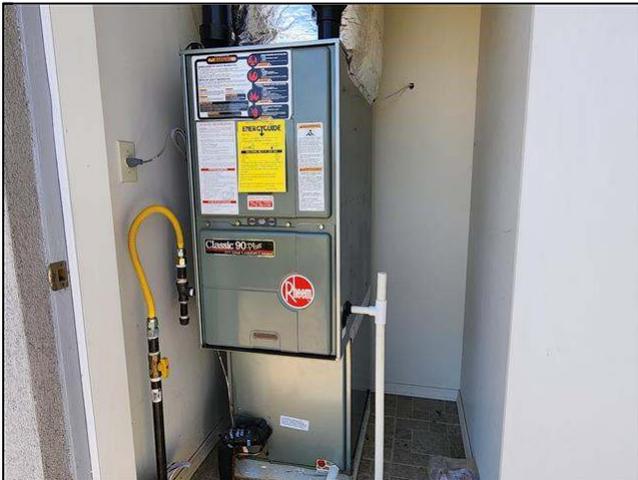
10.0 Item 5(Picture) northwest forced air furnace

(3) Northwest Unit... The heating equipment is original (16 years). The furnace is a vertical downdraft natural gas fired forced air unit, Rated at 75,000btu's, that operated as intended with normal operating controls. The burners have an even blue flame. Manufactured in 2007 by Rheem Heating.

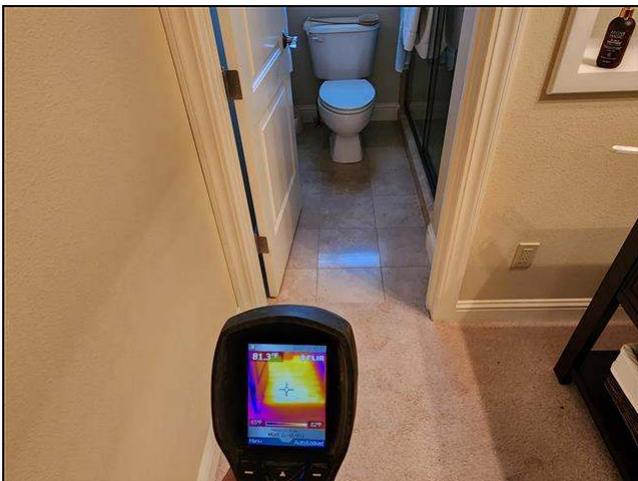
10.0 Item 7(Picture) in-floor heating at guest bathroom

(4) NOTE: The home also uses in-floor heating under tiled areas at master and guest bathrooms. Guest Bathroom floor showed even distribution of heating, however the Master Bathroom shows good/even heating at the water closet and "spotty" at the Main bathroom floor.
