# Inspection Report

**Property Address:**  
1459 Harvest Ave  
Gardnerville NV 89410

<b>Date:</b> 7/2/2024	<b>Time:</b> 08:00 AM	<b>Report ID:</b> CON145
<b>Property:</b> 1459 Harvest Ave Gardnerville NV 89410	<b>Customer:</b> Rosemarie Conner	<b>Real Estate Professional:</b> Thomas Vander Laan Coldwell Banker

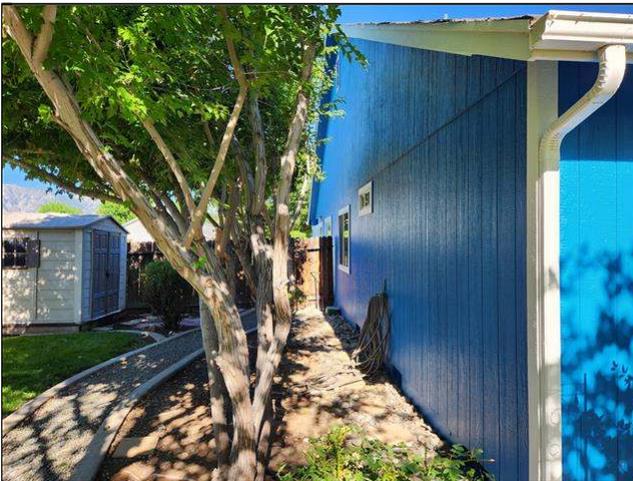
Exterior, as seen at time of inspection.

1.0 Item 1(Picture) view of exterior

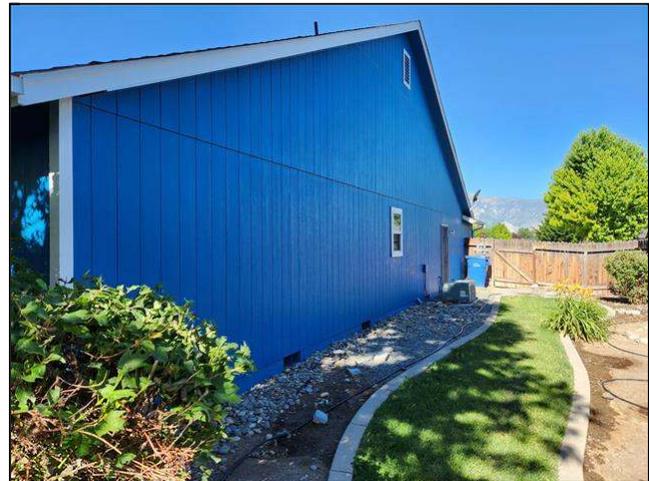
1.0 Item 2(Picture) view of exterior

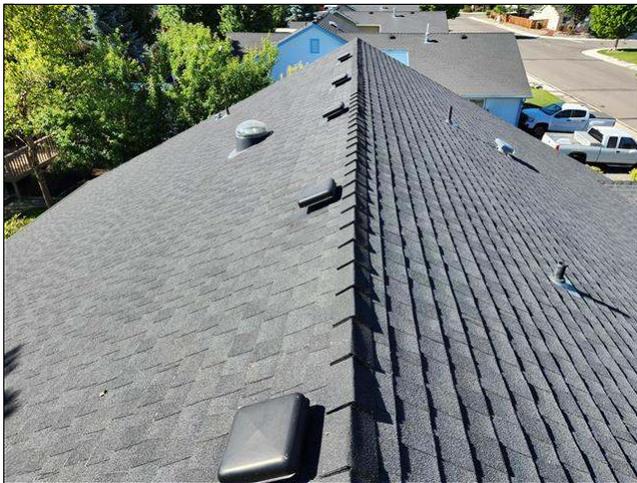
The roof, as seen at time of inspection. Inspected by walking the roof.

2.0 Item 1(Picture) view of roof

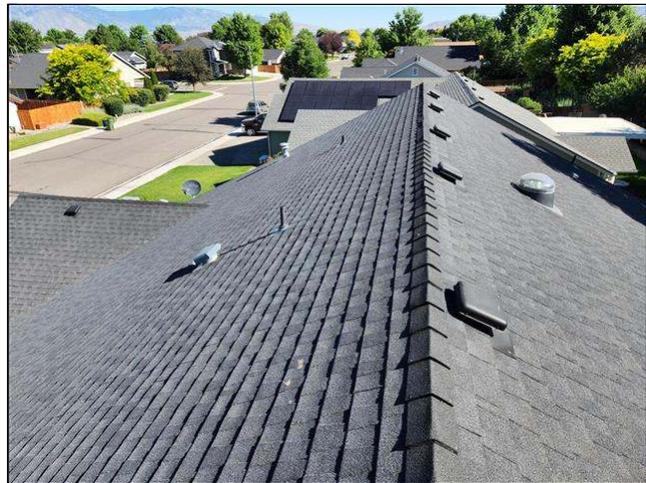
2.0 Item 2(Picture) view of roof

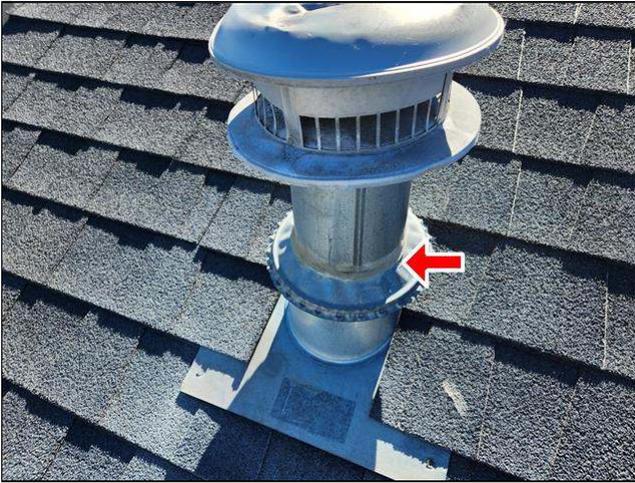
Plumbing and furnace vent pipes are sealed well against flashings to prevent moisture intrusion into attic framing areas.

2.3 Item 1(Picture) flue pipes sealed well

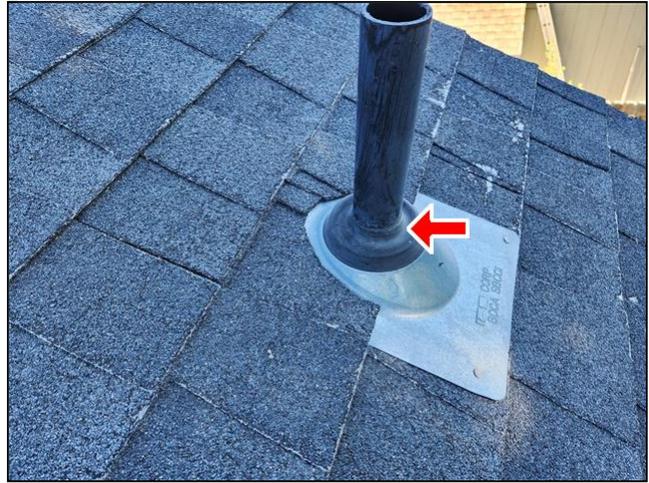
2.3 Item 2(Picture) plumbing vent pipes sealed well

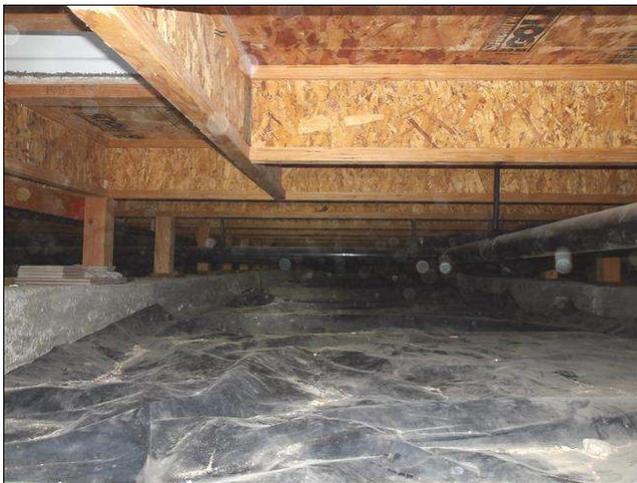
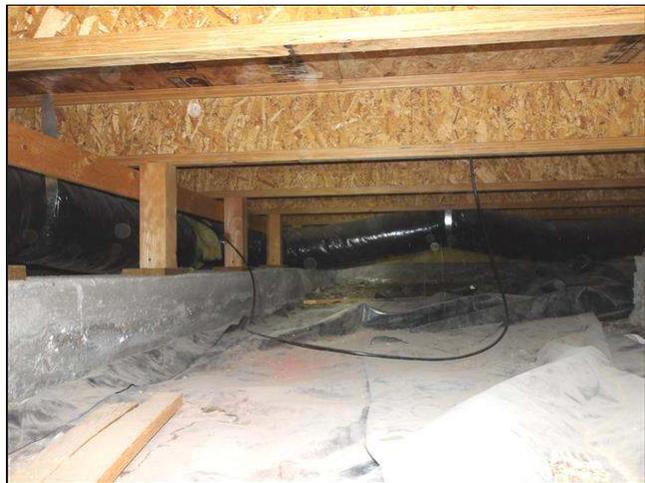
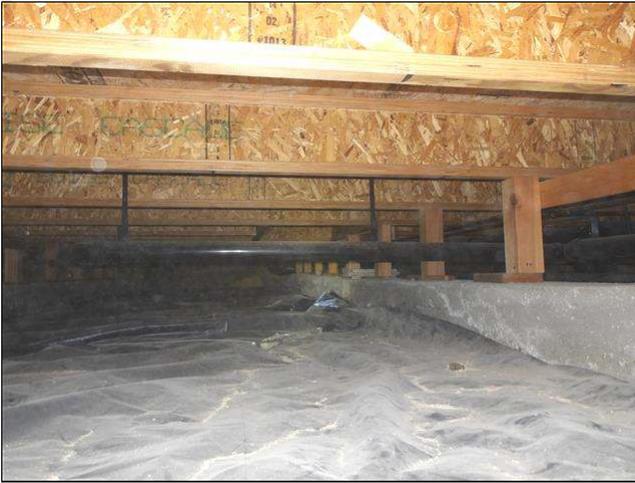
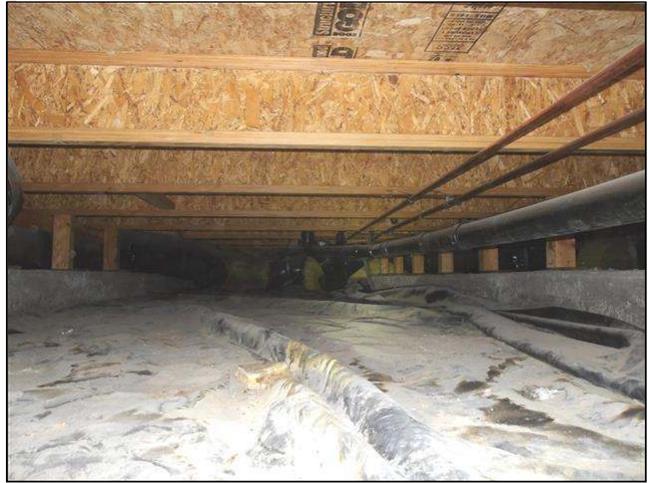
**Comments:** Inspected  
Crawlspace, as seen at time of inspection.

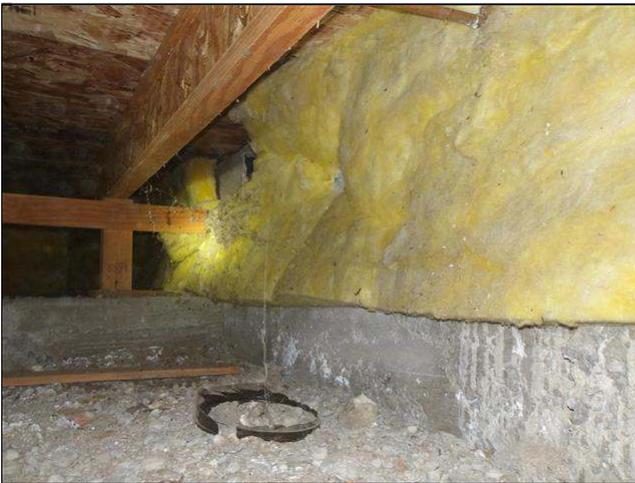
(1) Structure has poured concrete forming the stemwall and foundation, and only visible at the outer foundation wall, due to insulation covering at the interior of foundation. No obvious problems noted at time of inspection.

3.2 Item 1(Picture) foundation not fully visible through insulation

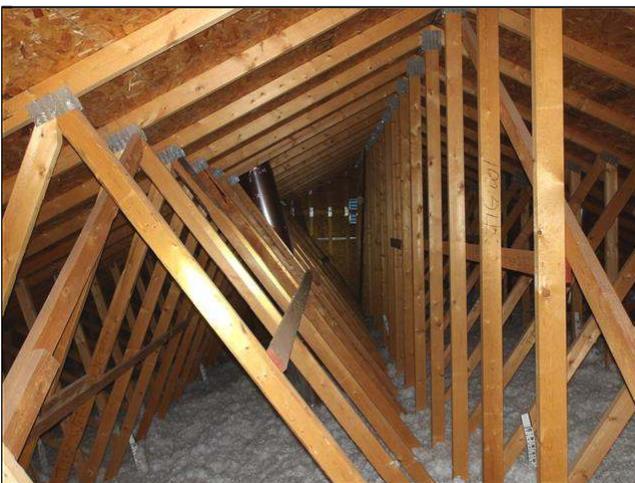
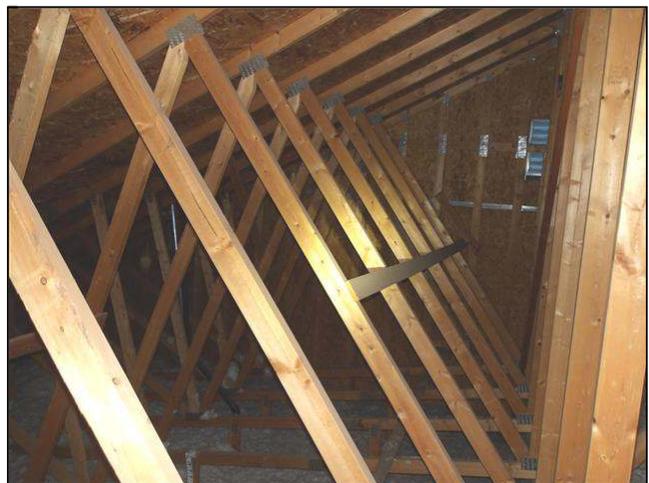
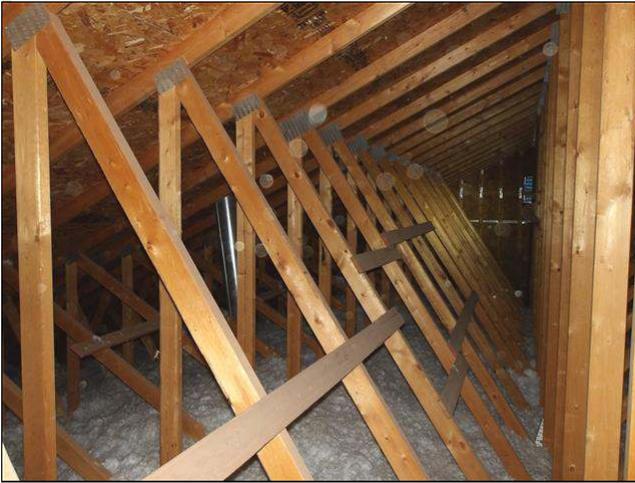
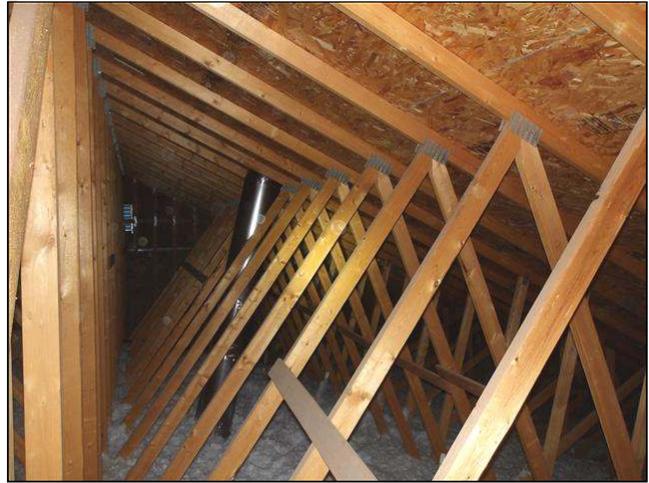
The Attic, as seen at time of Inspection.

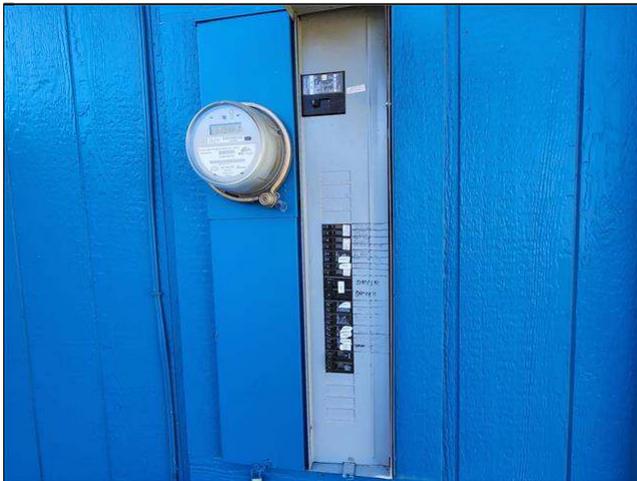
The Main and Distribution Panels are well labeled for circuit identification. "Dead front" cover appears serviceable. No problems noted.

4.1 Item 1(Picture) main electrical panel

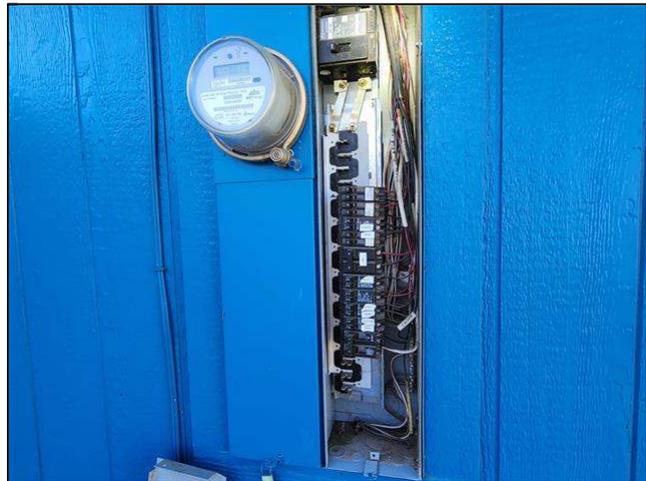
4.1 Item 2(Picture) main panel conductors

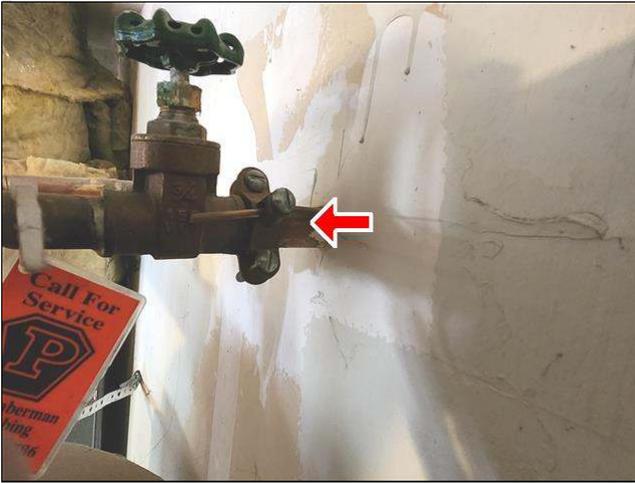
The Grounding system for the Main Service Panel is not visible due to construction materials. However, there is a Grounding wire present in the Panel, and there is a Bonding wire present at the cold water pipe, which are important for proper grounding (safety) of the home.

4.3 Item 1(Picture) bond to plumbing

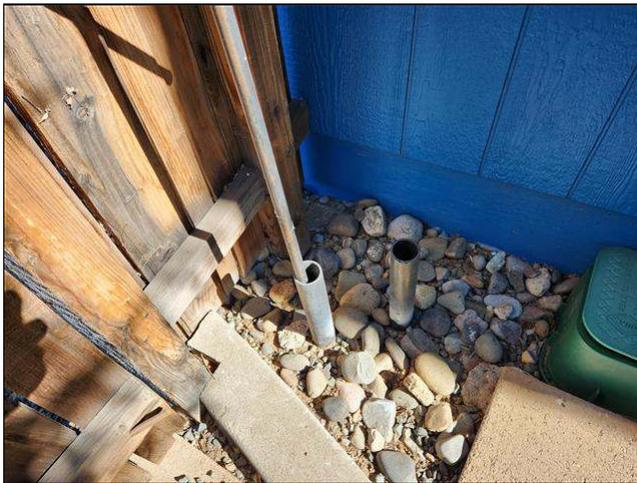
There are a couple main water shut-off locations. With the water meter at front of property (for emergencies), and at side yard to right of house. Note: Both of these locations will require a water key tool to operate. No problem noted.

5.0 Item 1(Picture) main water shut-off valve location

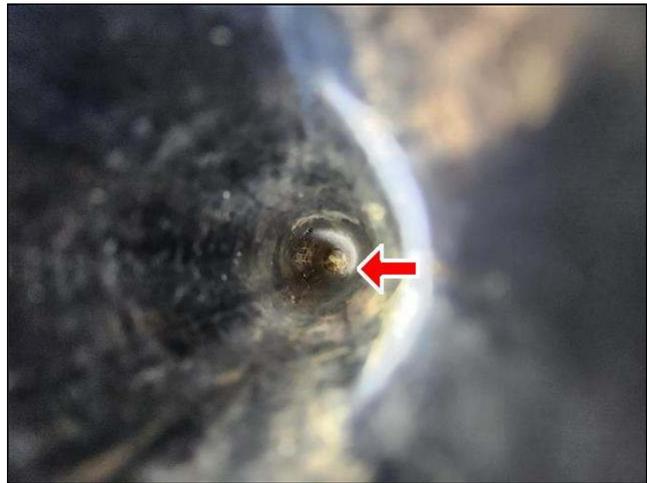
5.0 Item 2(Picture) main water shut-off valve

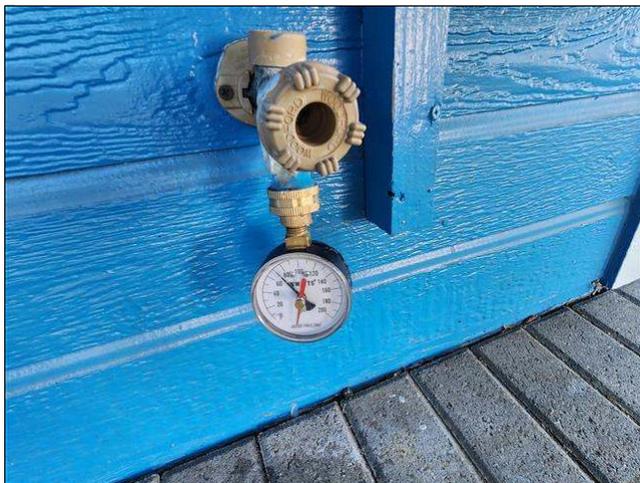
The water pressure was tested at the front hose bib, pressure was 70 psi at time of inspection.

5.2 Item 1(Picture) water pressure at front hose bib

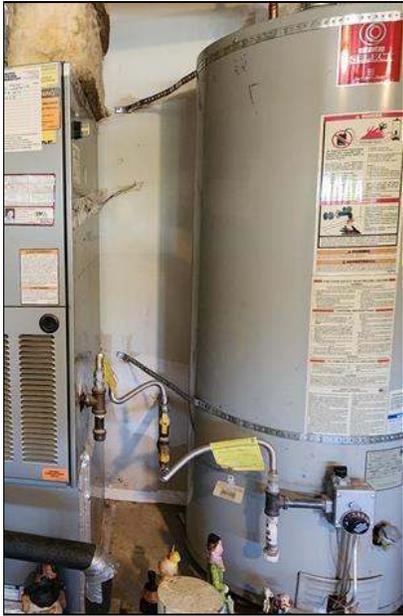
(1) Temperature and Pressure Relief valve is piped to the exterior of the house, or within 6 inches of the floor (for safety). Water Heater is strapped with approved strapping material, and is setting on a pedestal minimum of 18" above the garage floor. Drip leg is installed in the gas line, water and fuel shut-off valves are present. Water heater operated as intended with no leaks noted. No problems noted at time of inspection... Manufactured in 2002 by State Industries.

5.4 Item 1(Picture) water heater

(2) **NOTE: "Knocking" noise heard coming from water heater while unit was heating.** This condition is often caused by calcium build-up at the bottom of the water heater tank, being "pushed up" by boiling water. Flushing of the water heater tank can sometimes eliminate the noise, Recommend consulting a licensed plumber for further evaluation as necessary.

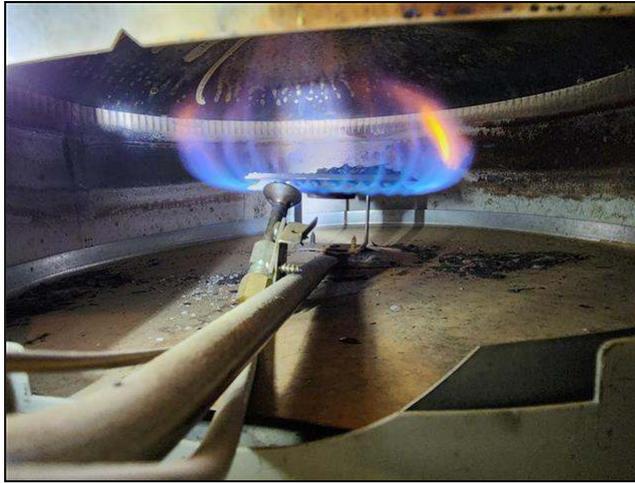
5.4 Item 2(Picture) water heater burner compartment

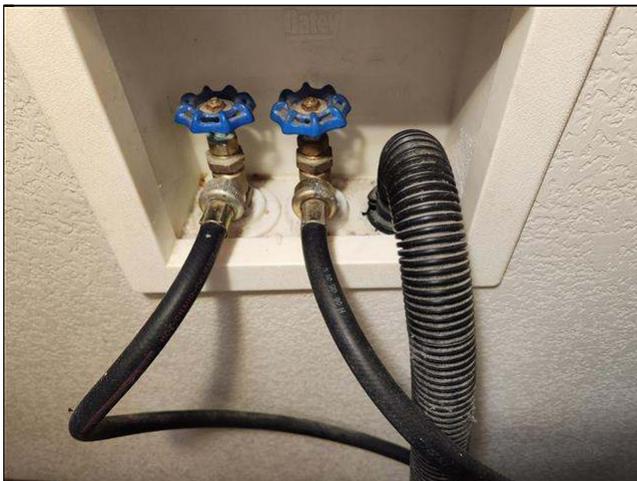
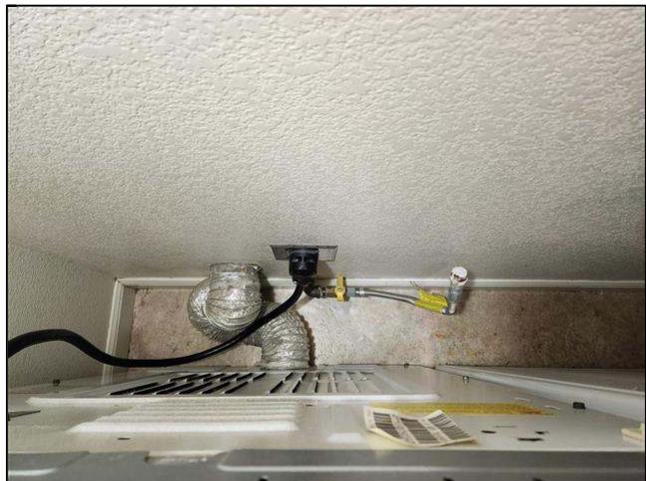
Washer and dryer hook-ups were inspected, with no problems noted. Dryer is electric or gas powered with rigid metal venting installed in the crawlspace. Washer drain is 2" diameter, Hot and Cold hook-ups with no problems noted.

5.6 Item 1(Picture) laundry hook-ups

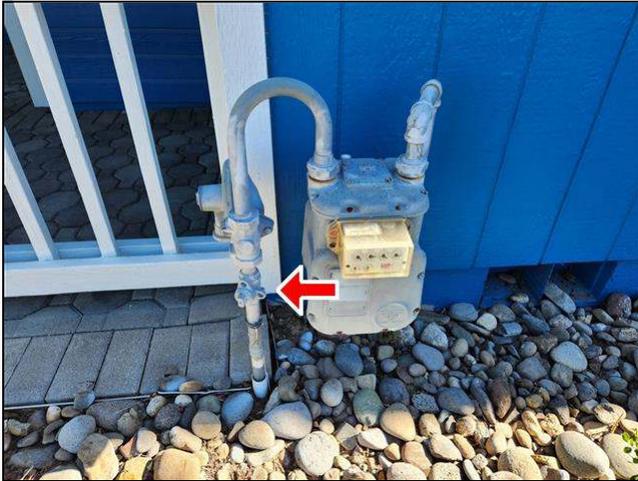
Located at the South side of the house with the gas meter. No problems noted.

5.11 Item 1(Picture) main fuel shut-off valve

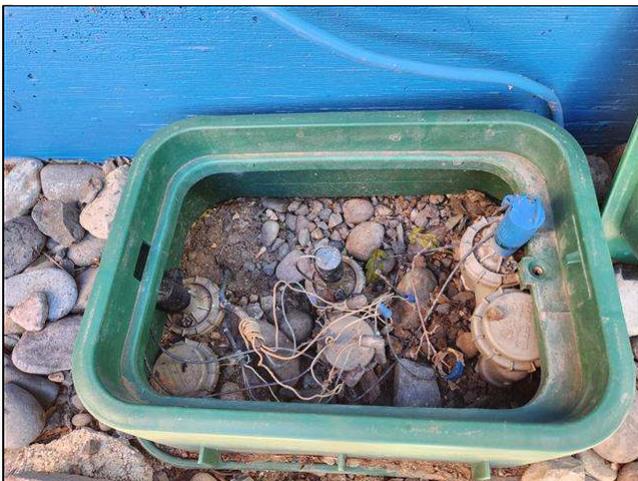
Sprinkler system inspection is beyond the scope of this Home Inspection. Irrigation boxes were opened and inspected for damage and/or major water leaks. No obvious problems noted at time of inspection.

5.13 Item 1(Picture) irrigation box/valves

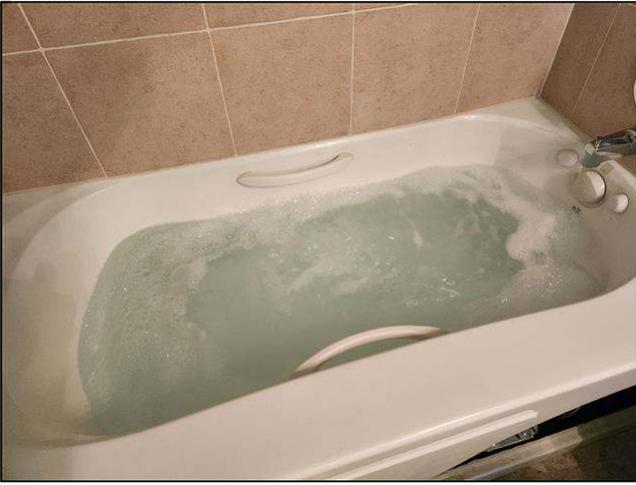
Guest Bathroom jetted tub was filled, and jets where checked for proper operation. No problems noted.

5.14 Item 1(Picture) guest bath jetted tub

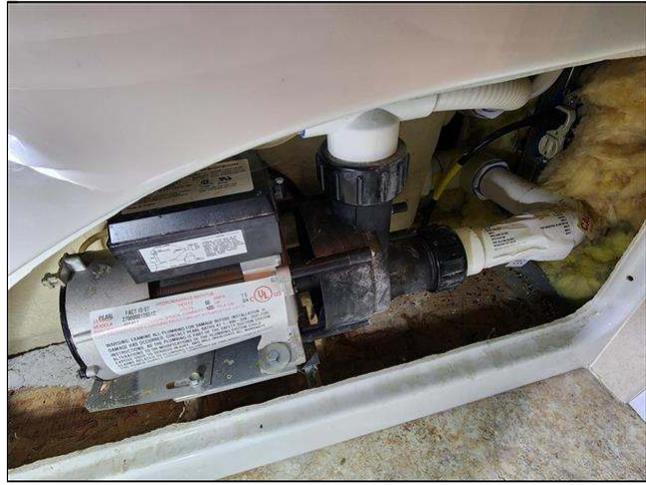
5.14 Item 2(Picture) tub pump and plumbing

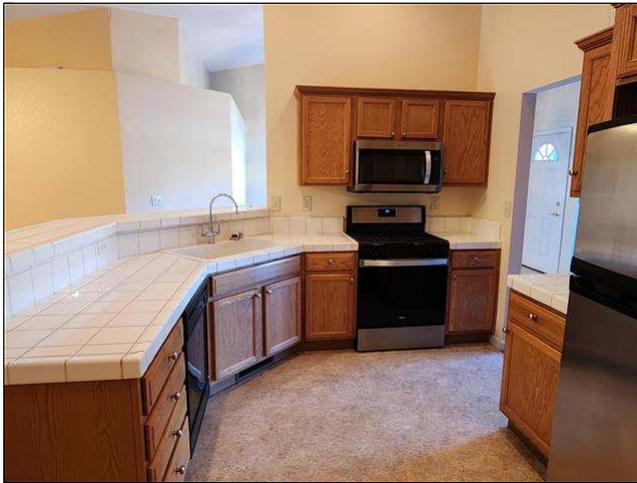
Kitchen, as seen at time of inspection.

6.0 Item 1(Picture) view of kitchen

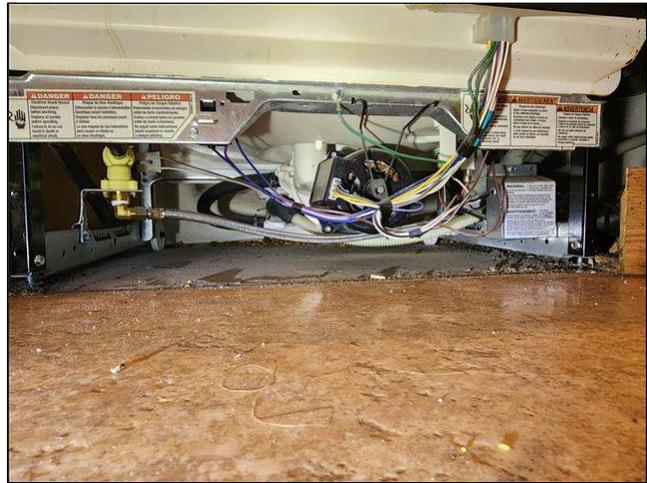
6.0 Item 2(Picture) dishwasher hook-ups

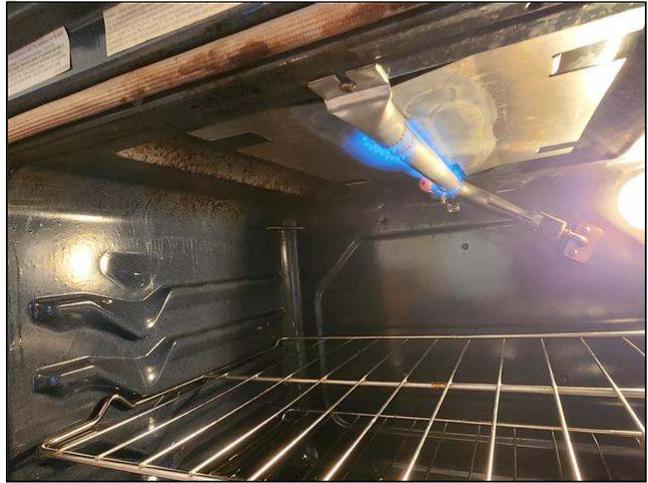
6.2 Item 2(Picture) range broiler burner

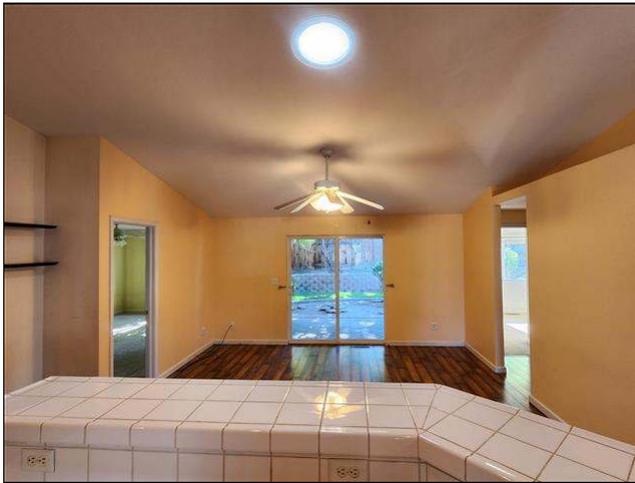
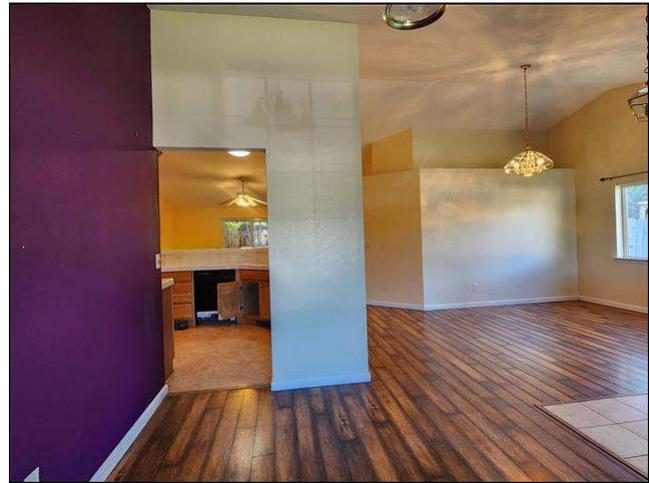
Interior, as seen at time of inspection.

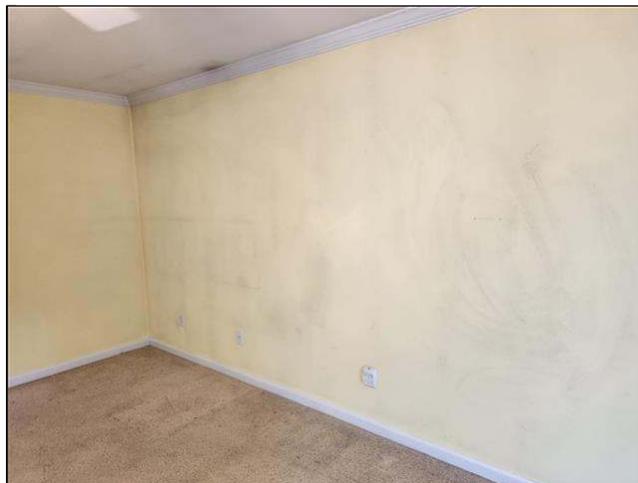
7.2 Item 7(Picture) master bedroom wall

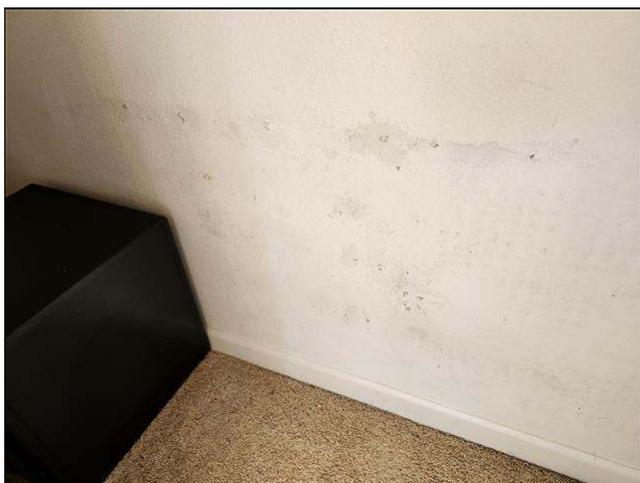
7.2 Item 8(Picture) guest bedroom

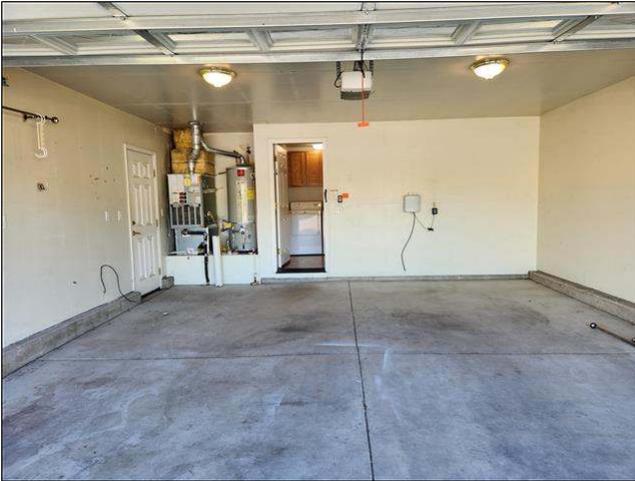
Garage, as seen at time of inspection.

8.0 Item 1(Picture) view of garage

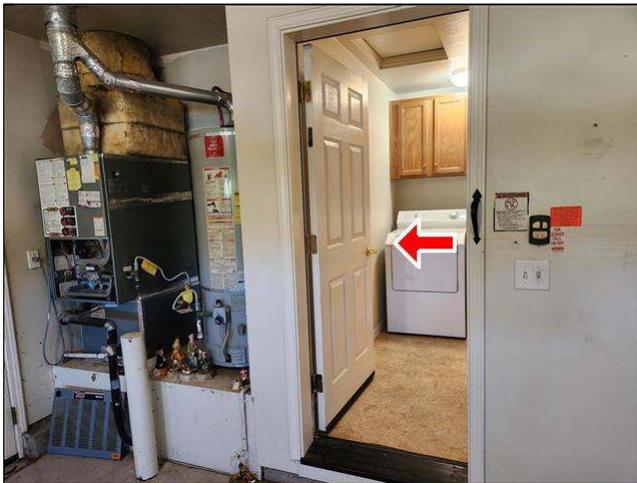
Occupant door is fire rated and weather stripped, and (does not) completely close with self closing hinges to prevent accidental carbon monoxide/fire intrusion to home.

8.7 Item 1(Picture) does not self close

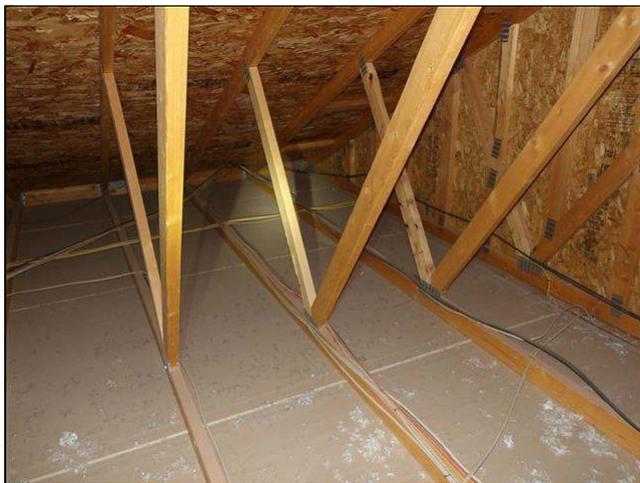
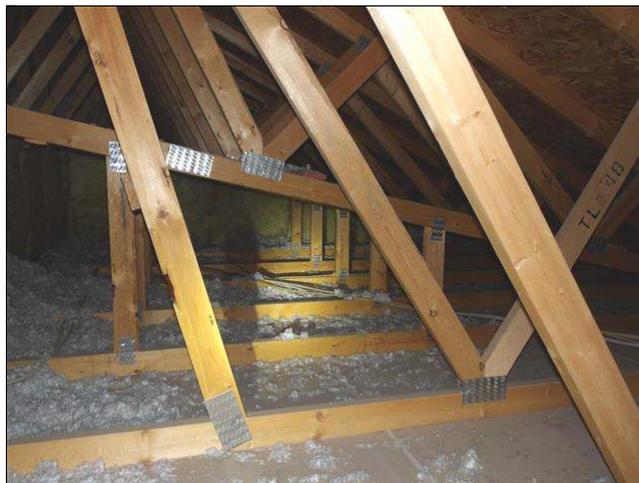
Garage attic area as seen at time of inspection. NOTE: Garage ceiling is NOT insulated.

8.10 Item 1(Picture) view of garage roof structure

8.10 Item 2(Picture) view of garage roof structure

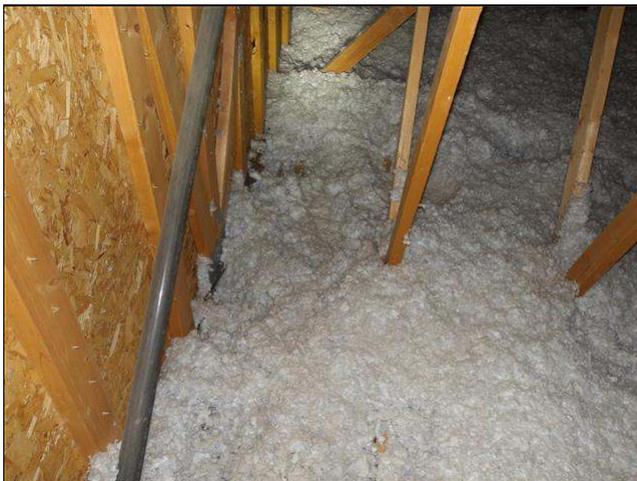
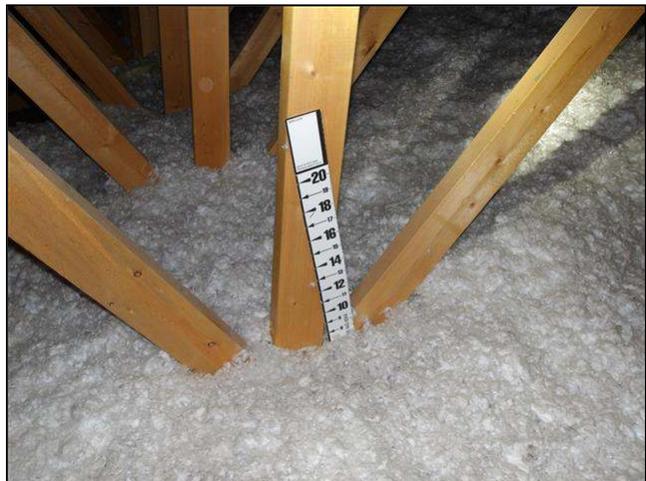
The attic insulation is blown-in, loose-fill, and is approximately 10 to 12 inches deep (R-30), with a few areas being pulled back for past installations or repairs. No problems noted.

9.0 Item 1(Picture) view of attic insulation

9.0 Item 2(Picture) view of attic insulation

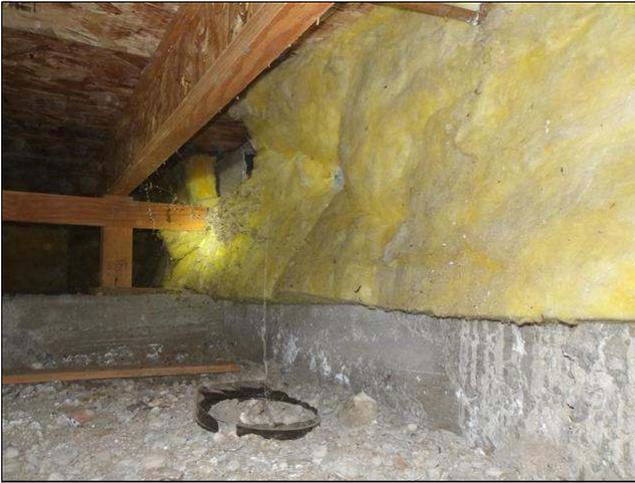
The crawlspace area is insulated on the perimeter of the foundation using R13 fiberglass Batts, no problems noted.

9.1 Item 1(Picture) view of crawlspace insulation

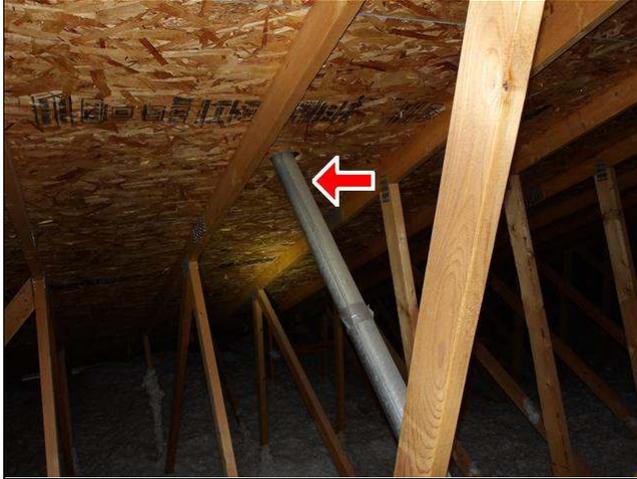
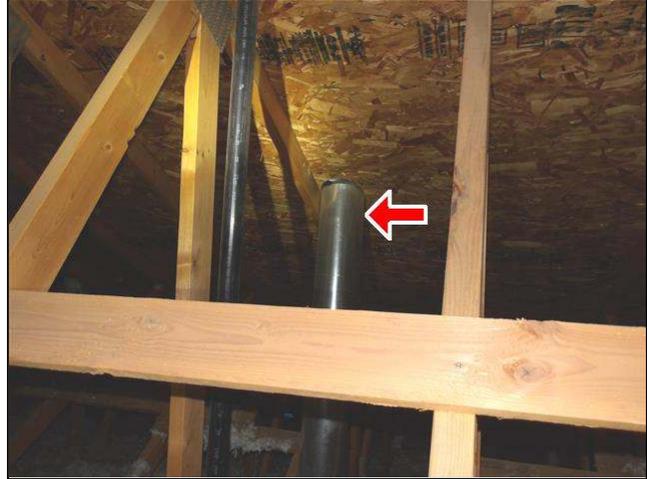
(1) Bathrooms, Kitchen and Laundry vents are properly ducted to the exterior of the home.

9.4 Item 1(Picture) properly vented to exterior

9.4 Item 2(Picture) kitchen properly vented to exterior

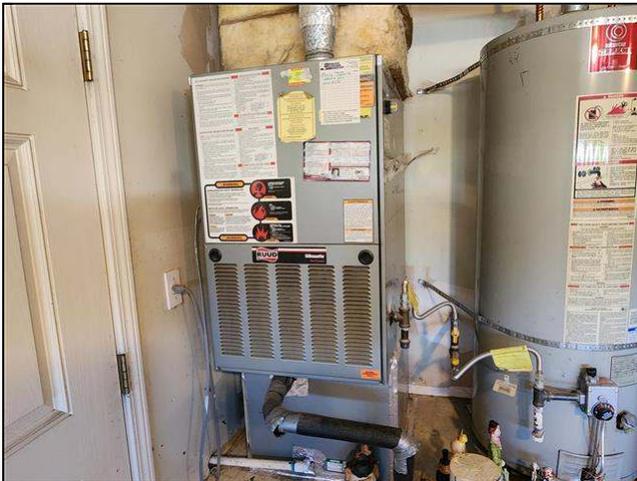
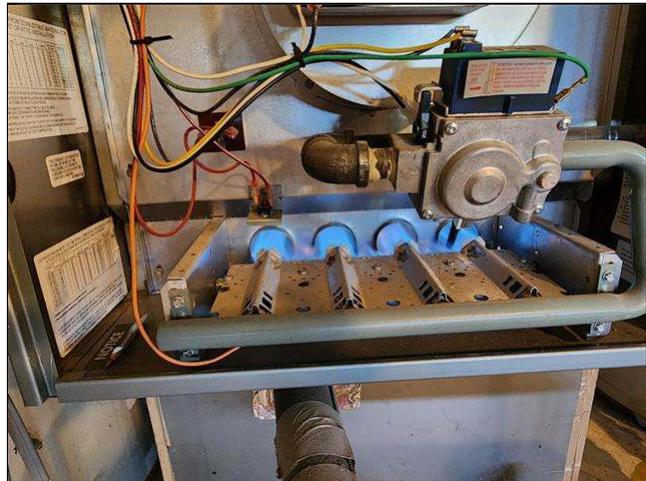
The heating equipment is original (22 years). The furnace is a vertical downdraft natural gas fired forced air unit, Rated at 100,000btu's, that operated as intended with normal operating controls. The burners have an even blue flame. Manufactured in 2002 by RUUD heating.

10.0 Item 1(Picture) forced air furnace

10.0 Item 2(Picture) furnace burners

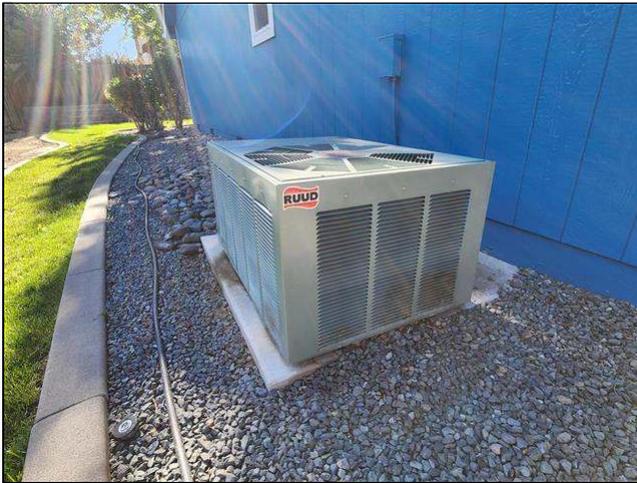
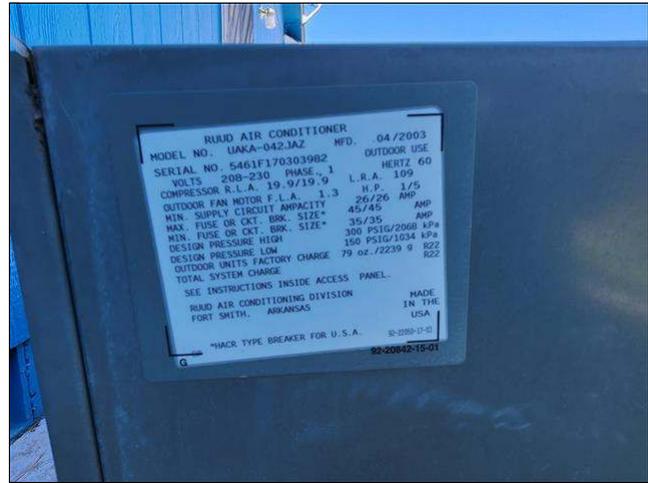
The ambient air test was performed by using thermometers on the air handler of Air conditioner to determine if the difference in temperatures of the supply and return air are between 14 degrees and 22 degrees which indicates that the unit is cooling as intended. The supply air temperature on your system read 50 degrees, and the return air temperature was 68 degrees (a/c cabinet temperature measured 82 degrees). This indicates the range in temperature drop is normal. Condensing unit operated as intended with normal operating controls, and no abnormal noises noted. Unit was manufactured in April 2003 by RUUD.

10.5 Item 1(Picture) condensing unit

10.5 Item 2(Picture) manufacturer's label
