Inspection Report

304 Kathy Ave.
Yerington NV 89447

Date: 2/21/2023	Time: 08:15 AM	Report ID: CRE304
Property: 304 Kathy Ave. Yerington NV 89447	Customer:	Real Estate Professional: Thomas Vander Laan Coldwell Banker

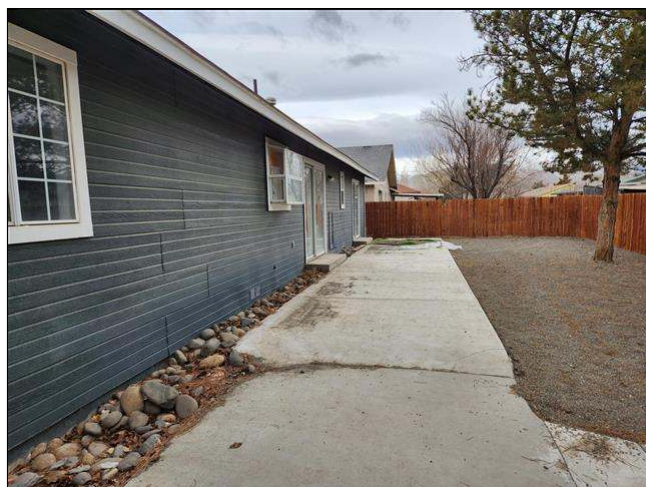
1.0 Item 1(Picture) view of exterior

Exterior, as seen at time of inspection.

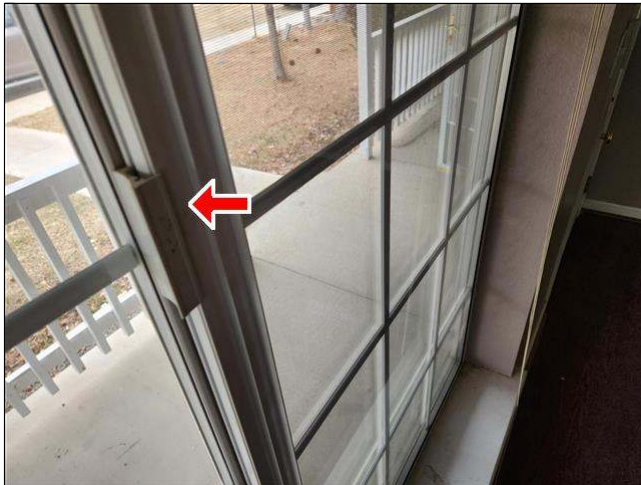
(1) Living room and master bedroom sliding windows do not close far enough to latch, however the lower secondary lock does operate and secures the windows.

1.4 Item 1(Picture) do not close far enough to latch

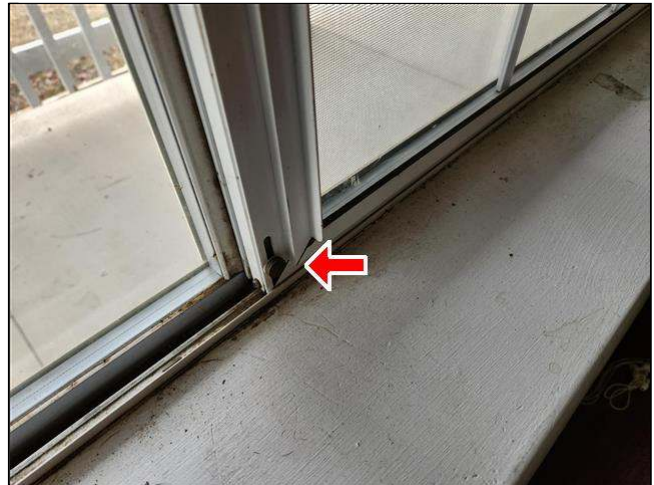
1.4 Item 2(Picture) windows secure with secondary lock

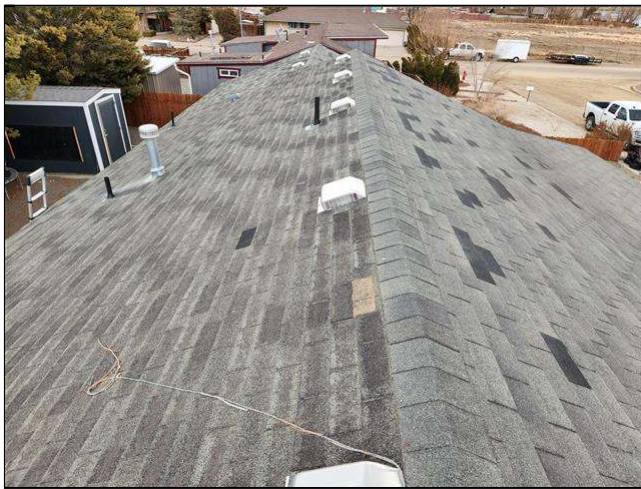
2.0 Item 1(Picture) view of roof

The roof, as seen at time of inspection. Inspected by walking the roof.

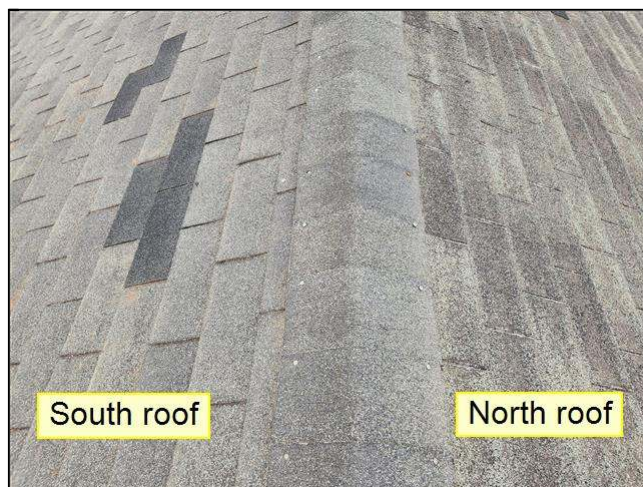
(1) North Slope... The roof covering appears to be original (30 years) and is a 20 year asphalt/fiberglass Composition shingle that appears to be near/at the end of its useful life. Typical loss of granules noted from shingles. No major problems noted at time of inspection, with a few "patched" roofing areas. Recommend further evaluation of roof covering materials by a licensed Roofing Contractor for estimated remaining life of roof, as desired.

2.1 Item 3(Picture) condition of roofing

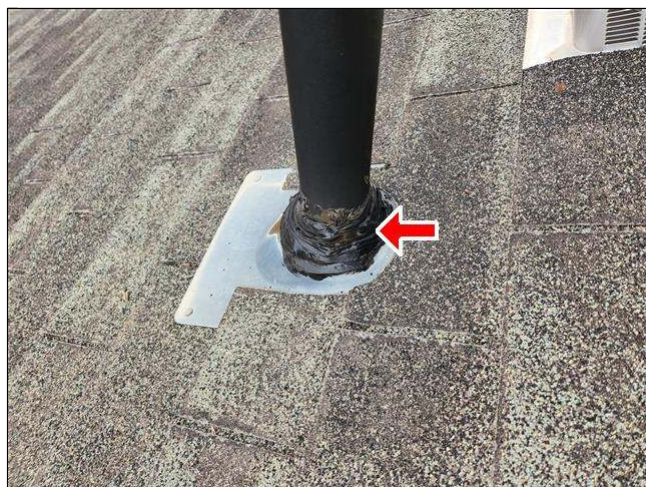
Plumbing and furnace vent pipes are sealed well against flashings to prevent moisture intrusion into attic framing areas.

2.3 Item 1(Picture) plumbing vent pipes sealed well

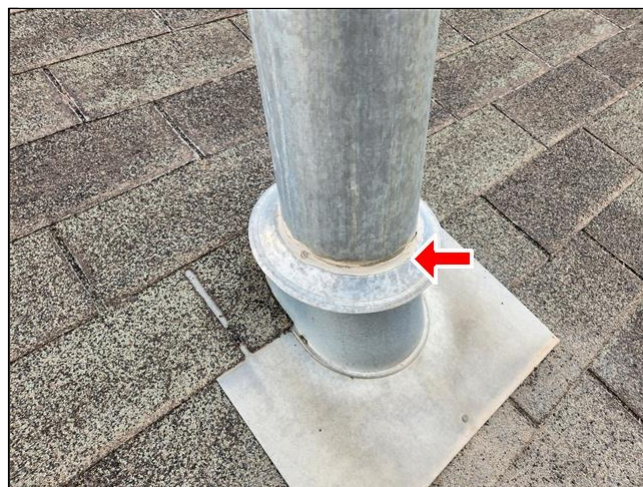
2.3 Item 2(Picture) flue pipes sealed well

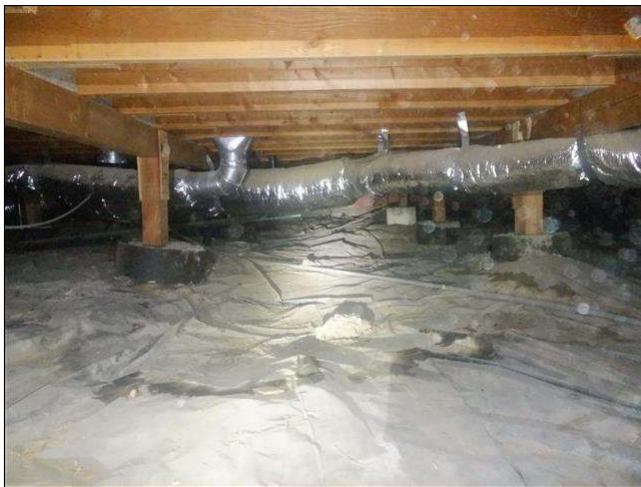
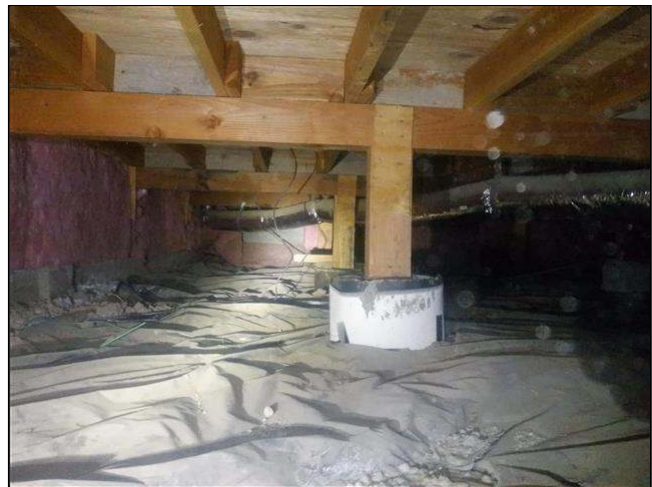
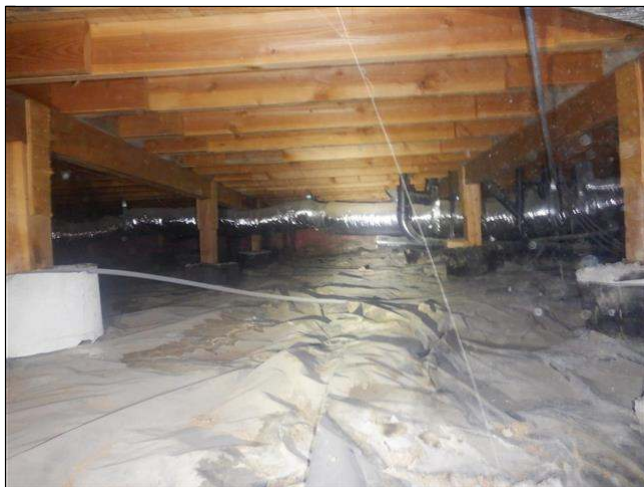
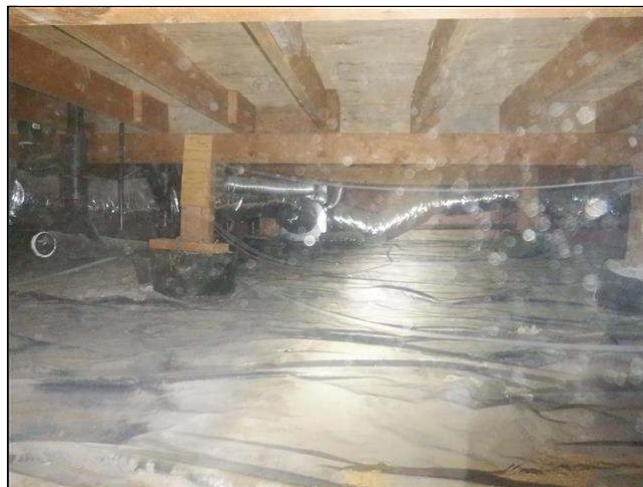
Crawlspace, as seen at time of inspection.

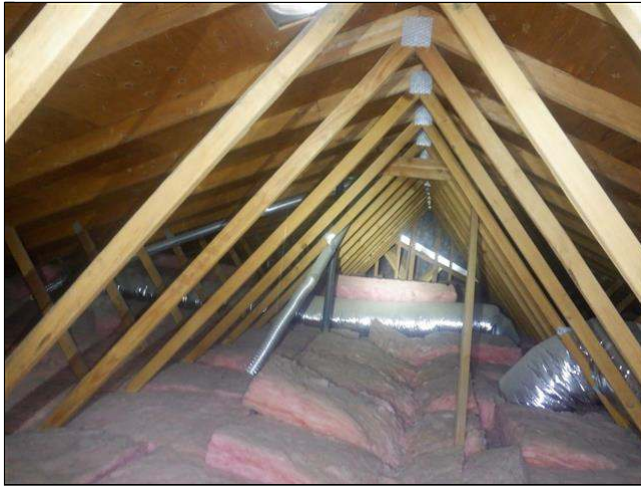
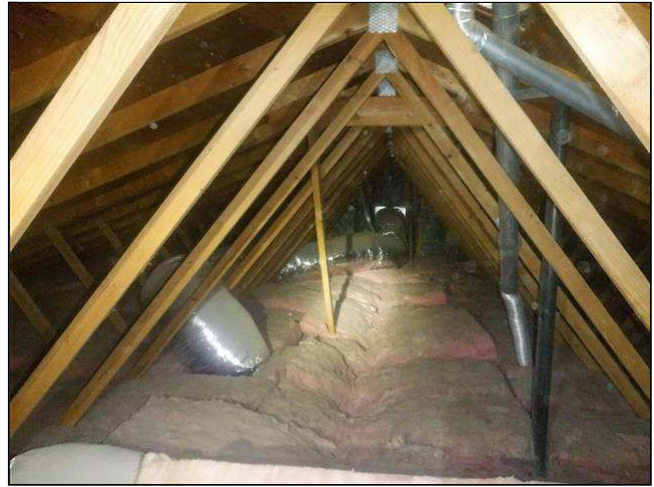
The Attic, as seen at time of Inspection.

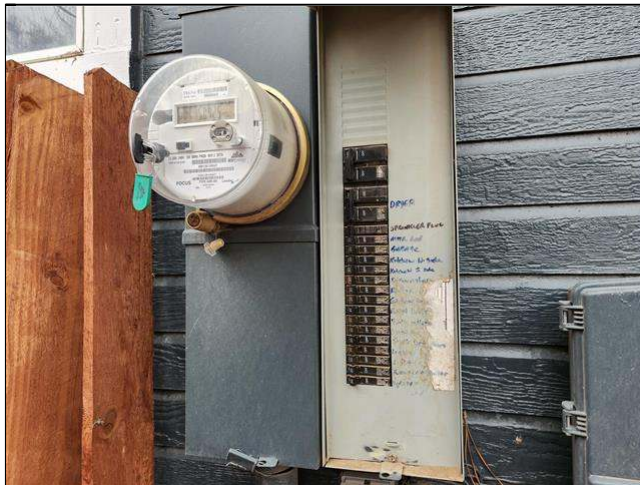
4.1 Item 1(Picture) main electrical panel

The Main and Distribution Panels are well labeled for circuit identification. "Dead front" cover appears serviceable. No problems noted.

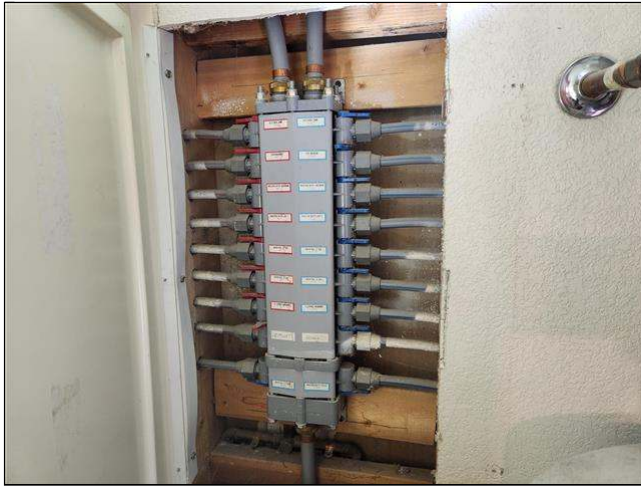
5.1 Item 1(Picture) distribution manifold

(1) Plumbing supply distribution manifold was noted at the Utility Closet, with no obvious problems or leaks noted.

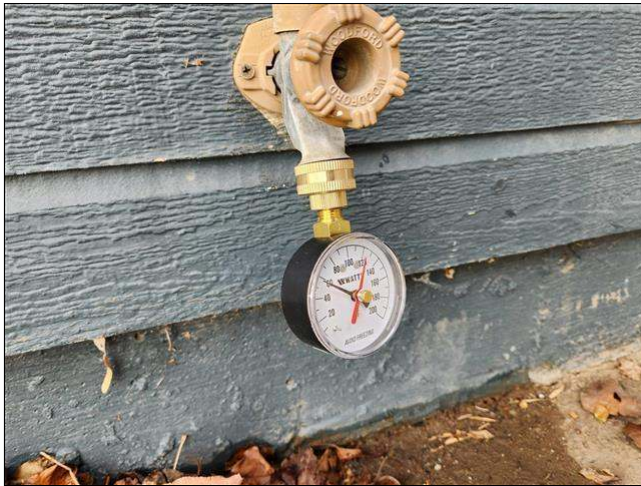
5.1 Item 2(Picture) water pressure at SE hose bib

(2) The water pressure was tested at the front hose bib, pressure was 58 psi at time of inspection... Pressure regulator noted at the Southwest corner of crawlspace area, for future water pressure adjustments, if necessary.

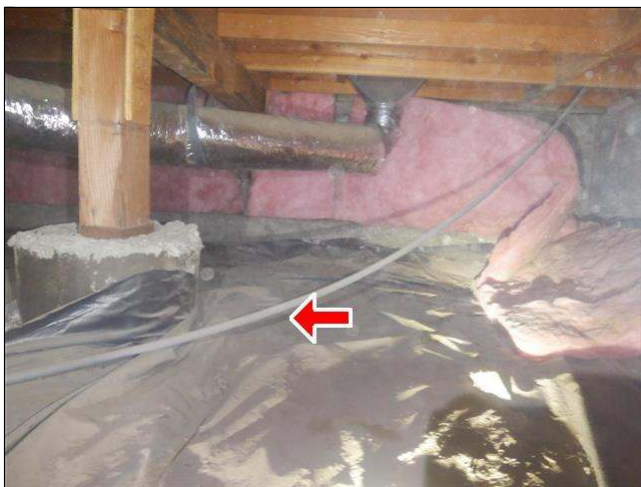
(3) NOTE: Water supply piping to Southeast corner hose bib, is not properly supported at the subfloor, and needs to be secured in-place "above" the ground.

5.1 Item 4(Picture) water supply pipe needs securing

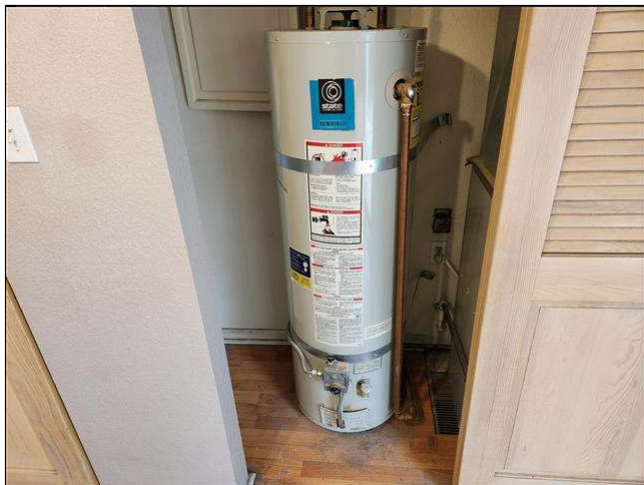
5.3 Item 1(Picture) water heater

Water heater is located in the inside Utility Closet, and is strapped to current local codes. Temperature and Pressure Relief Valve is piped to the exterior of the home, or within 6 inches of the floor (for safety reasons). Drip leg has NOT been installed in the gas supply piping, water and fuel shut-off valves are present. Water heater operated as intended with no abnormal noises or leaks noted. Manufactured in 1994 (29 years old) by State Industries.

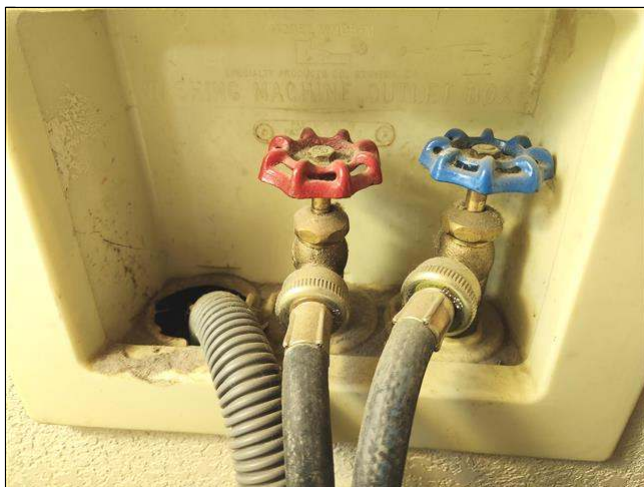
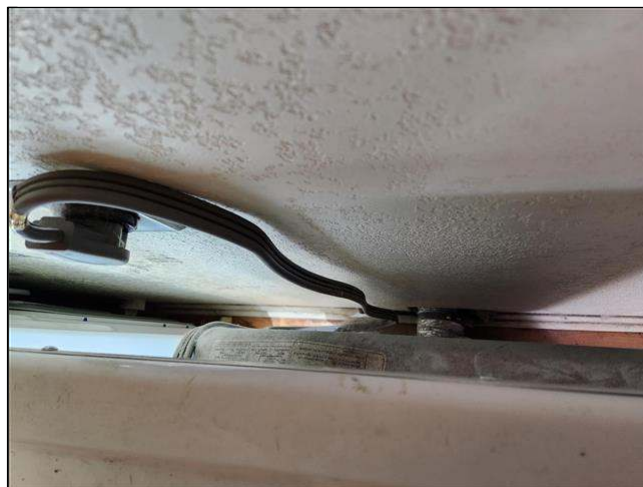
Washer and dryer hook-ups were inspected, with no problems noted. Dryer is electric powered with rigid metal venting installed in the crawlspace. Washer drain is 2" diameter, Hot and Cold hook-ups with no problems noted.

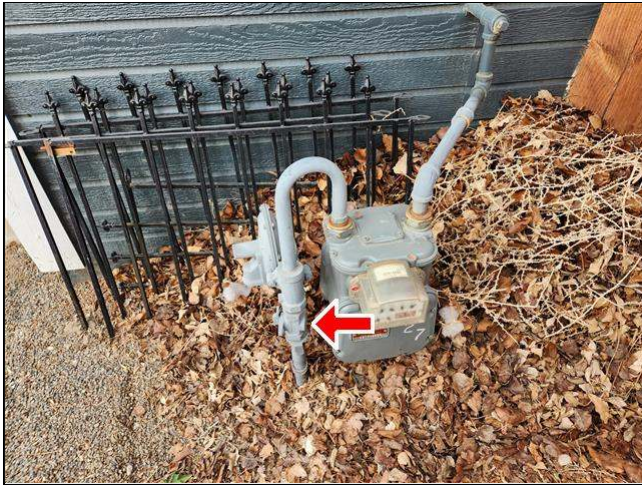
5.10 Item 1(Picture) main fuel shut-off valve

Located at the East side of the house with the gas meter. No problems noted.

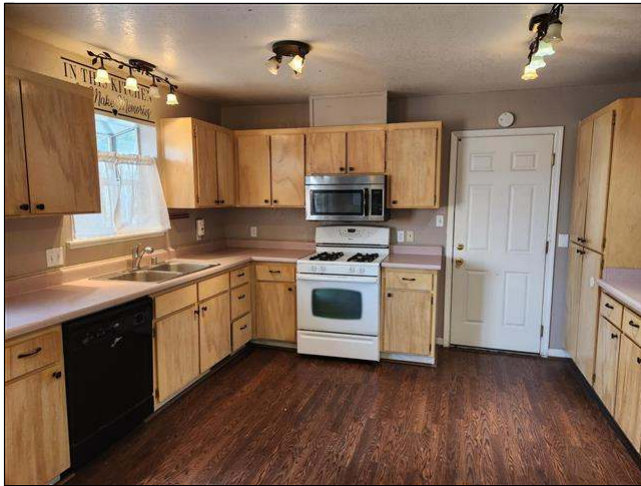
6.0 Item 1(Picture) view of kitchen

Kitchen, as seen at time of inspection.

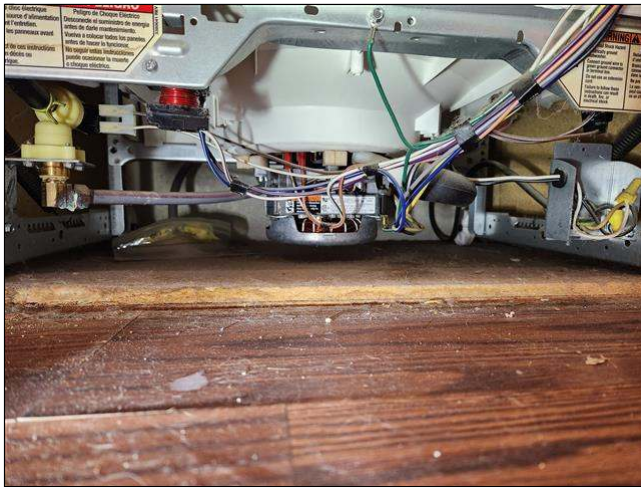
6.1 Item 1(Picture) dishwasher hook-ups

(1) The Dishwasher was run through a complete cycle, with no leaks or abnormal noises noted. Inspection cover was removed to view the Dishwasher electric/plumbing hook-ups, Door seals and dish racks appear in serviceable condition. Mounted securely to under countertop. Drain hose is routed to a high loop prior to connecting to drain, as required to prevent backflow/siphon of waste into dishwasher.

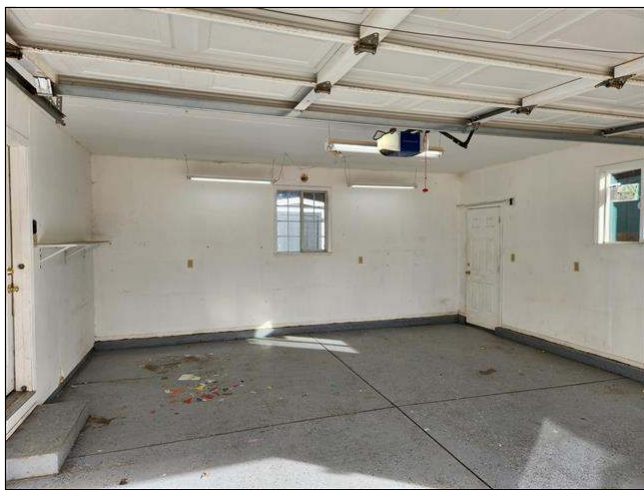
8.0 Item 1(Picture) view of garage

Garage, as seen at time of inspection.

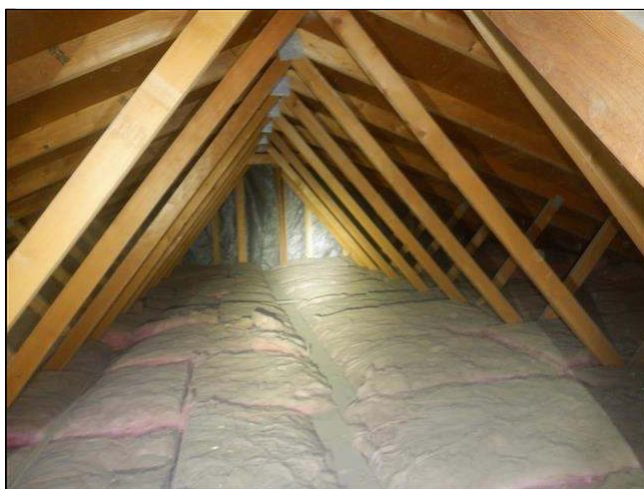
8.11 Item 1(Picture) view of garage roof structure

Garage attic area as seen at time of inspection. NOTE: garage ceiling is insulated with R19 fiberglass bats.

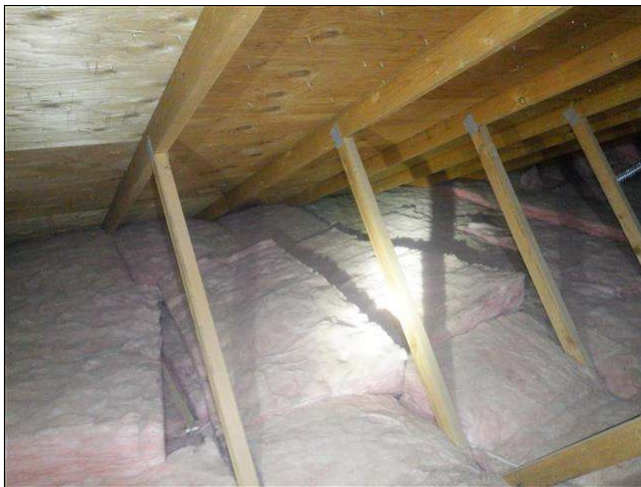
9.0 Item 1(Picture) view of attic insulation

Attic insulation is Fiberglass Batt type approximately 9 to 10 inches thick (R30). No problems noted at time of inspection.

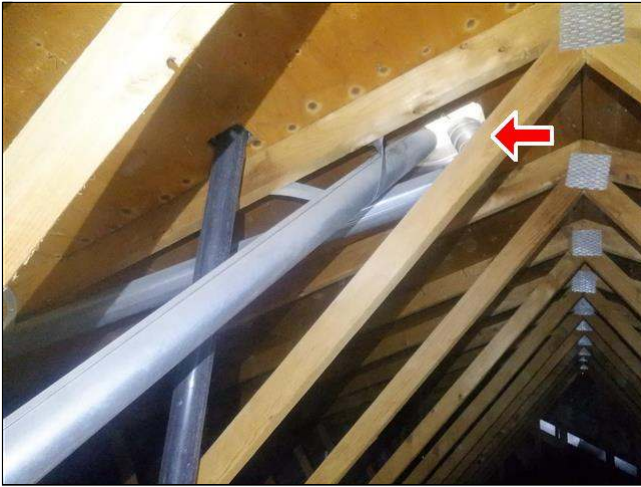
(1) Bathrooms, Kitchen and Laundry vents are properly ducted to the exterior of the home.

9.4 Item 1(Picture) properly vented to exterior

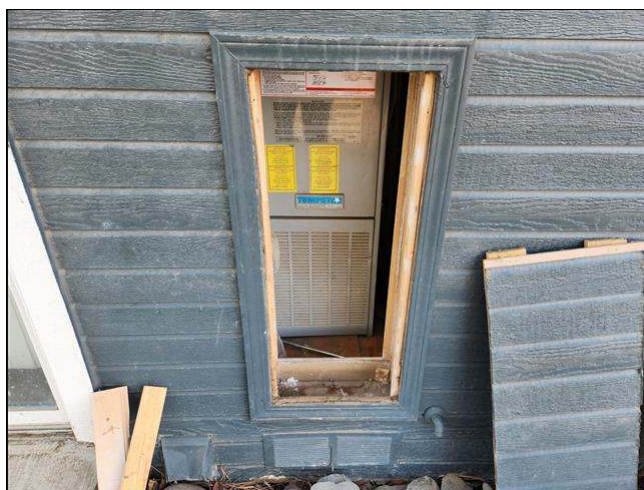
10.0 Item 1(Picture) forced air furnace

(1) The heating system was paced through it's normal sequence of operating modes, with no obvious defects noted at time of inspection. However, due to systems age, it is nearing the end of it's life expectancy (25-30 years), and future replacement should be considered. Until then, I recommend annual maintenance and a heat exchanger evaluation from a licensed HVAC contractor. Manufactured in 1993 by Inter City Products.

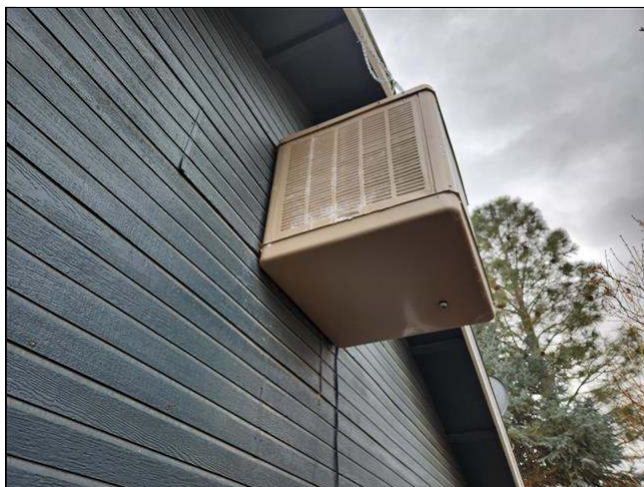
10.4 Item 1(Picture) evaporative cooler

The home uses an Evaporative Cooler located at the West gable end. Cooler has been winterized, and could not be checked for proper operation. Water pan appeared serviceable with no signs of past leaking. Could not determine if water pump functions properly. Cooler airflow is ducted through the attic area and discharges at the hallway ceiling register. No obvious problems noted.

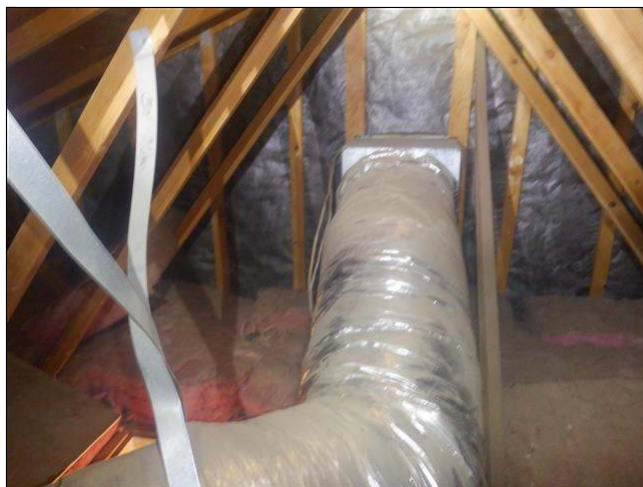
10.4 Item 2(Picture) cooler ducted through attic
