Inspection Report

Property Address:
1241 Esther Way
Minden NV 89423

Clear Choice Home Inspection Services

Date: 11/4/2024	Time: 09:00 AM	Report ID: CHA124
Property: 1241 Esther Way Minden NV 89423	Customer: Valerie Chargualaf	Real Estate Professional: Thomas Vander Laan Coldwell Banker

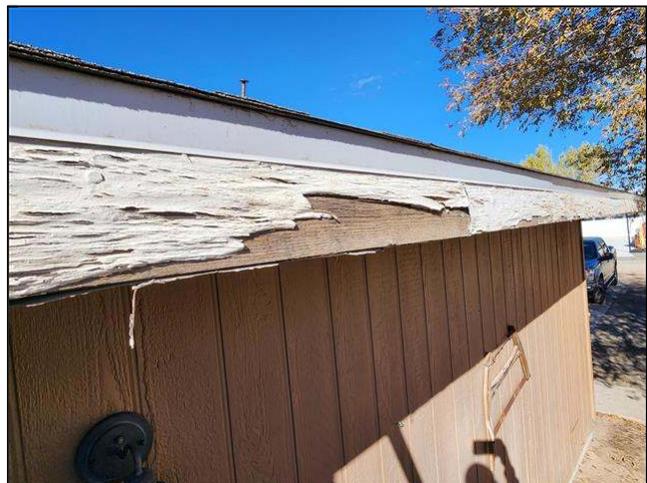
The fascia boards at eaves are peeling paint, with fascia board at East facing upper roof area being damaged from moisture absorption, and swollen/warped ends at South side of home. Further deterioration may occur if not corrected. Recommend paint fascia boards by a qualified person as needed.

1.5 Item 2(Picture) fascia peeling paint

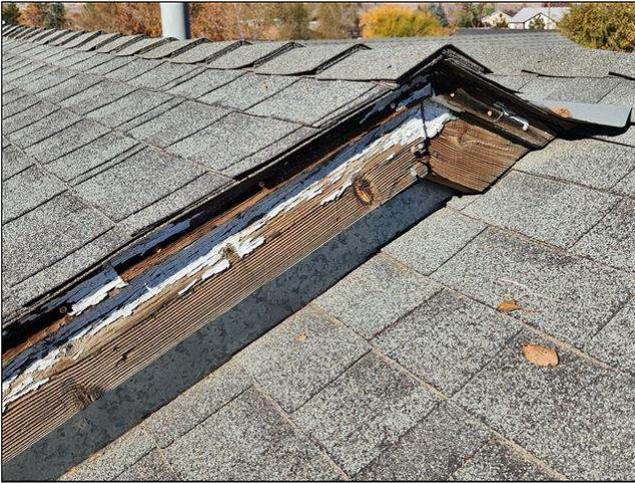
1.5 Item 3(Picture) east facing upper fascia boards

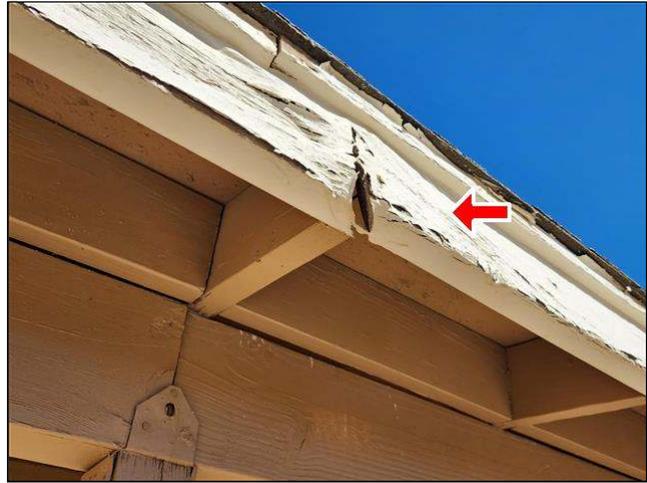
1.5 Item 4(Picture) warped fascia at south side

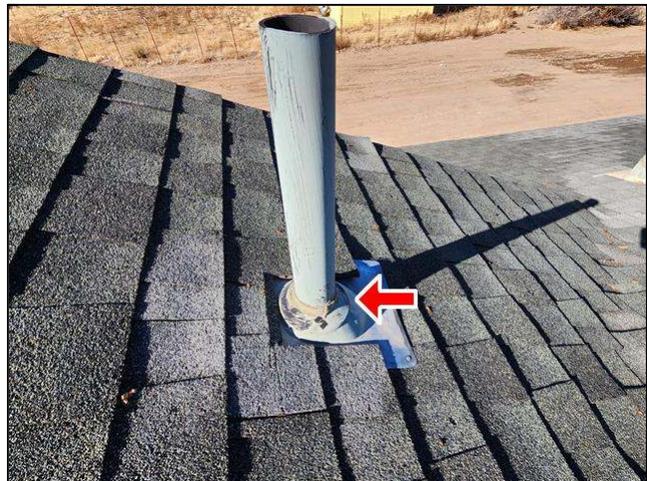
Plumbing and furnace vent pipes are sealed well against flashings to prevent moisture intrusion into attic framing areas.

2.3 Item 2(Picture) plumbing vent pipes sealed well

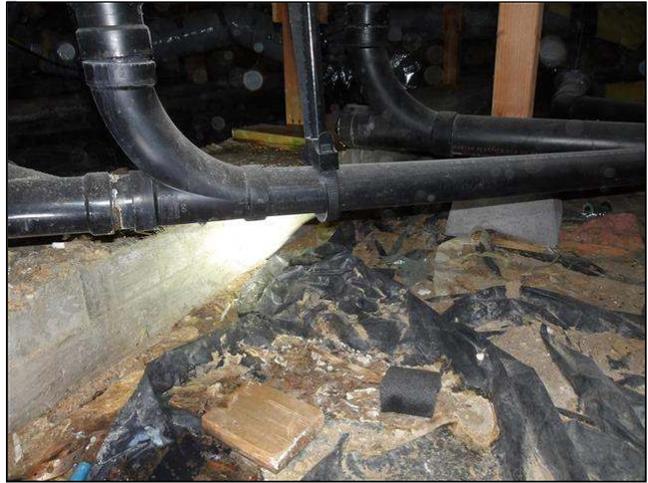
(3) Construction debris (and/or trash) should be removed from the crawlspace area. Trash/Debris noted at the following locations: Under guest bathroom area.

3.2 Item 2(Picture) construction debris in crawlspace

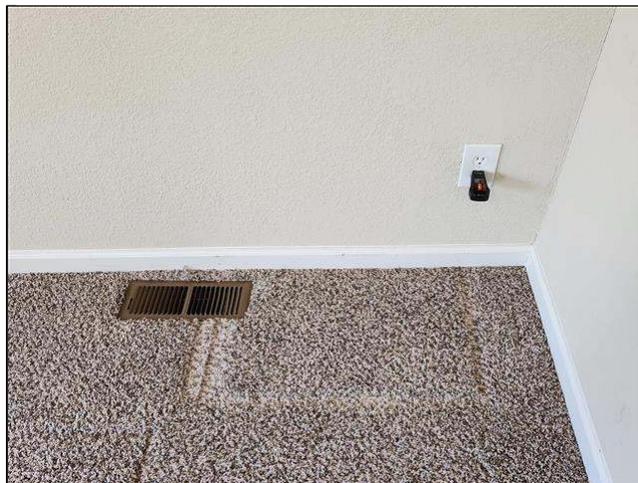
4.5 Item 2(Picture) open grounded outlet

RE: ITEM 4.5(2) -- Please see Exhibit: Seller Repair Itemization

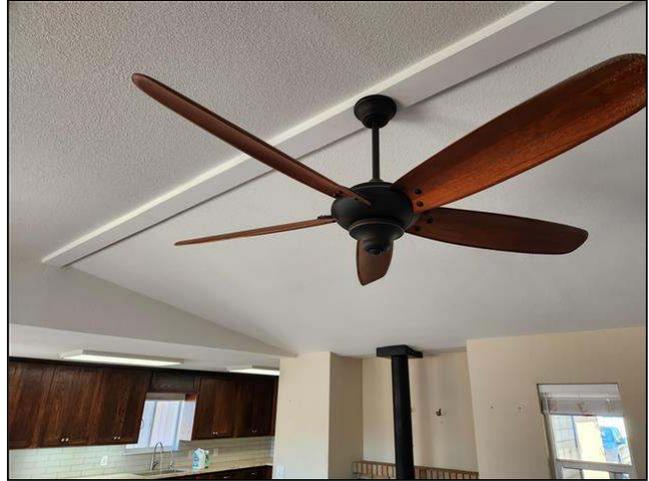
4.6 Item 2(Picture) fan only fixture

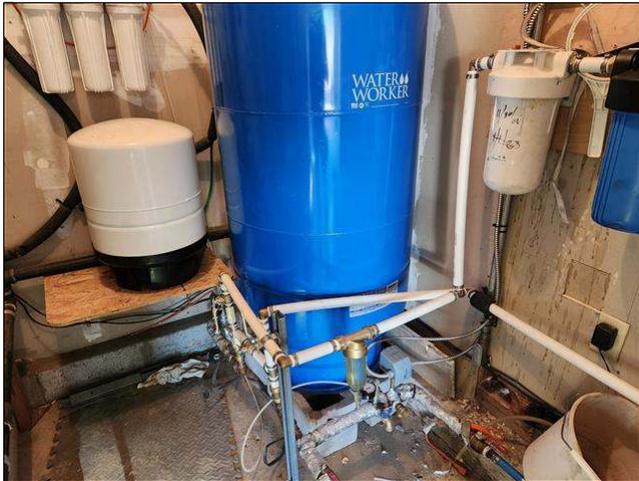
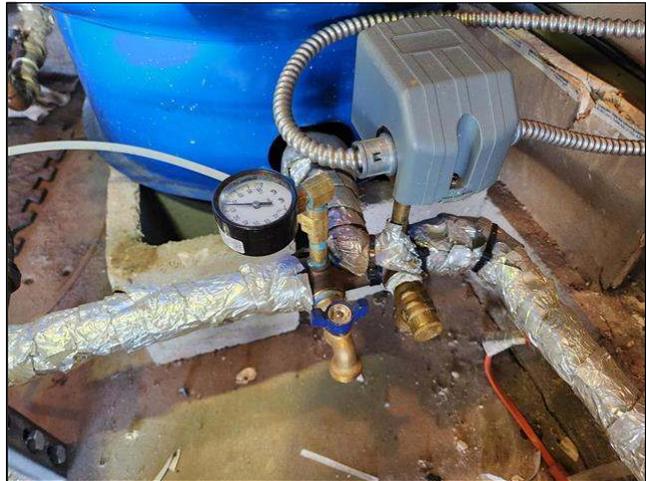
(1) The water supply system was fully operational as intended at time of inspection. The working system pressure fluctuated between 35 and 55 psi during the inspection. Pressure tank is 119 gallon, and the pump controller is for 3/4 h.p. pump, which is not visible or accessible.

5.2 Item 1(Picture) well pump equipment

5.2 Item 2(Picture) well pump equipment

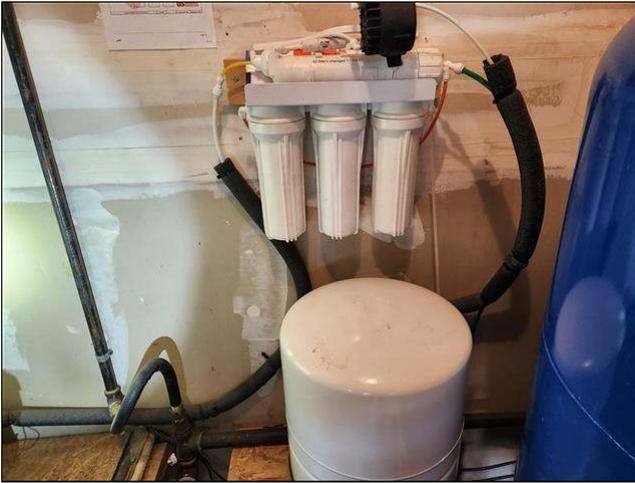
(2) Reverse Osmosis water purification system noted installed in the garage. System was not checked for proper operation, however there are no leaks noted at the storage tank, filters or water lines. Water appears clear/pure at dispenser, however was not tested for purification.

5.2 Item 3(Picture) reverse osmosis system

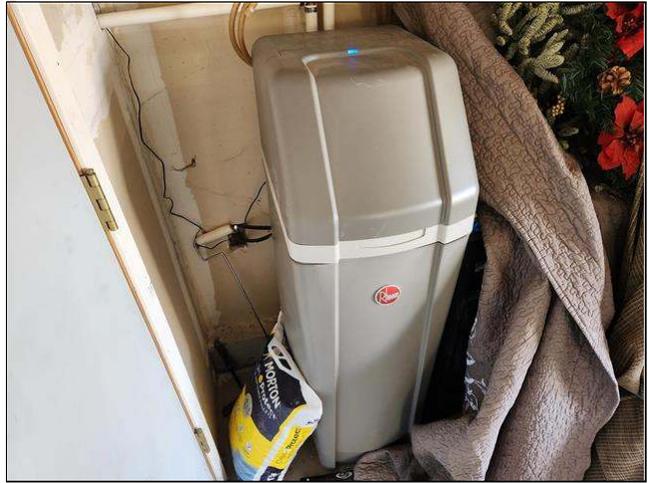
Water Softener system (with salt tank) noted installed in the Garage. System was not checked for proper operation, however there are no leaks noted at the storage tank, filters or water lines. No problems noted at time of inspection. Recommend contacting the installer/manufacturer for information on life expectancy or condition.

5.2 Item 4(Picture) water softener system

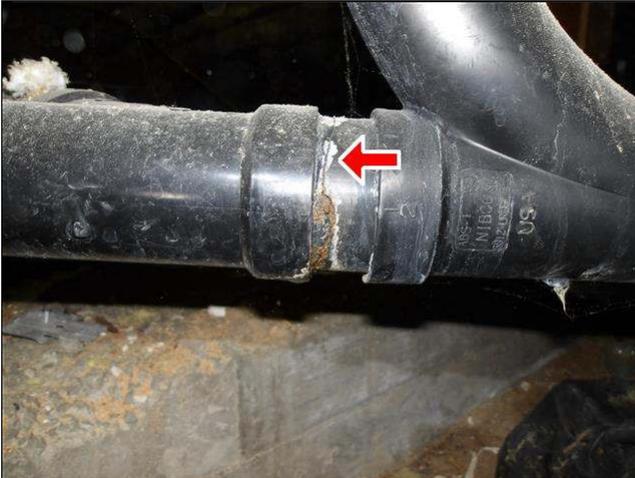
(1) The 2" waste line is cracked and leaks in the crawlspace area under the guest bathroom. Water leaking under home can cause problems such as mold, erosion or deterioration. A qualified licensed plumber should repair or correct as needed. **RE: ITEM 5.3(1) -- Please see Exhibit: Seller Repair Itemization**

5.3 Item 1(Picture) cracked pipe under guest bathroom

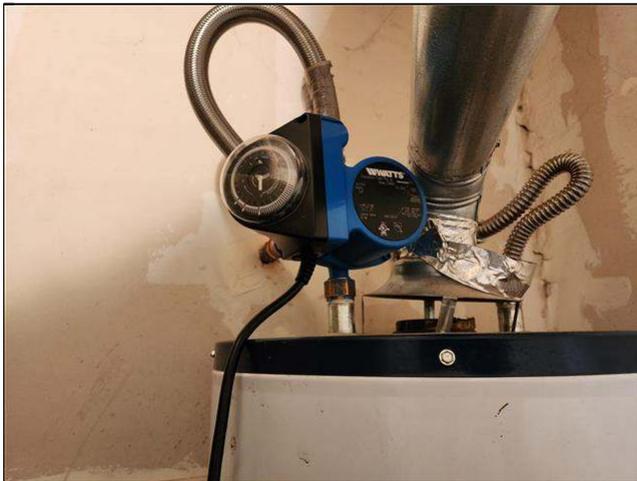
- (3) Recirculation pump for hot water is present, and operating as intended at time of inspection. No problems noted.

5.4 Item 5(Picture) recirculation pump

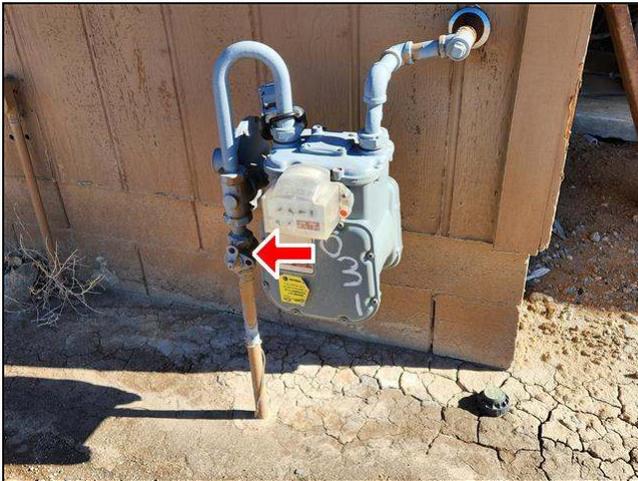
5.11 Item 1(Picture) main fuel shut-off valve

Located at the West side of the house with the gas meter. No problems noted.

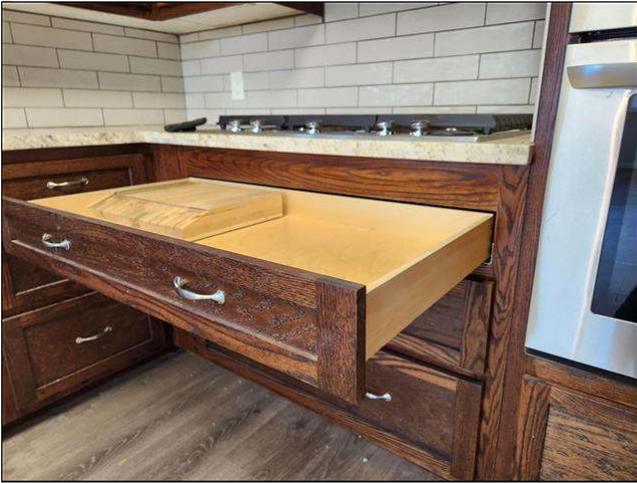
6.2 Item 1(Picture) gas shut-off valve behind drawer

The gas Range was inspected at all burners and settings. The Electric double Oven was inspected at all heating elements and random settings. No problems noted at time of inspection. NOTE: Gas shut-off valve is located under the cooktop range, and requires removing a drawer for access.

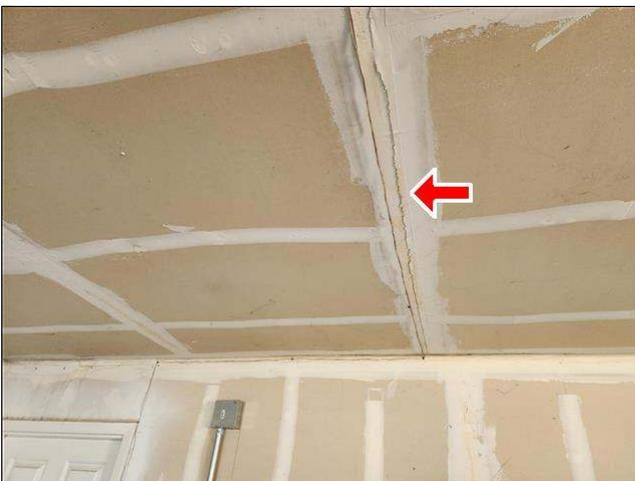
8.2 Item 1(Picture) typical settlement cracks

(1) Ceilings finished with drywall, with typical settlement cracks.

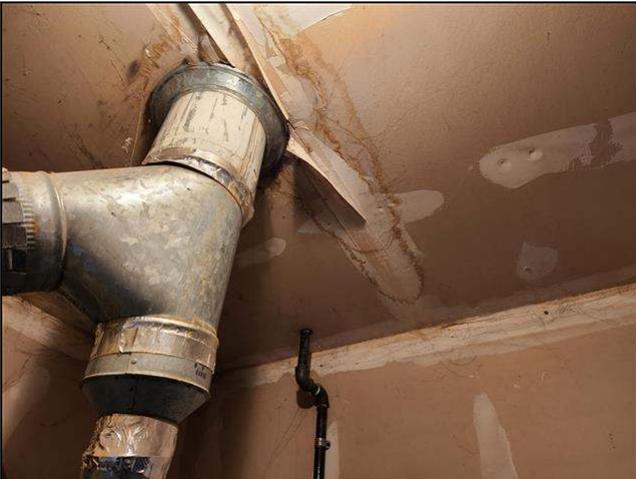
8.11 Item 3(Picture) moisture stains from past leaks

Moisture stains noted at the garage ceiling and wall finish, however appears to be caused from past roof covering issues that no longer exist.

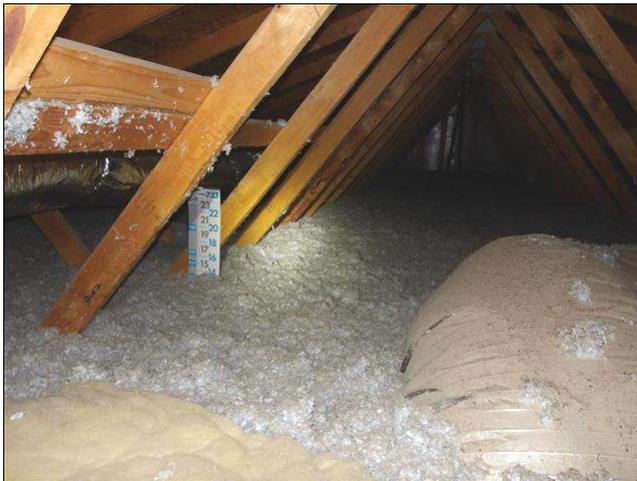
9.0 Item 1(Picture) view of attic insulation

(1) Master Bedroom attic insulation is loose-fill, and is approximately 14 to 16 inches deep. (R-38) No problems noted.

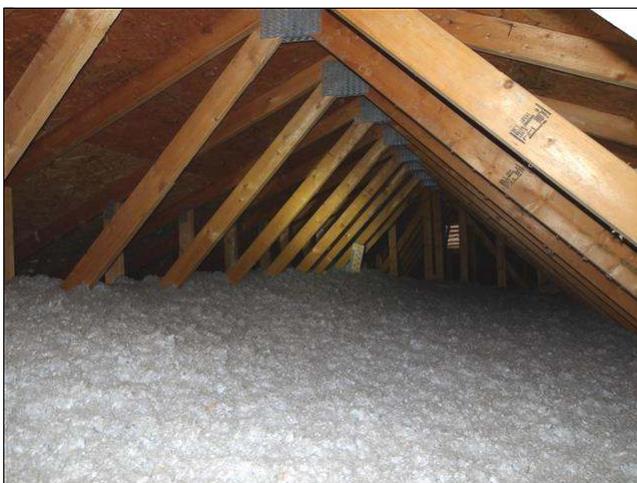
9.0 Item 2(Picture) view of main house attic insulation

(2) The Main House attic insulation is loose-fill, and is approximately 14 to 16 inches deep. (R-38) No major problems noted... Attic insulation has been pulled back for installations/repairs over the hall bathroom area. Recommend re-installing insulation in this area to maximize heating/cooling efficiency and comfort.

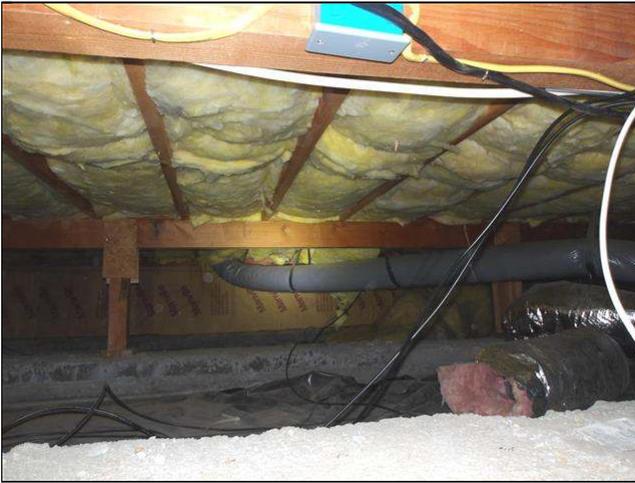
9.1 Item 1(Picture) view of subfloor insulation

(1) Main House... The subfloor area is insulated between the floor joists using R19 fiberglass Batts, no problems noted.

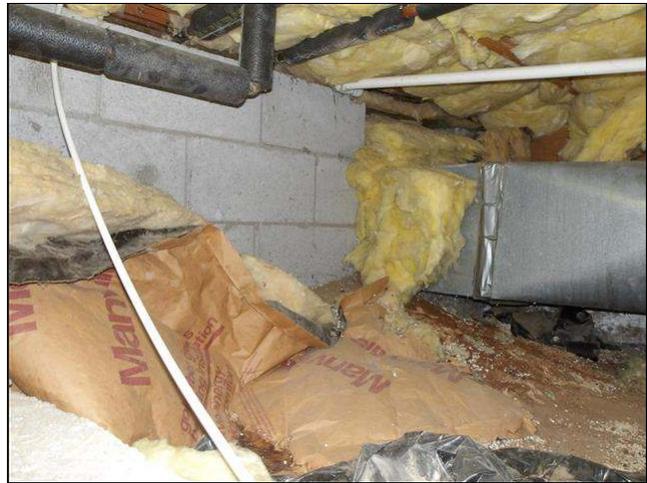
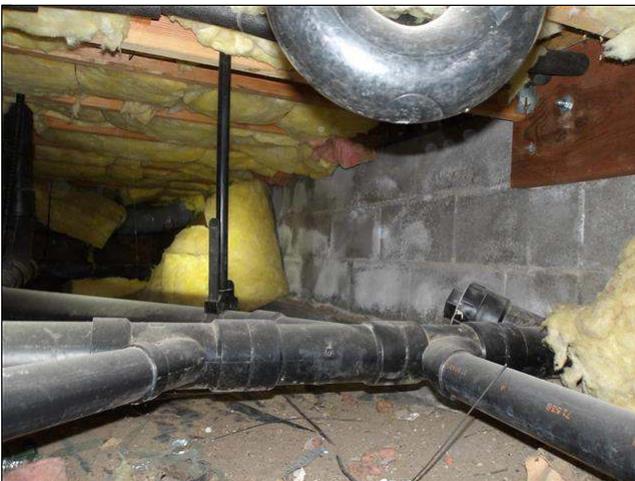
(2) Main House... The crawlspace area is insulated on the perimeter of the inner foundation wall using R13 fiberglass bats. Insulation is falling away from the foundation stemwall at various locations. Recommend securing insulation to foundation wall to maximize the home's efficiency and comfort.

9.1 Item 3(Picture) fallen crawlspace insulation

9.1 Item 4(Picture) fallen crawlspace insulation

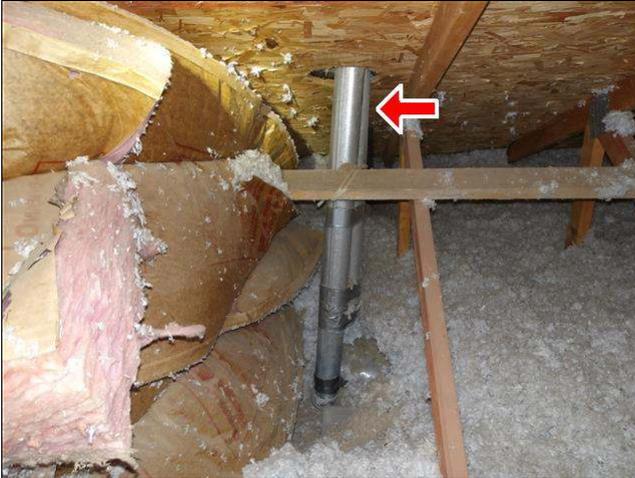
9.4 Item 1(Picture) properly vented to exterior

Bathrooms, Kitchen and Laundry vents are properly ducted to the exterior of the home.

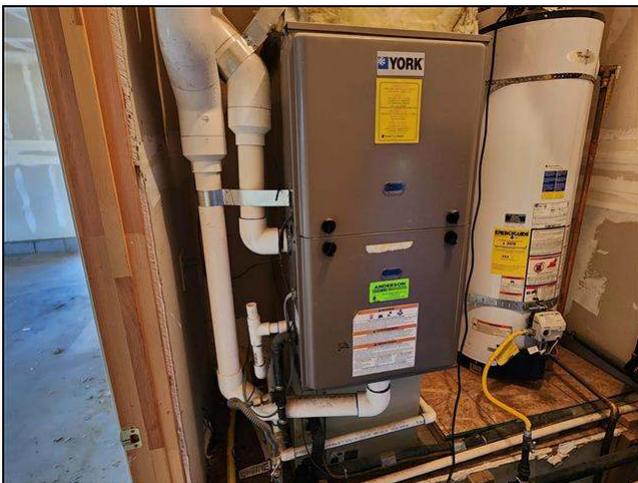
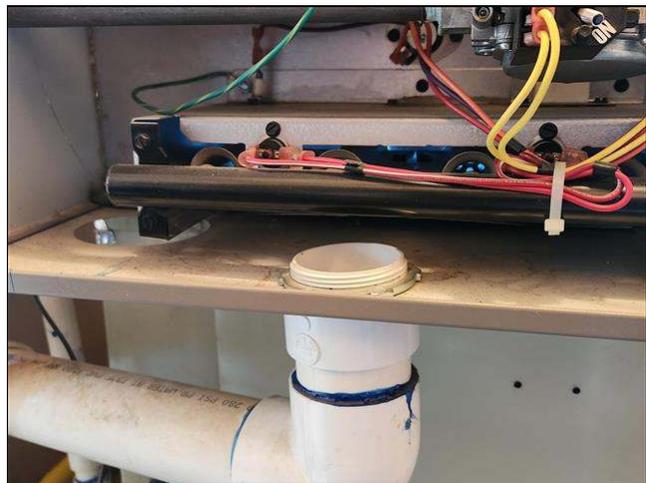
(1) Main House... The heating equipment is NOT original (15 years). The furnace is a vertical downdraft natural gas fired forced air unit, Rated at 80,000btu's, that operated as intended with normal operating controls. The burners have an even blue flame. Manufactured in 2009 by YORK heating.

10.0 Item 1(Picture) main house furnace

10.0 Item 2(Picture) furnace burners

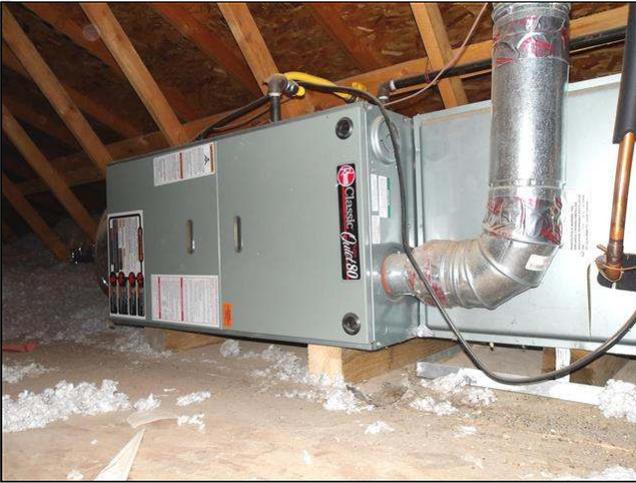
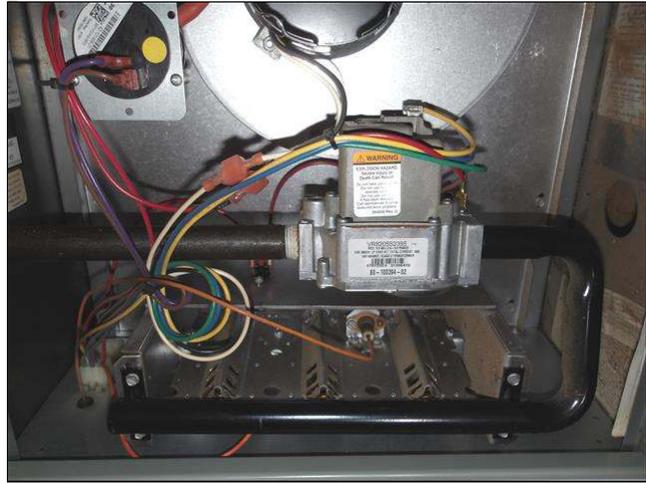
(2) Master Bedroom... The heating equipment is original (16 years). The furnace is a Horizontal Upflow natural gas fired forced air unit, Rated at 75,000btu's, that operated as intended with normal operating controls. The burners have an even blue flame. Manufactured in 2008 by Rheem Heating.

10.0 Item 3(Picture) master bedroom furnace

10.0 Item 4(Picture) furnace burners

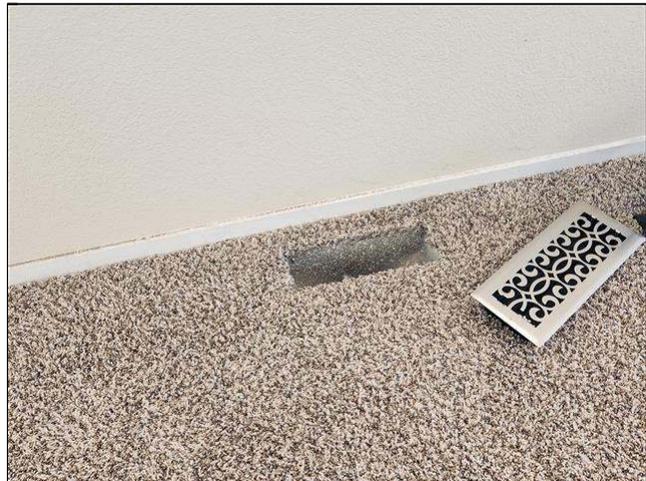
10.3 Item 2(Picture) no heat at living room registers

There is NO heating discharging from the South living room floor registers. Supply ducting was noted to be disconnected in the crawlspace area. Recommend further evaluation/repair by a qualified person.

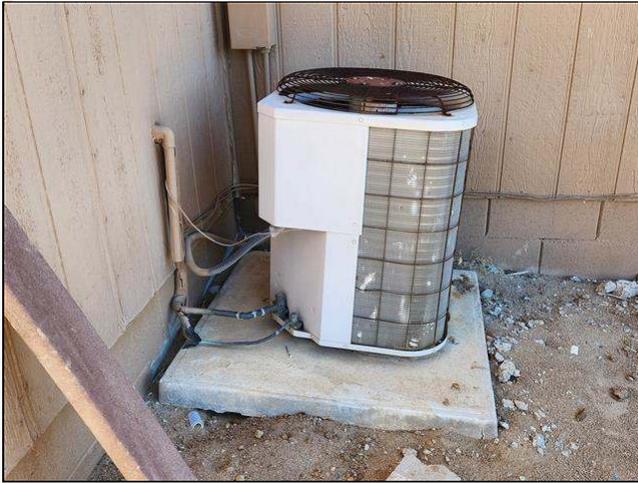
10.5 Item 1(Picture) main house condensing unit

(1) Main House... Performed a visual only inspection. The A/C was not tested for proper operation due to the outside air temperature being 46 degrees or less, and possibility of cooling equipment failure could occur. 60 degree minimum ambient temperature must be achieved for safe compressor operation. NOTE: Licensed HVAC Contractors possess the required knowledge and equipment to check operation of cooling system in cold weather. Recommend consulting an HVAC Contractor for further evaluation of cooling system as desired. We did not inspect this unit(s). 3 ton unit Manufactured in 1992 by CARRIER.... NOTE: The foam sleeve on suction line is beginning to deteriorate. Missing foam on suction line can cause energy loss and condensation. I recommend service or repair as needed.

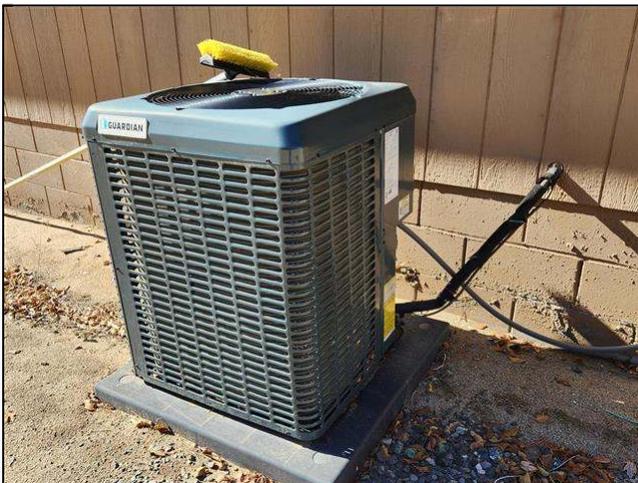
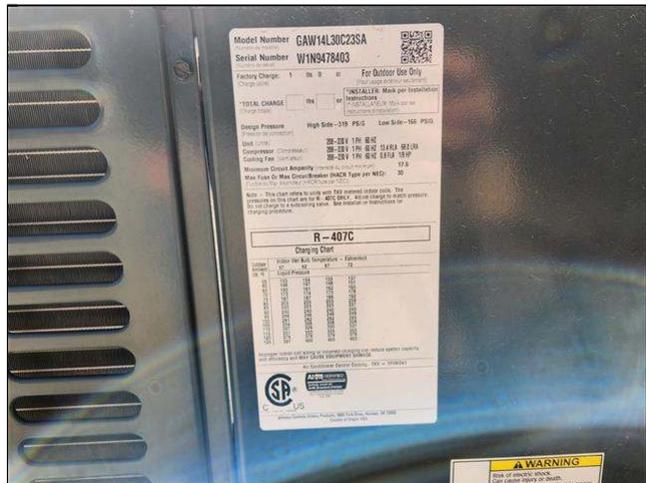
(3) Addition Building... Performed a visual only inspection. The A/C was not tested for proper operation due to the outside air temperature being 46 degrees or less, and possibility of cooling equipment failure could occur. 60 degree minimum ambient temperature must be achieved for safe compressor operation. NOTE: Licensed HVAC Contractors possess the required knowledge and equipment to check operation of cooling system in cold weather. Recommend consulting an HVAC Contractor for further evaluation of cooling system as desired. We did not inspect this unit(s). 2.5 ton unit Manufactured in 2019 by Guardian.

10.5 Item 3(Picture) master bedroom condensing unit

10.5 Item 4(Picture) manufacturer's label

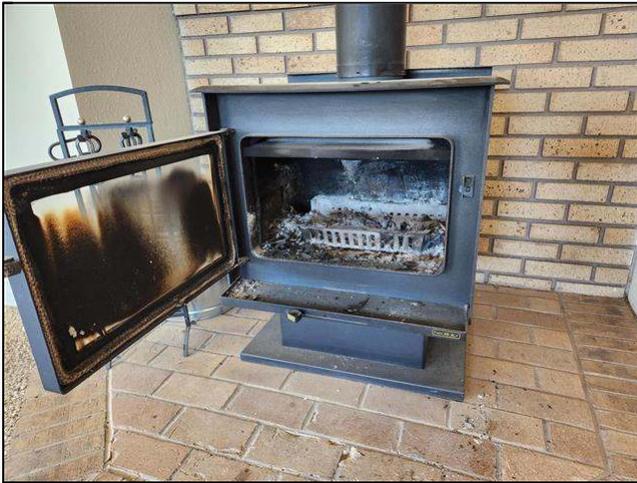
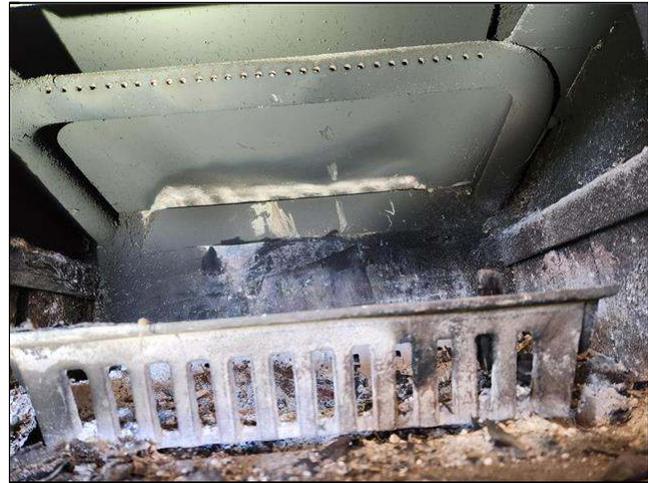
Woodstove appears operational, with stovepipe fastened securely. Clearances to combustibles appears acceptable. Door seals and damper controls appear serviceable. Note: Recommend consulting a licensed fireplace contractor for a more thorough examination of the woodstove, pipe systems and code compliance, as needed.

11.1 Item 1(Picture) living room woodstove

11.1 Item 2(Picture) woodstove burn box

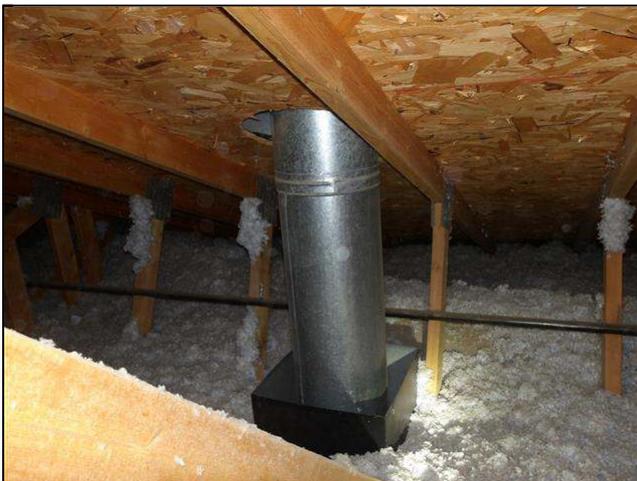
11.3 Item 1(Picture) proper clearances through attic

Chimney pipe has proper clearances from combustibles at ceiling and roof penetrations.

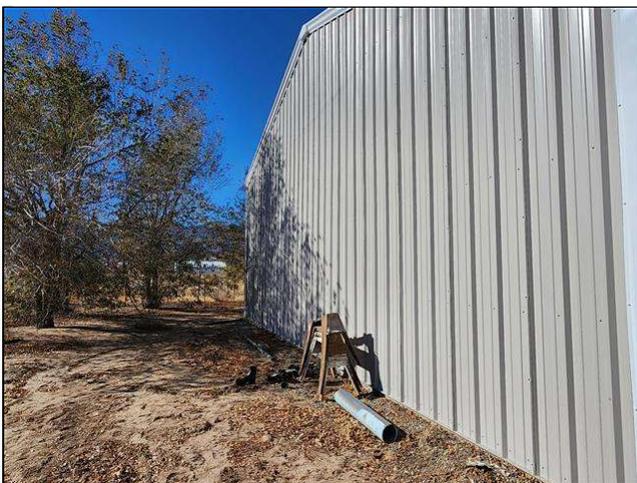
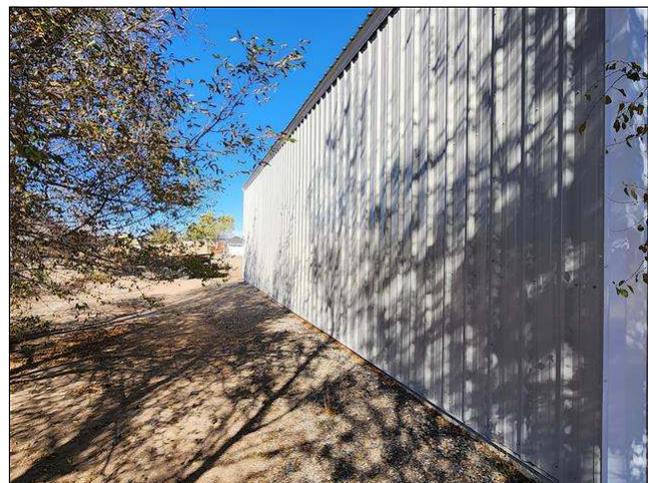
Siding material is ribbed metal with sealed fasteners. Material is secured well at all sides, with proper use of flashings where needed. Insulated foam was noted at ribbed areas to prevent access for birds, and to help with heating the building. No problems noted at time of inspection.

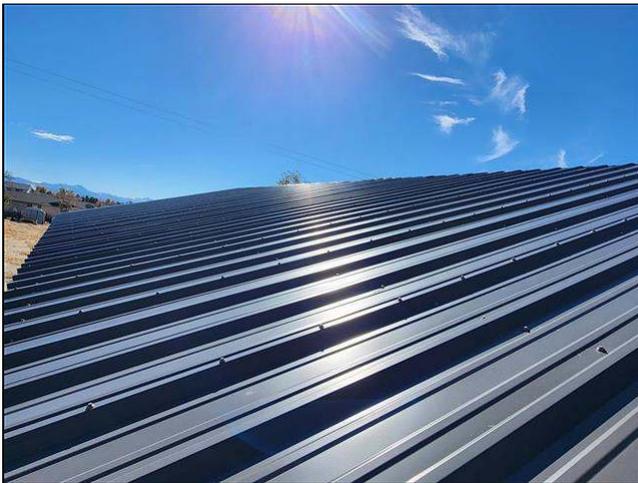
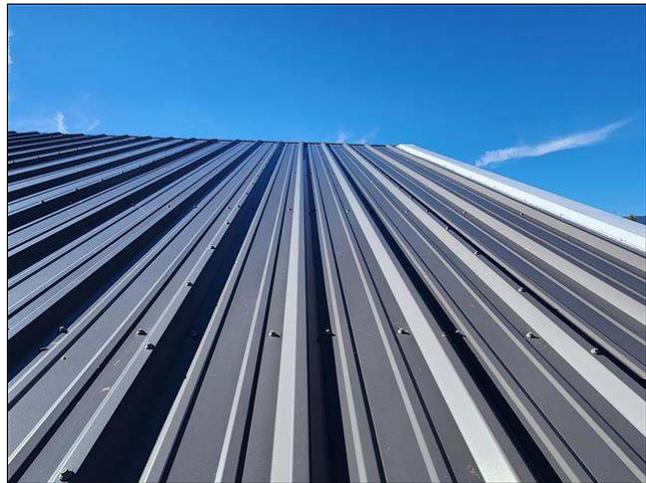
Roofing material is ribbed metal with sealed fasteners. Material is secured well to main structure framing , with proper use of flashings where needed. No problems noted at time of inspection.

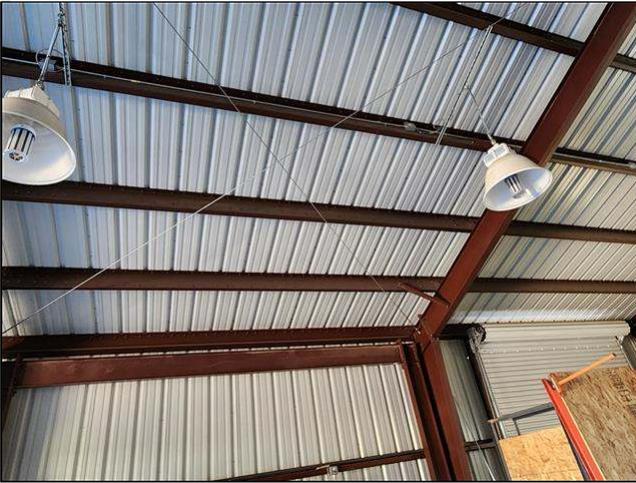
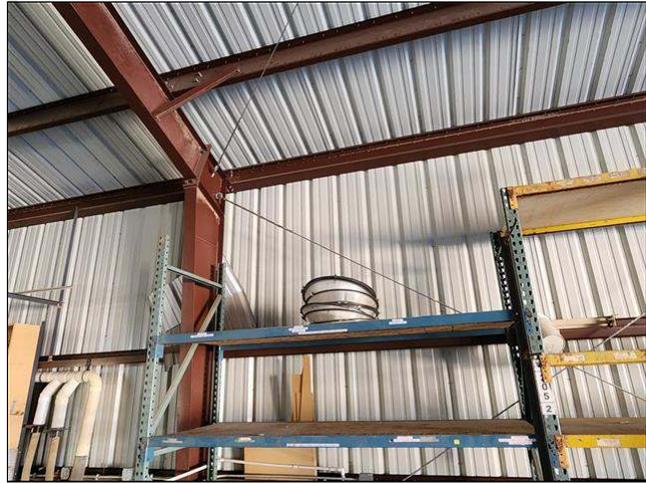
The Shop building has steel beam construction with cables used to maintain shear strength for structural integrity. All beam connections are tight. All cable connections appear in good condition, and are tight. No problems noted at time of inspection.

12.4 Item 1(Picture) structural cables

12.4 Item 2(Picture) structural beams and purlins

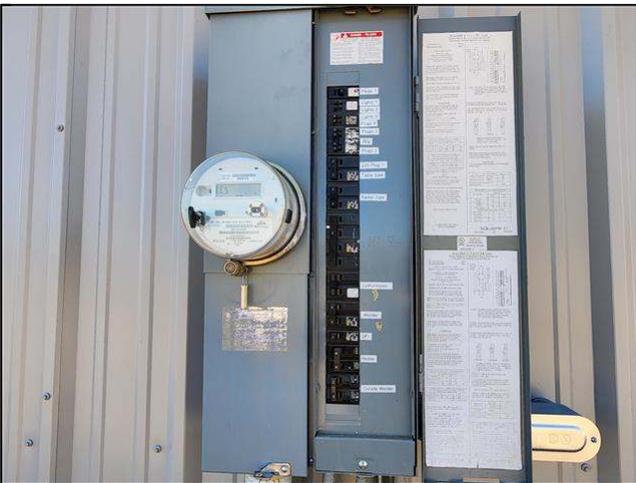
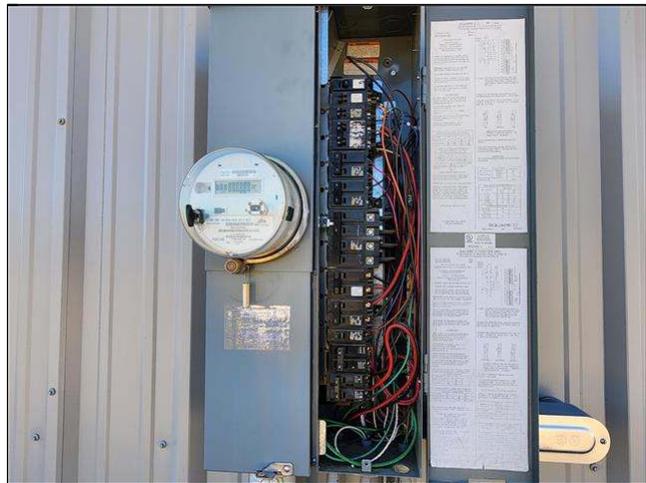
Garage panel is well labeled for circuit identification, The circuit conductors appear in good condition, and are properly sized for their prospective overcurrent devices. No "double tap" circuit breakers or burned connections noted.

12.6 Item 1(Picture) main garage panel

12.6 Item 2(Picture) main panel conductors
