Inspection Report

Property Address:
2747 Stewart Ave.
Minden NV 89423

Date: 9/11/2023	Time: 07:30 AM	Report ID: BOR274
Property: 2747 Stewart Ave. Minden NV 89423	Customer: Suzanne Bornstein	Real Estate Professional: Thomas Vander Laan Coldwell Banker

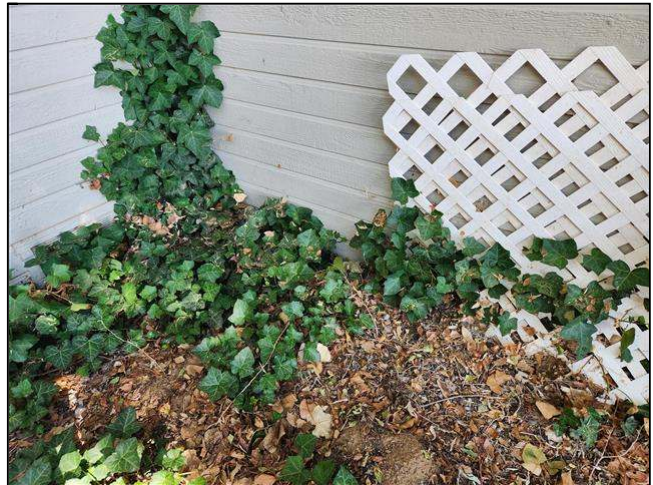
Siding in contact with the ground in areas across the South side, Southeast corner, and East side of the home. This condition can rapidly deteriorate siding materials. Recommend correct grade to eliminate ground contact.

1.1 Item 2(Picture) southeast corner siding

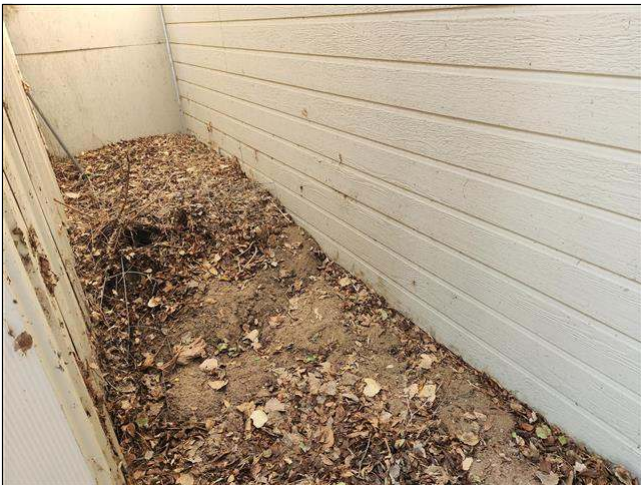
1.1 Item 3(Picture) southeast corner siding

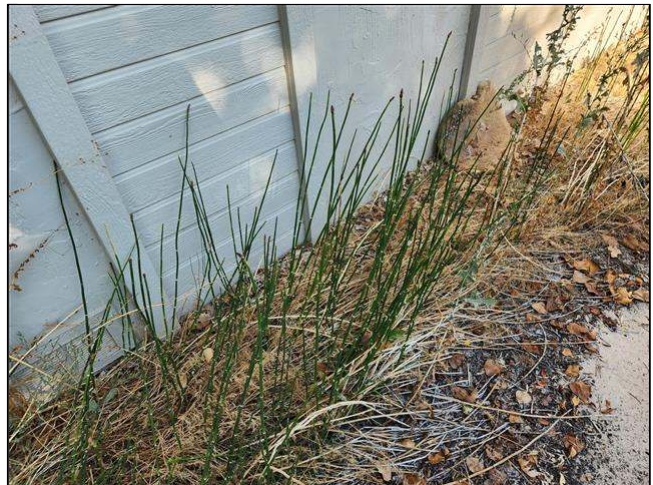
1.1 Item 4(Picture) east wall siding

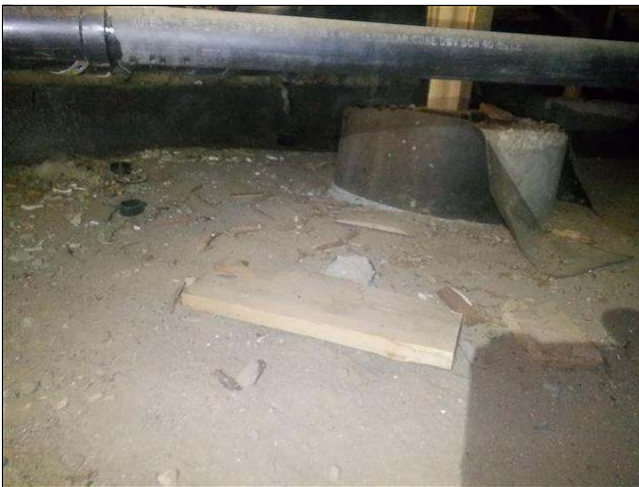
(3) Construction debris (and/or trash) should be removed from the crawlspace area.

3.2 Item 1(Picture) construction debris

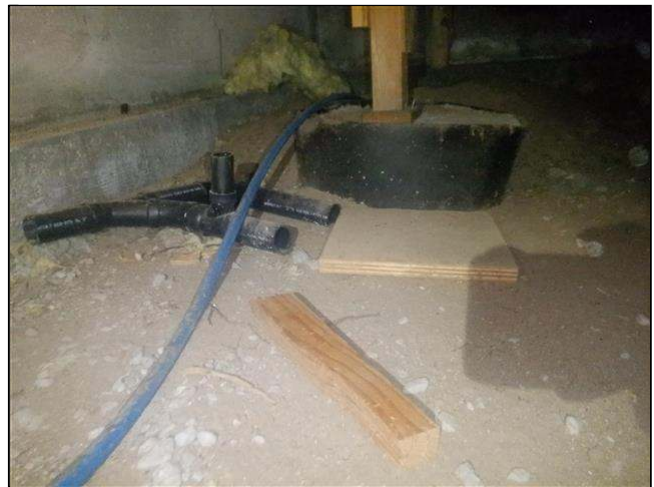
3.2 Item 2(Picture) construction debris

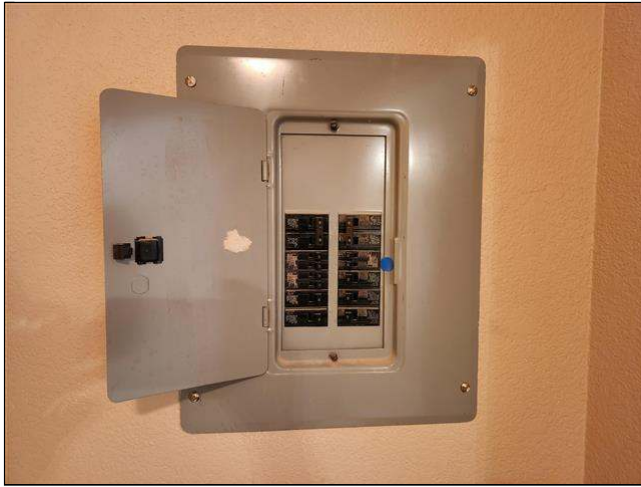
Circuit identification labels are missing and/or illegible at the Laundry room panel. Recommend identifying and labeling circuits, to ensure proper circuit disconnection when needed.

4.1 Item 3(Picture) laundry room panel

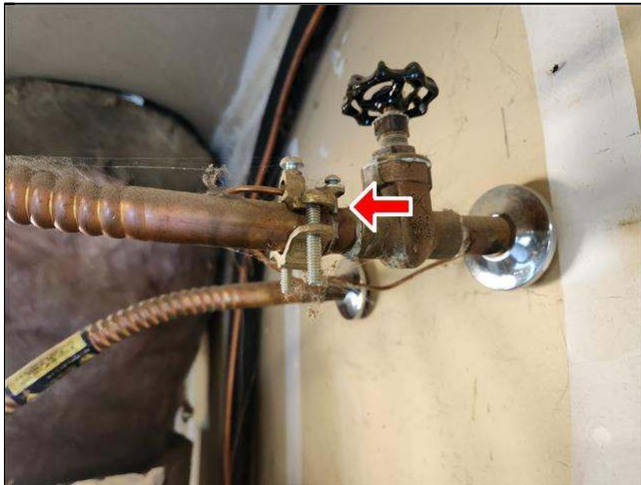
The Grounding system for the Main Service Panel is not visible due to construction materials. However, there is a Grounding wire present in the Panel, and there is a Bonding wire present at the cold water pipe, which are important for proper grounding (safety) of the home.

4.3 Item 1(Picture) bond to plumbing

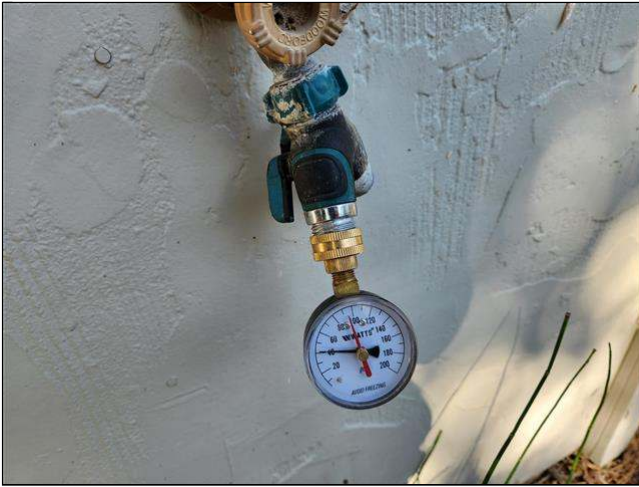
The water pressure was tested at the rear hose bib, pressure was 42 psi at time of inspection.

5.1 Item 1(Picture) water pressure at rear hose bib

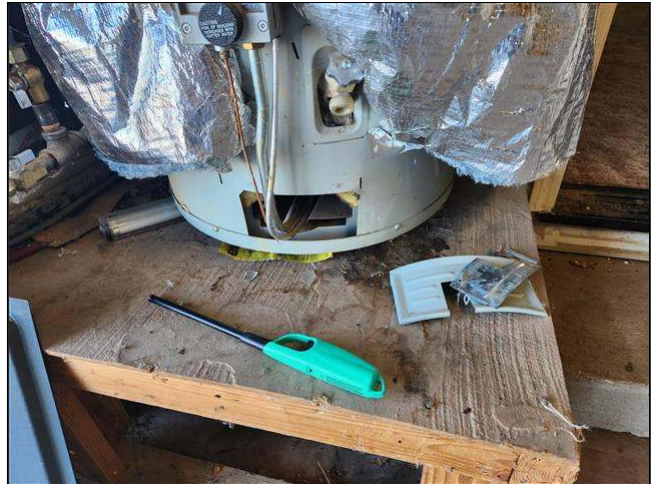
5.4 Item 2(Picture) water heater could not be operated

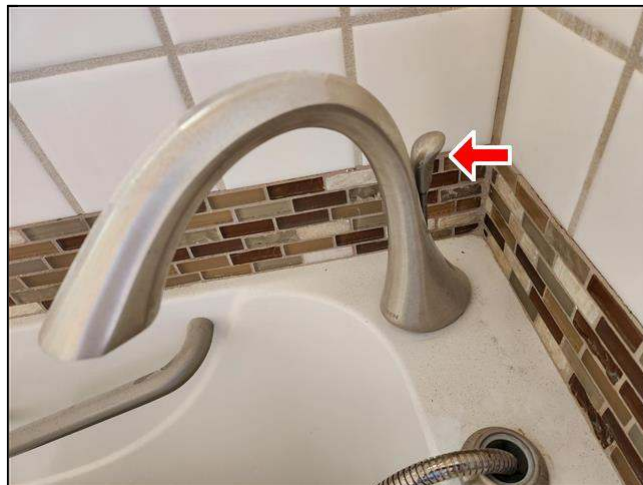
5.5 Item 2(Picture) cannot redirect water from hose

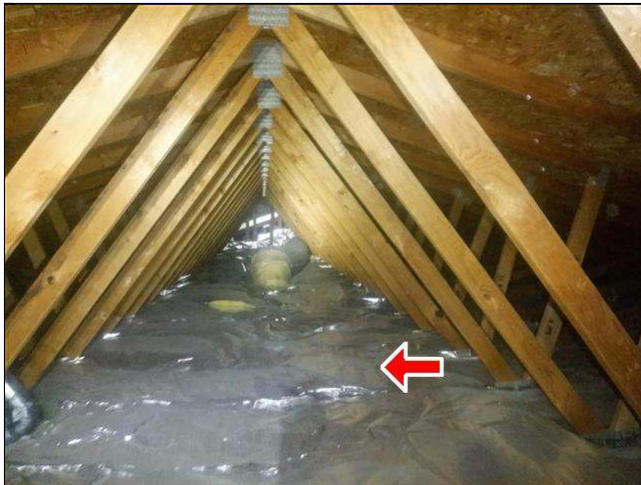
Attic insulation is original to the home, and is Fiberglass Batt type with foil facing, approximately 6 inches thick (R19). No problems noted.

9.0 Item 1(Picture) view of attic insulation

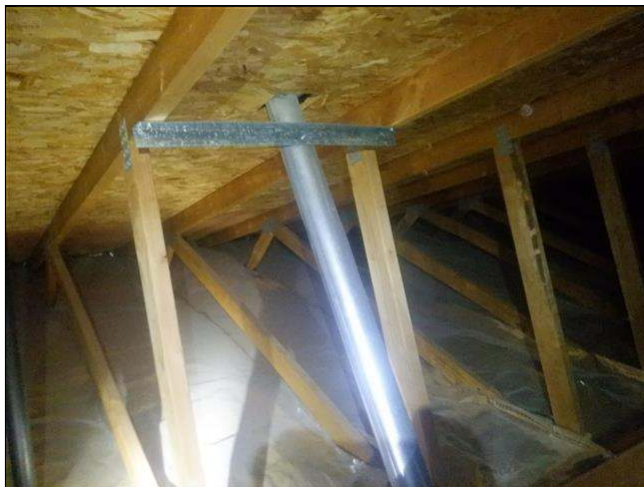
Kitchen and Laundry vents are properly ducted to the exterior of the home. Bathrooms use windows only for ventilation.

9.4 Item 1(Picture) properly vented to exterior

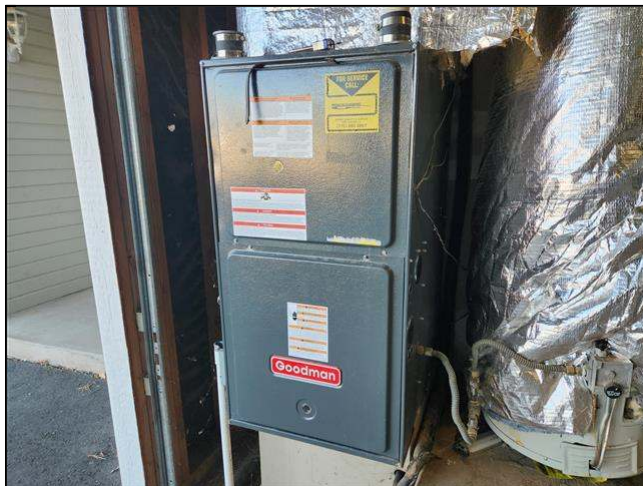
The furnace is a GOODMAN Mfg. NOT original equipment for the home, and was visually inspected only due to gas supply being turned/locked off at time of inspection. No obvious problems noted. NOTE: Recommend further evaluation by a qualified HVAC contractor to verify proper operation of the heating system.

10.0 Item 1(Picture) forced air furnace

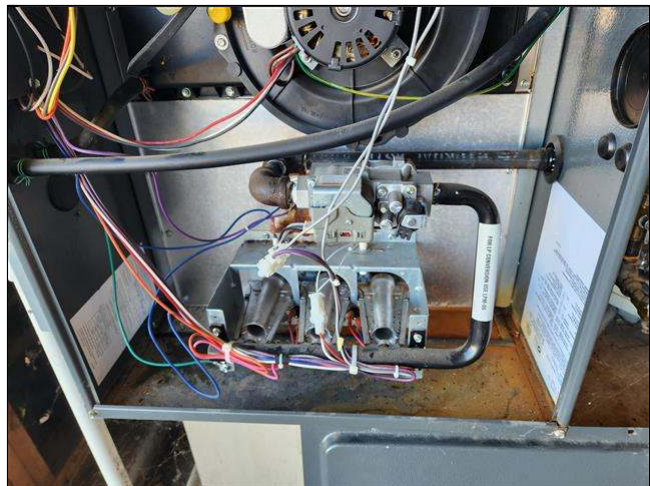
10.0 Item 2(Picture) furnace burners

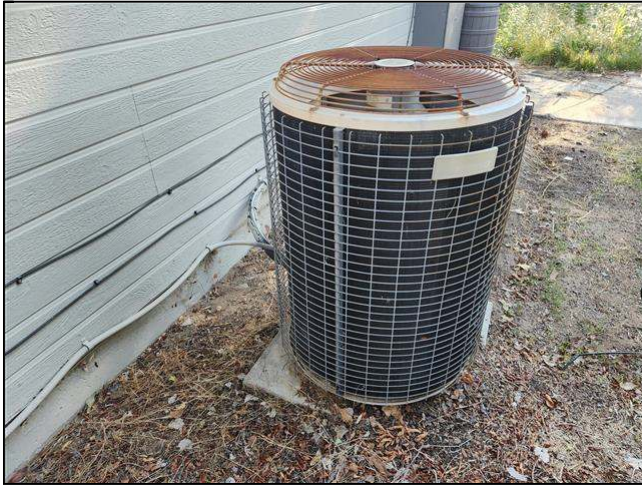
The ambient air test was performed by using thermometers on the air handler of Air conditioner to determine if the difference in temperatures of the supply and return air are between 14 degrees and 22 degrees which indicates that the unit is cooling as intended. The supply air temperature on your system read 56 degrees, and the return air temperature was 71 degrees (a/c cabinet temperature measured 72 degrees). This indicates the range in temperature drop is normal. Condensing unit operated as intended with normal operating controls, and no abnormal noises noted. Unit was manufactured in 1992 by Amana.

10.4 Item 1(Picture) condensing unit

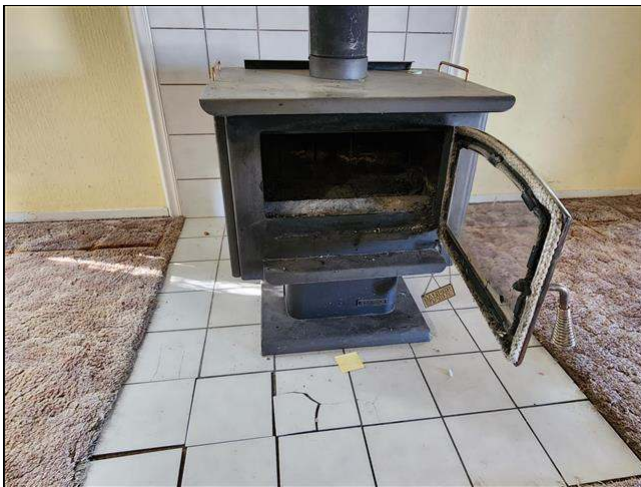
Woodstove appears operational, with stovepipe fastened securely. Clearances to combustibile materials appears acceptable. Door seals and damper controls appear serviceable. **Several floor tiles are cracked/loose.** Note: Recommend consulting a licensed fireplace contractor for a more thorough examination of the woodstove, pipe systems and code compliance, as needed.

11.3 Item 1(Picture) family room woodstove

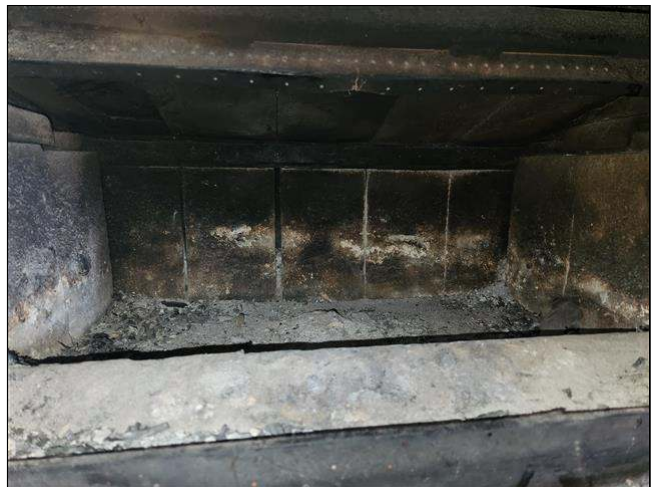
11.3 Item 2(Picture) woodstove firebox
