INSPECTION REPORT
3895 Golden Eagle
Manhattan KS 66502

INSPECTED BY
Todd Thompson
Trust Inspection
Services

INSPECTION DATE
📅 5/14/2024
🕒

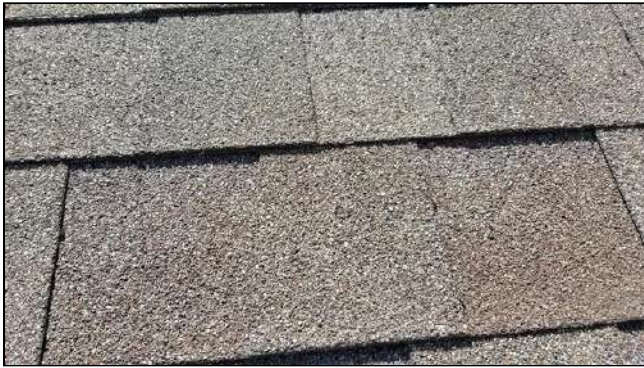
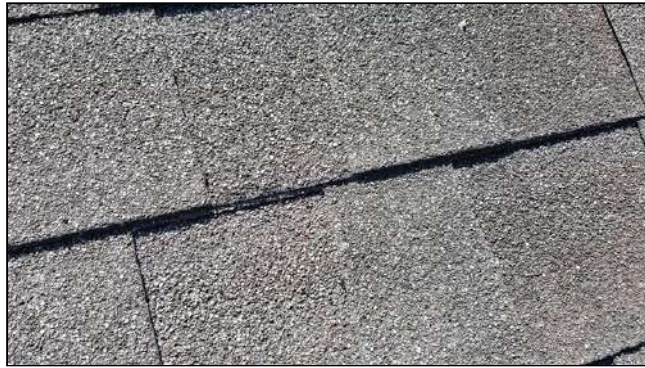
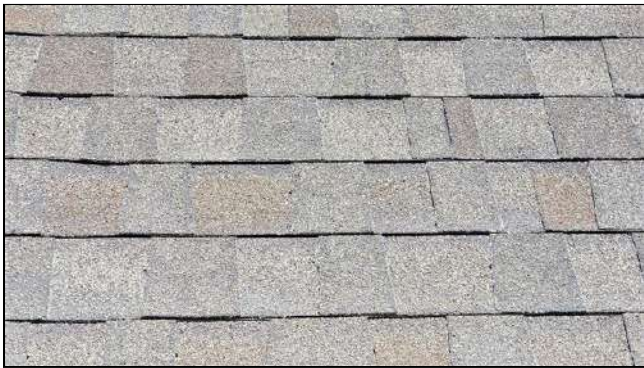
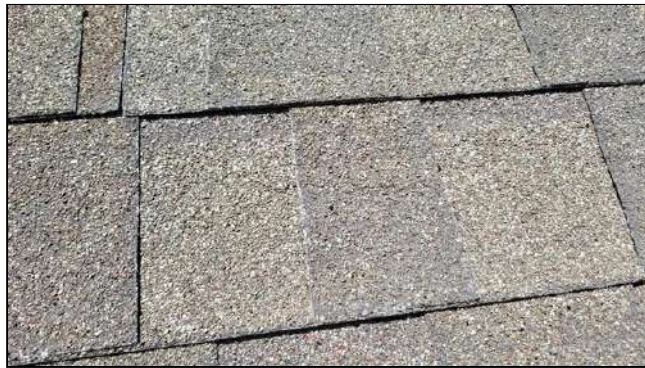
There's evidence of granule loss visible on the shingles especially on the south and west facing surfaces

There's some missing shingles on the south facing roof.

Recommend having a roofer further evaluate the roof for life expectancy. Weddle and Sons roofing does free inspections and provides a report with life expectancy and estimates for any recommended repairs.

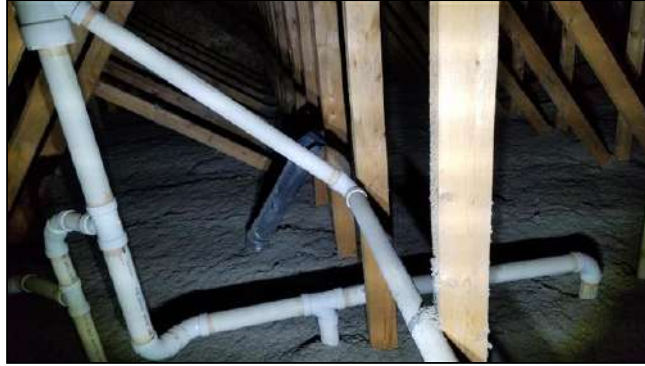
1.5 Item 2(Picture)

1.5 The bathroom exhaust fans vent into the attic space - while not ideal, no excessive moisture was noticed in the attic.

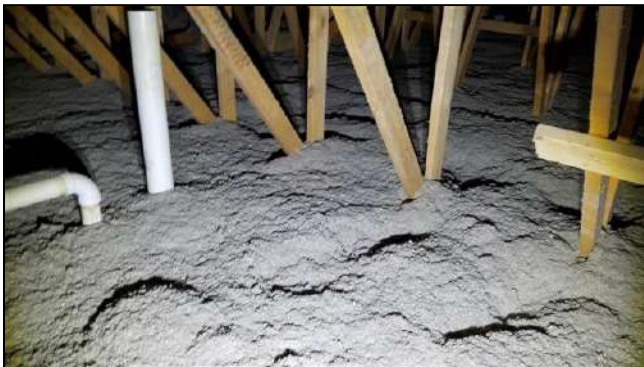
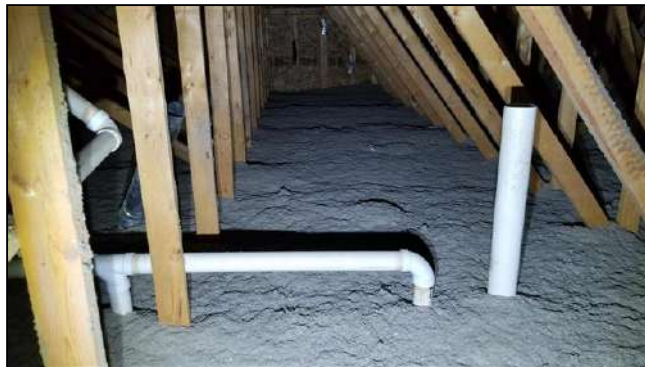
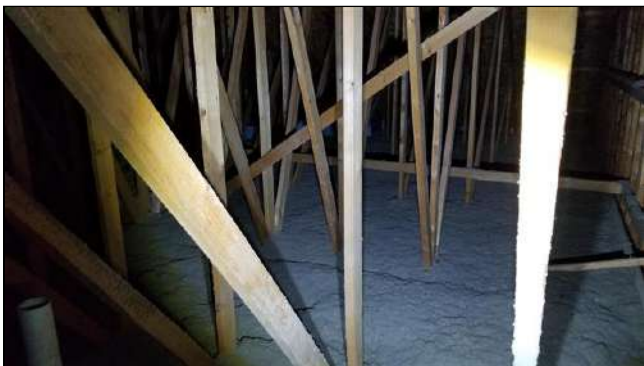
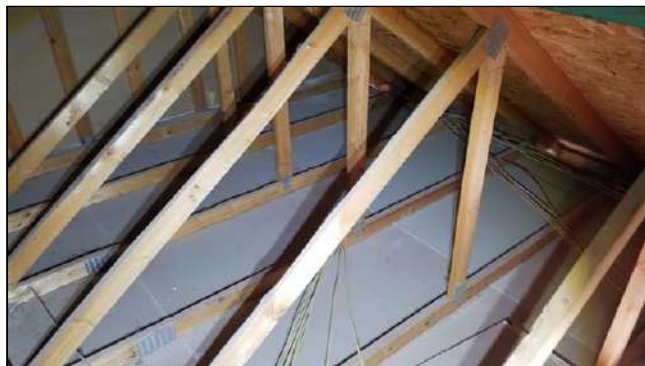
1.6 Insulation levels in the attic appear to be adequate.

There is no insulation above the garage.

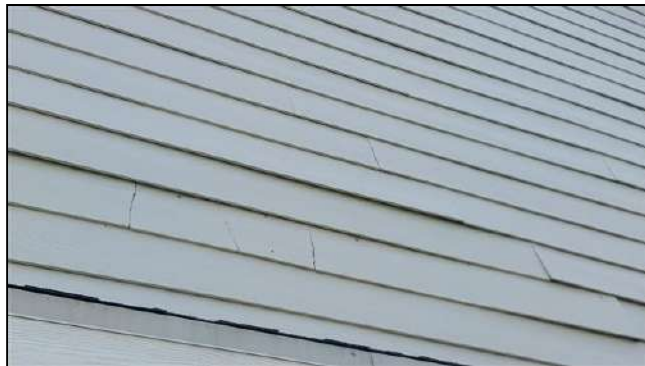
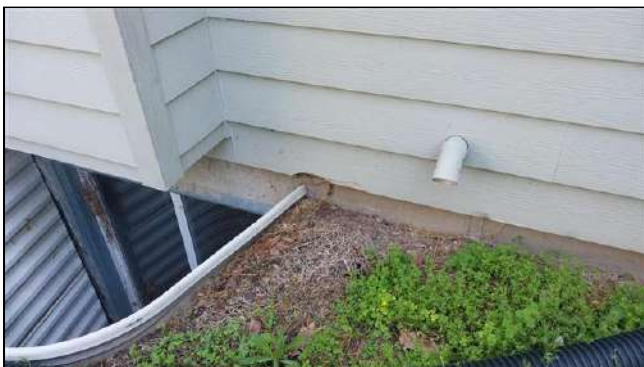
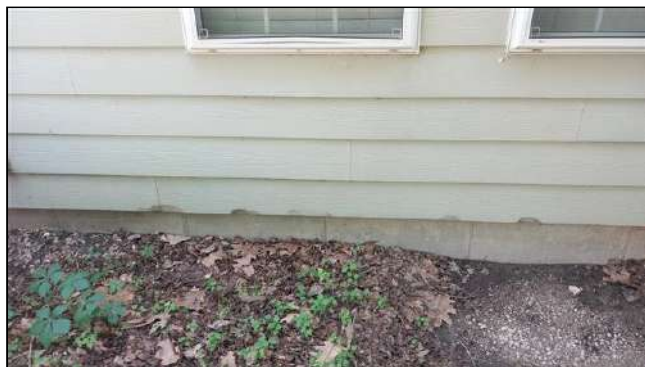
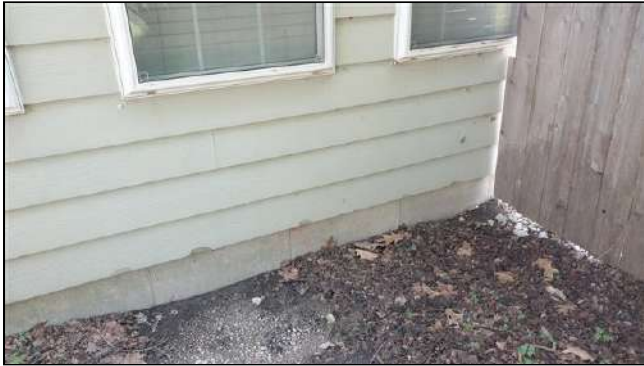
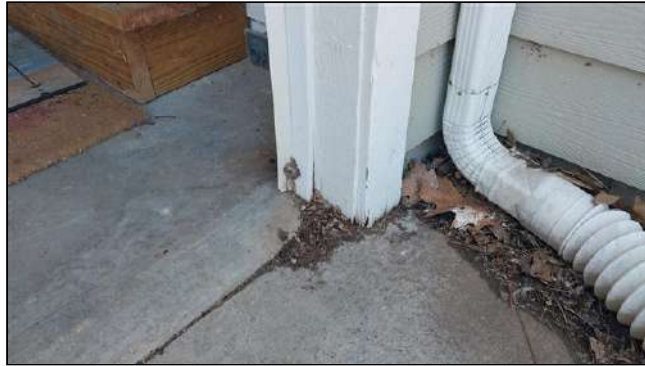
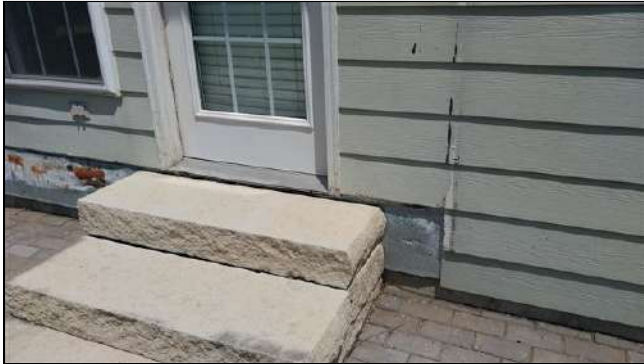
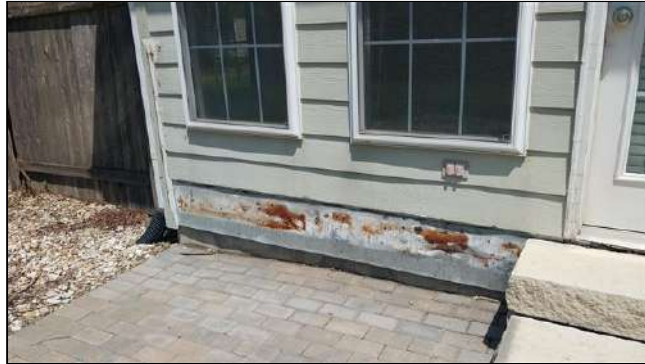
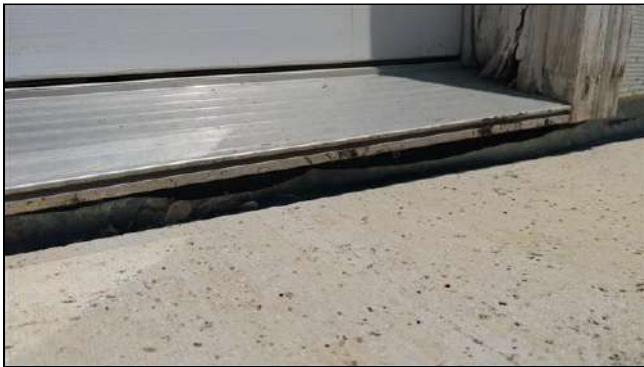
There are some loose pieces of siding in the upper West gable end. Some cracking can be seen in one of the pieces of siding - treat this as a butt joint and caulk it. The siding butt joints appear to have a building paper behind them - making it not necessary to caulk the butt joints

The flashing for the previous deck needs to be repaired. The gaps under the patio door sill need to be sealed.

There is some damage to the bottom piece of siding on the west side.

There is a little bit of chipping paint and water damage on the garage door opening trim.

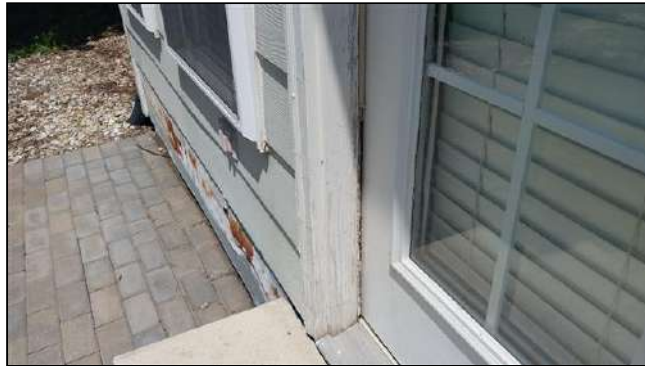
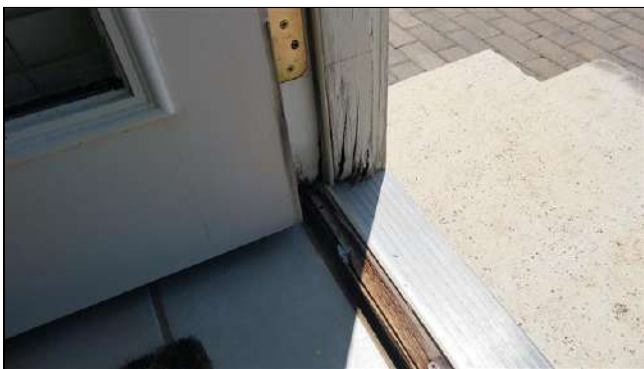
2.1 Water damage, chipping paint, and damage to the weather seal can be seen on the south patio door. Daylight can be seen from the inside.

The front entry door knob is loose and does not lock properly.

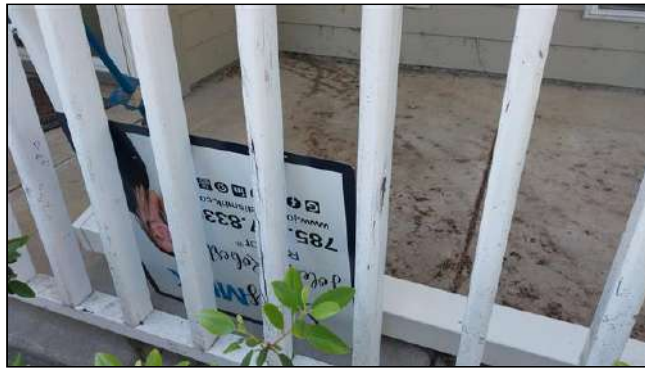
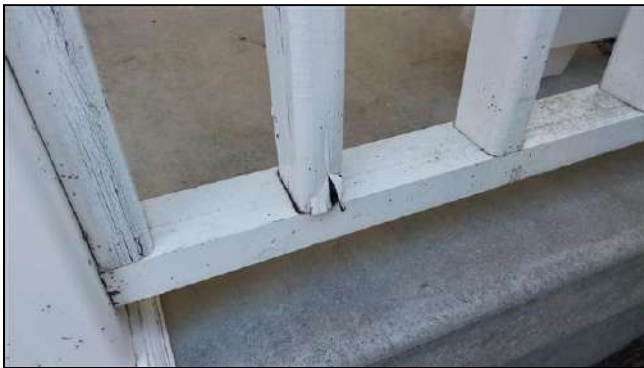
(2) Areas of chipping paint and water damage can be seen on the front porch railing.

2.3 (1) Recommend adding fall protection to the basement window wells.

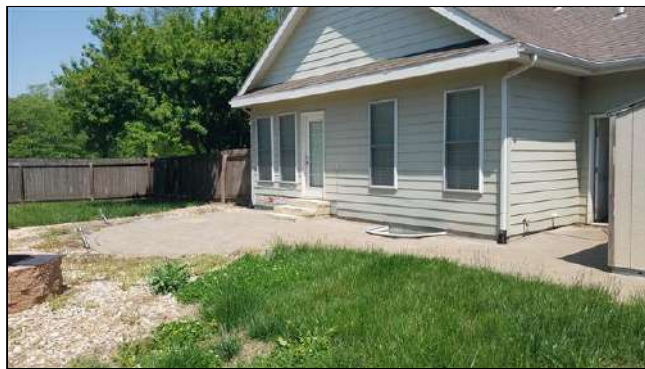
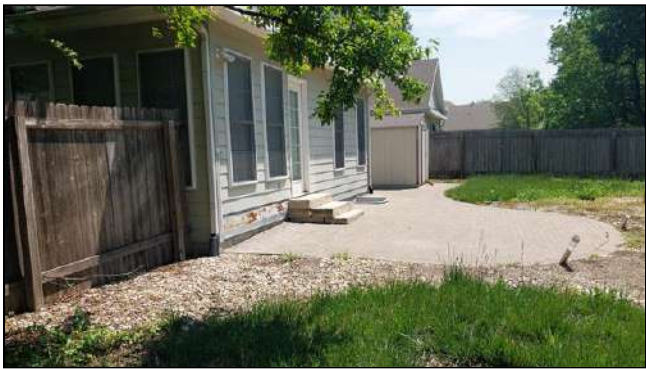
The caulking along the driveway and basement wall needs to be redone. This is likely the entry point to the moisture seen in the basement walls.

2.4 The drainage slope along the west side of the house and around the front porch is flat to negative

Recommend walking around the home at least annually to inspect the drainage. Add soil as necessary to maintain positive drainage away from the home.

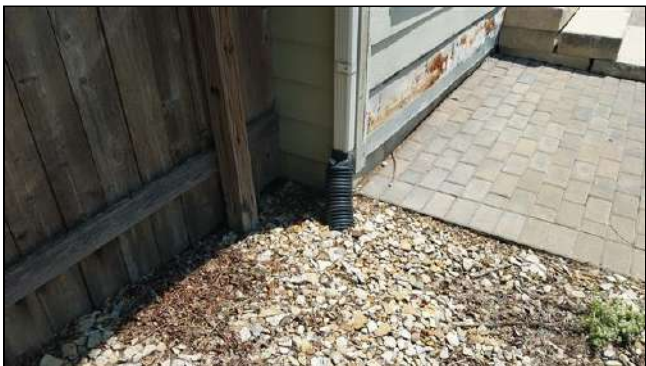
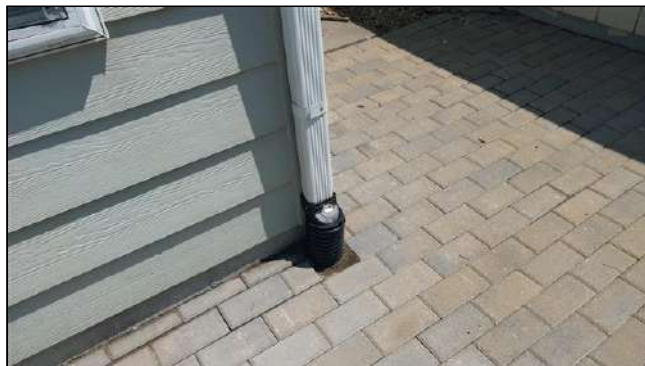
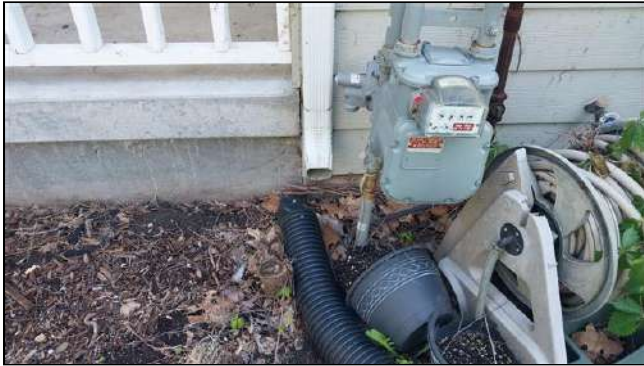
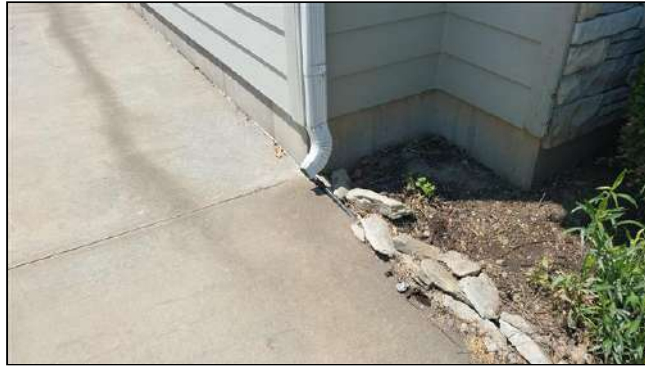
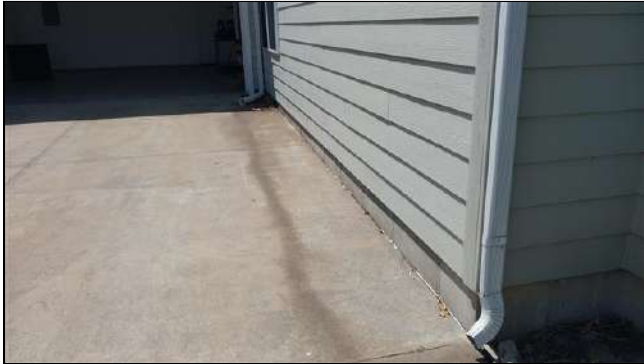
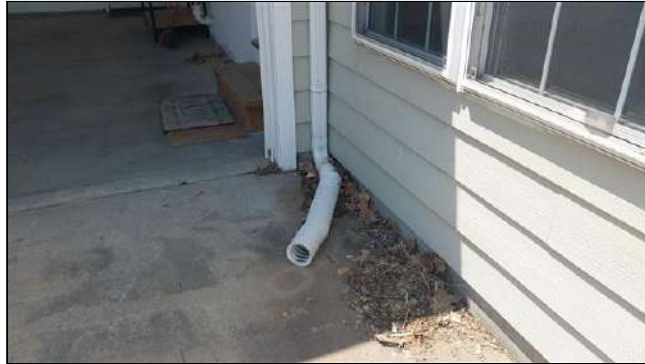
2.5 (1) The West downspout extension needs to be reconnected and extended away from home

Recommend ensuring that the buried downspouts flow freely and do not back up.

Be sure that the downspouts are extended far enough to effectively move water away from the home.

Recommend extending the downspout near the garage in PVC along the wall and then combine with the downspout at the northwest corner and extend far enough to ensure water does not run under the driveway.

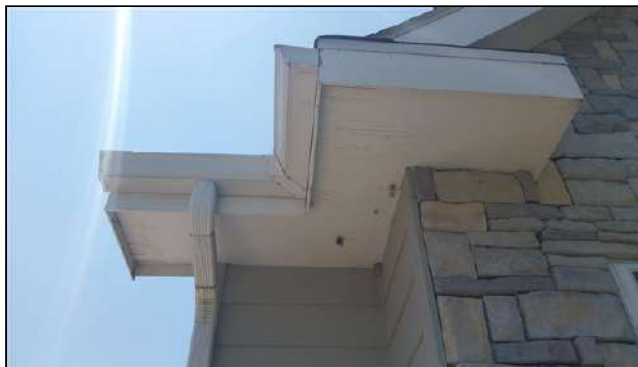
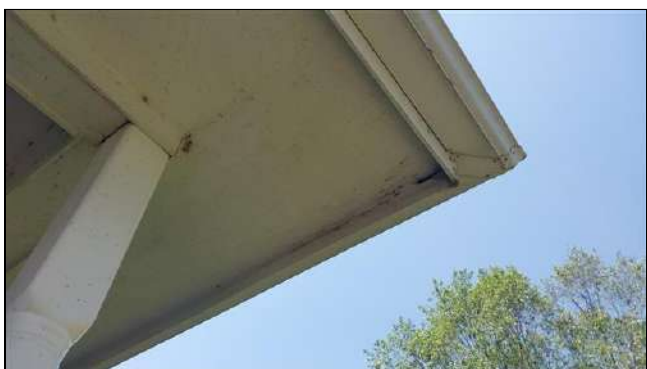
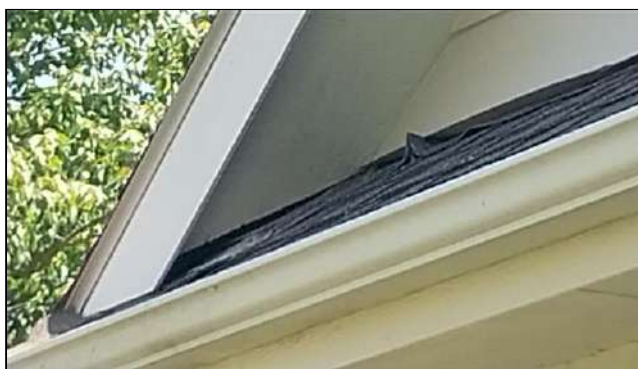
There is some cracking in areas of the soffit board

2.6 Recommend installing some flashing to seal off the gap in the soffit above the garage roof and at the NW corner.

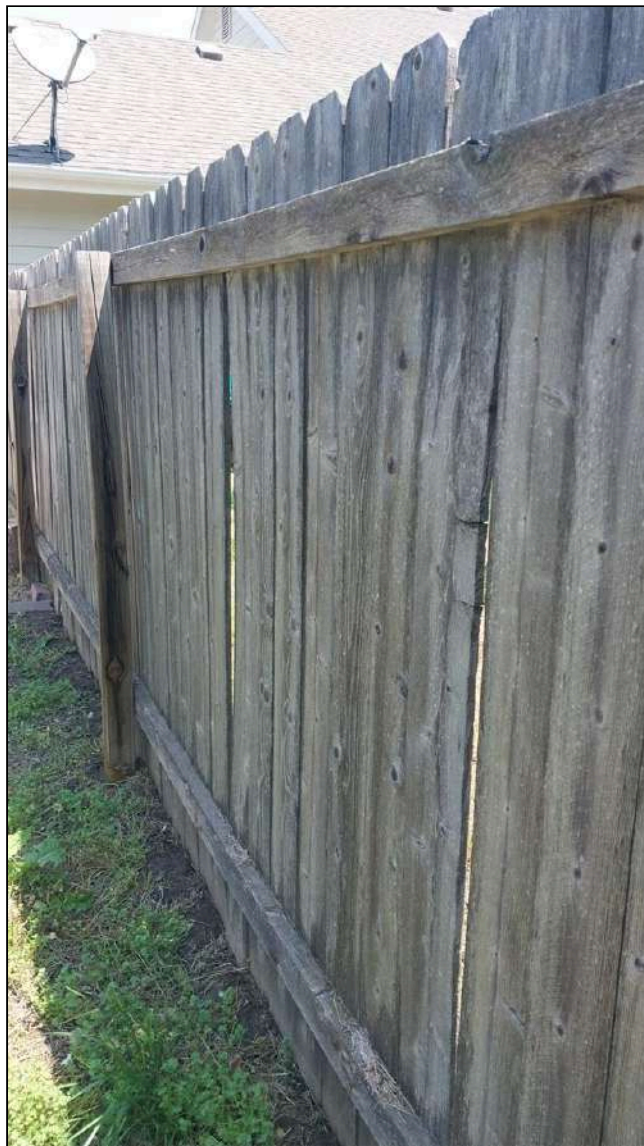
2.9 Item 2(Picture)

2.9 There's a little bit of repair needed on the fence.

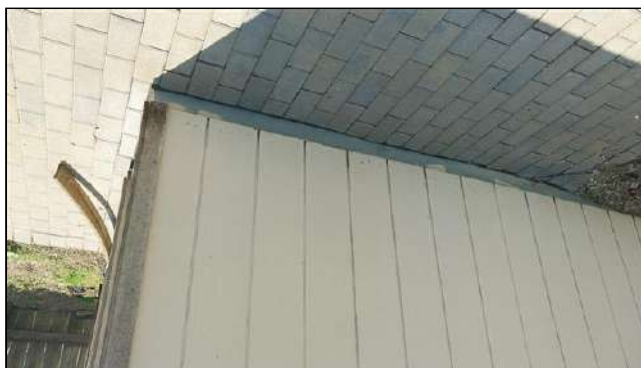
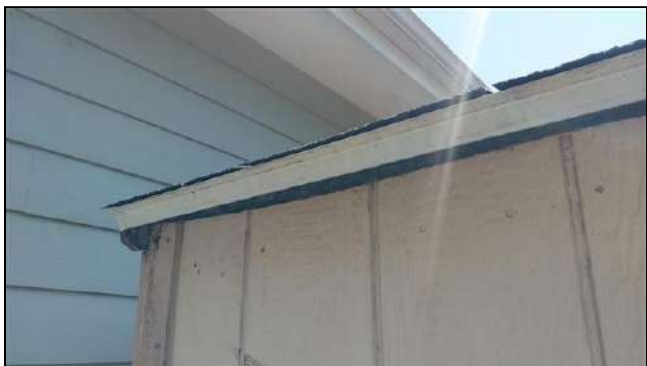
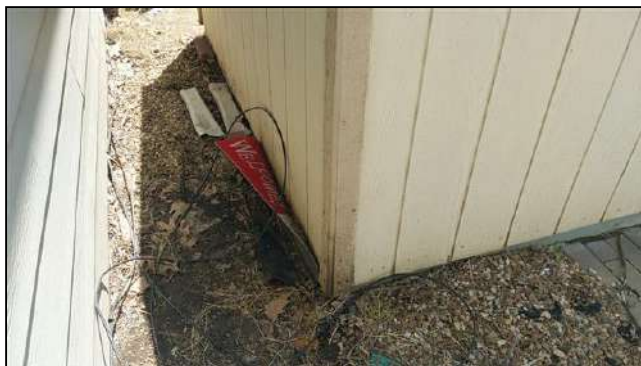
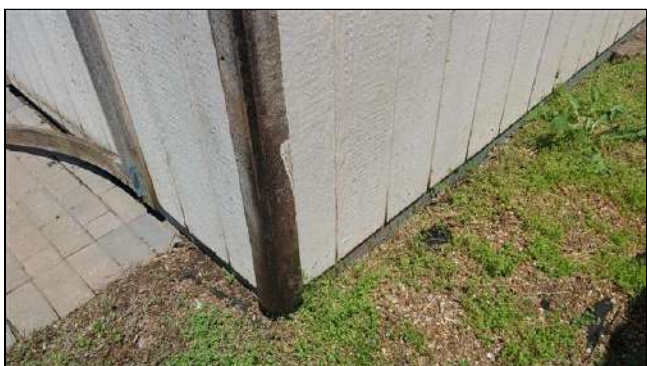
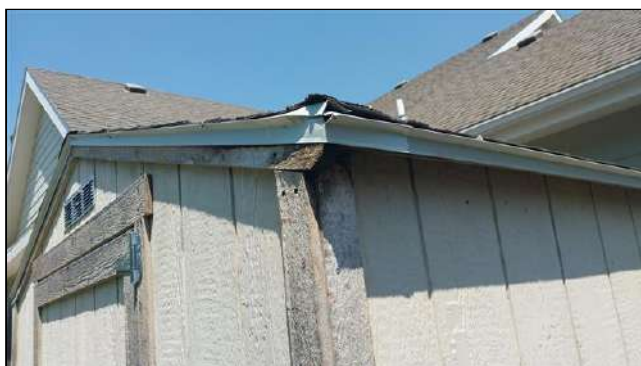
2.10 The shed has areas that need some repair and the exterior needs to be painted.

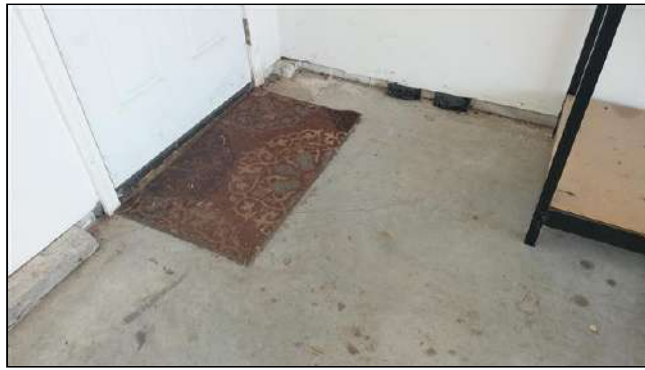
3.2 Item 2(Picture)

There are some cracks in the garage floor

3.2 Recommend caulking the gap along the garage floor to wall joint.

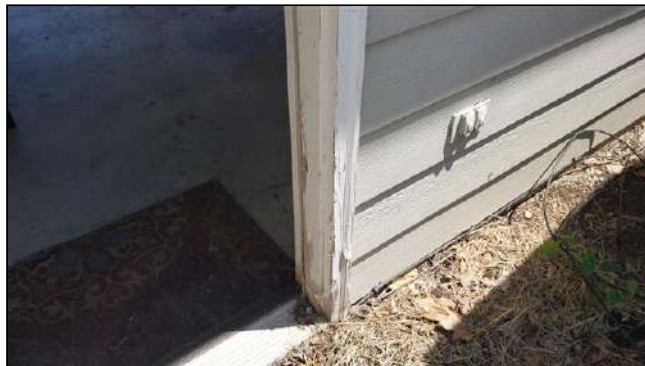
3.3 Item 2(Picture)

3.3 Some water damage and chipping paint that can be seen on the rear entry garage door and frame.

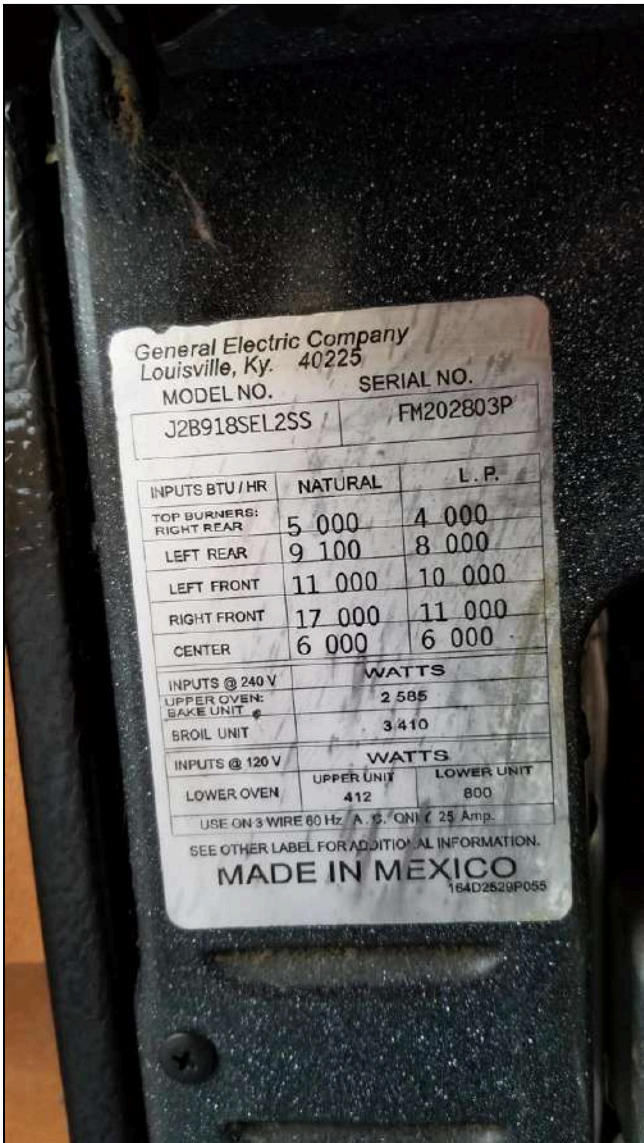
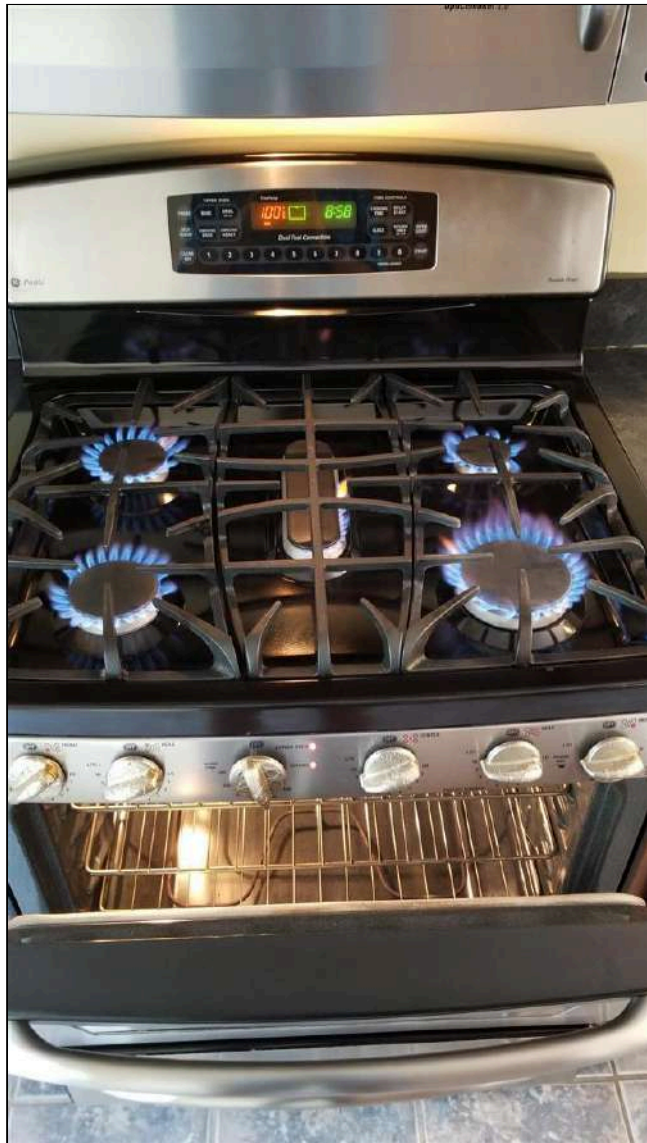
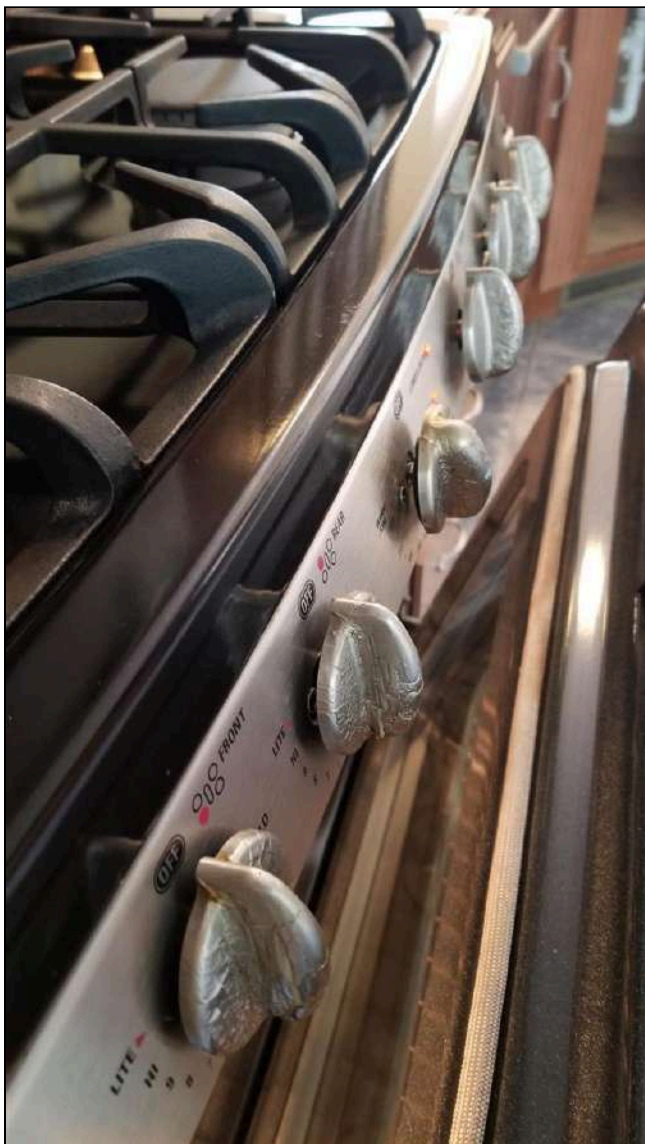
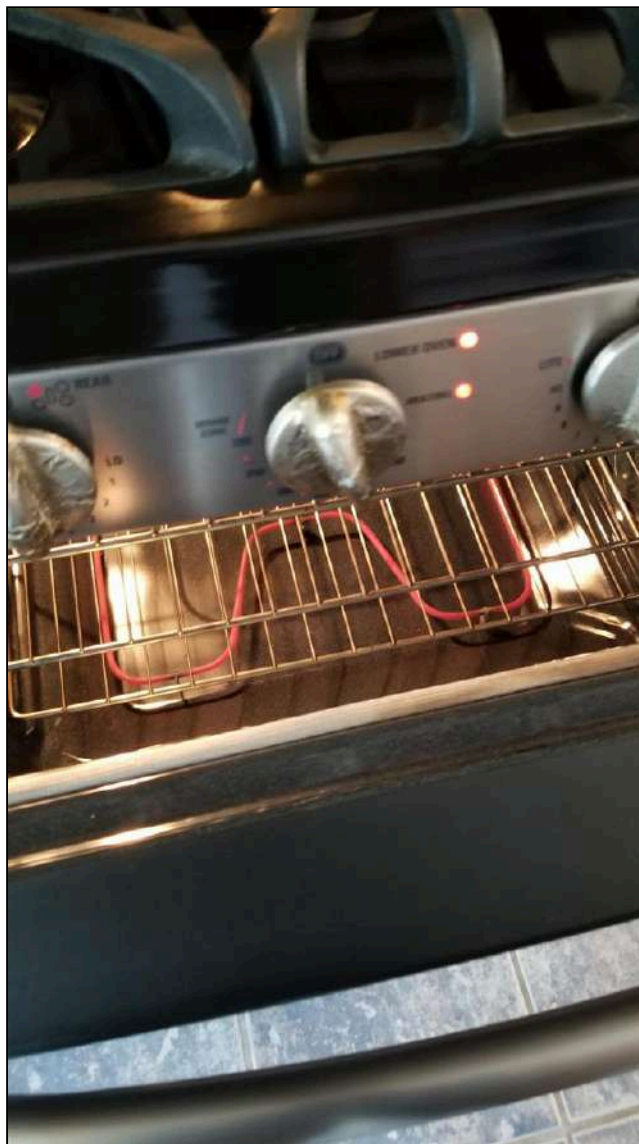
4.10 The finish on the cooktop control knobs appear to be partially melted.

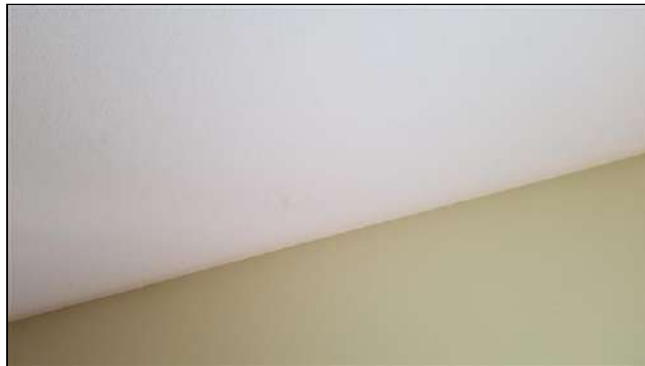
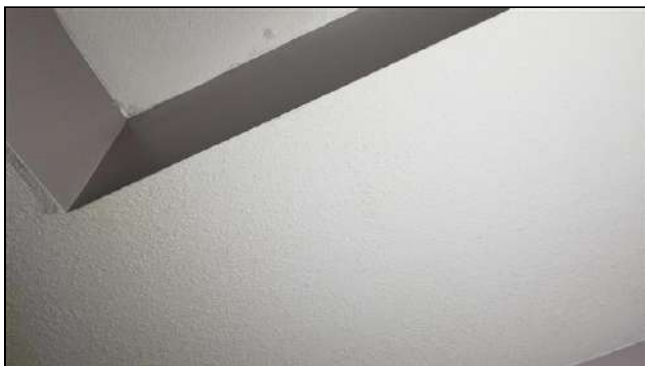
There's a small stain in the master bedroom ceiling.

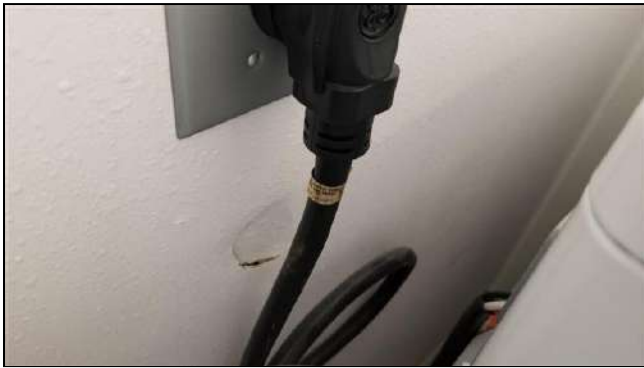
5.1 Item 1(Picture)

5.1 There's a hole in the laundry room wall behind the dryer.

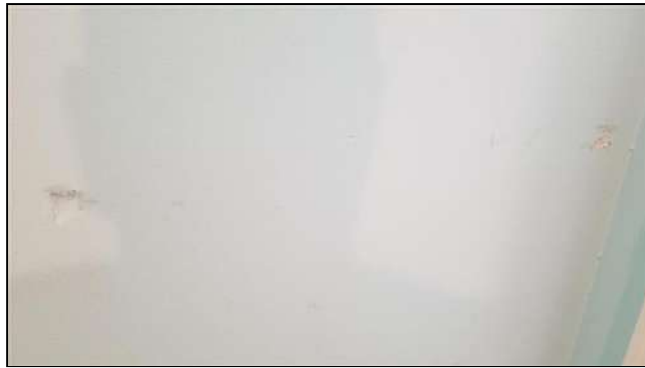
5.1 Item 2(Picture)

There's a dent and a scrape in the south hallway wall.

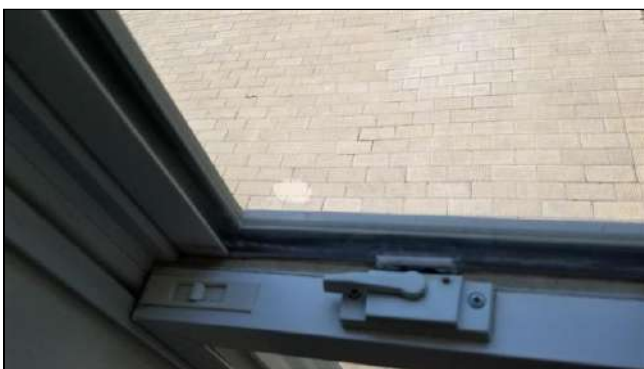
5.5 Item 1(Picture)

5.5 The operate assist is failing on the northwest bedroom window causing the sash to be dead weight.

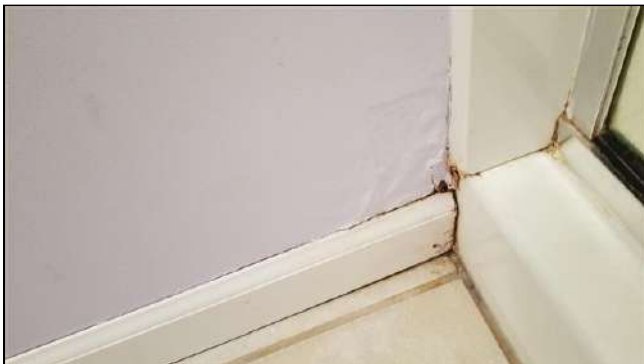
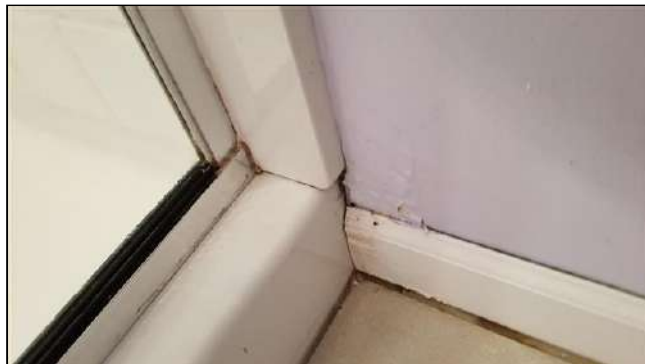
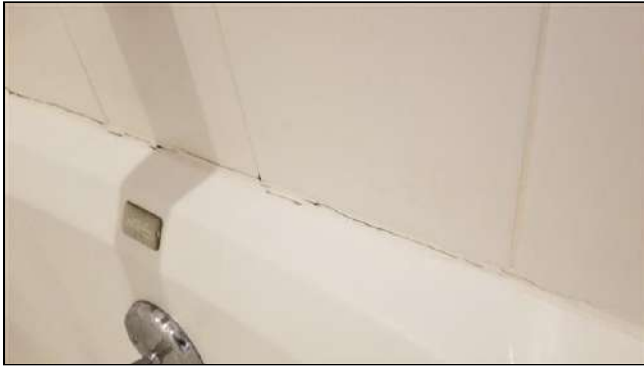
6.0 There's a little bit of water damage to the drywall and base trim on either side of the master shower.

Recommend maintaining the caulking around the edges of the tub deck to prevent water from getting behind the tile.

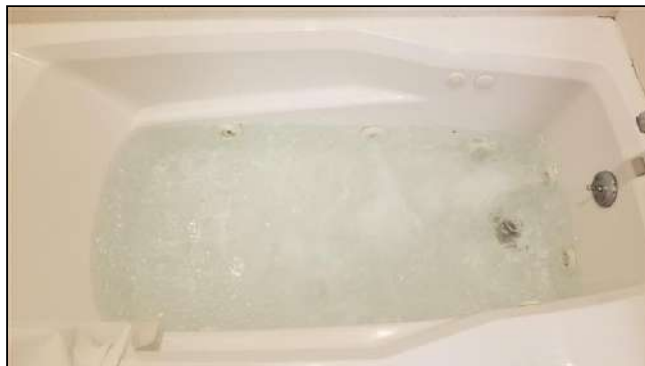
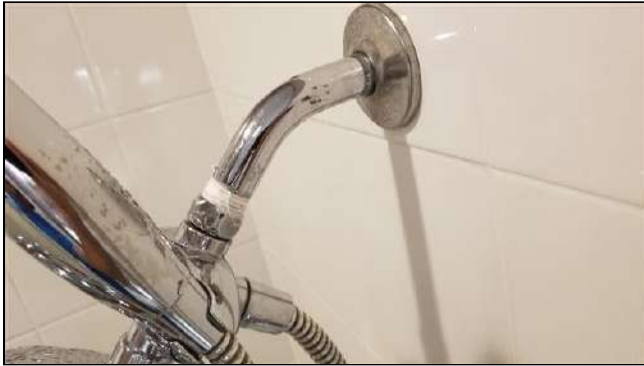
6.6 The master bathroom shower head leaks when running.

The guest bathroom shower head leaks when running.

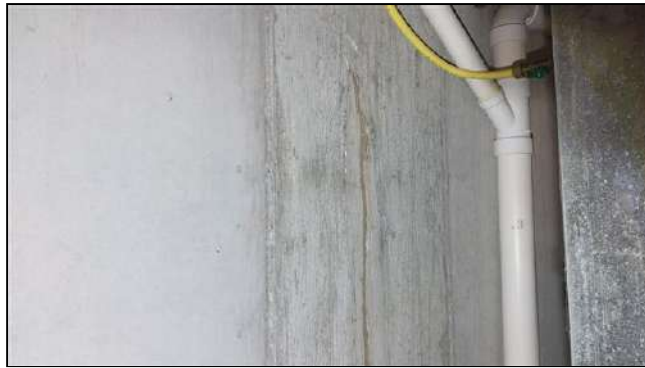
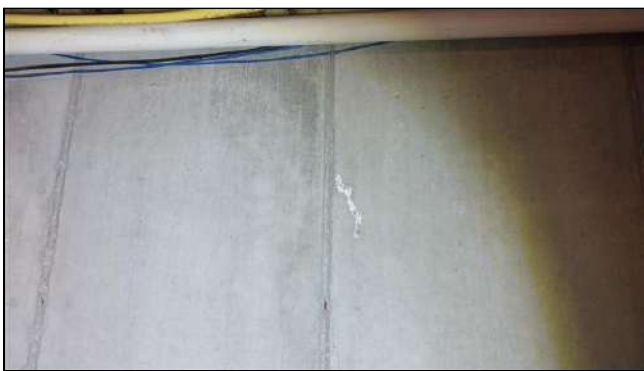
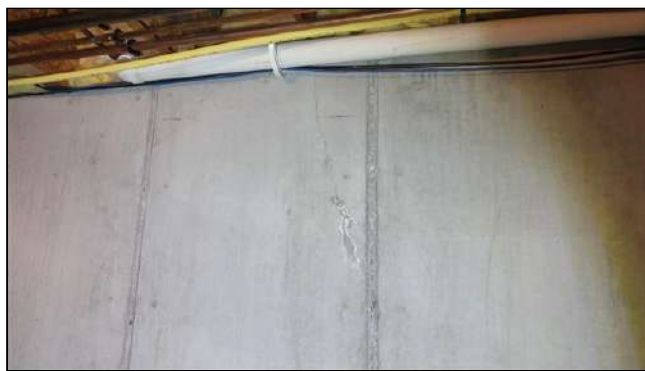
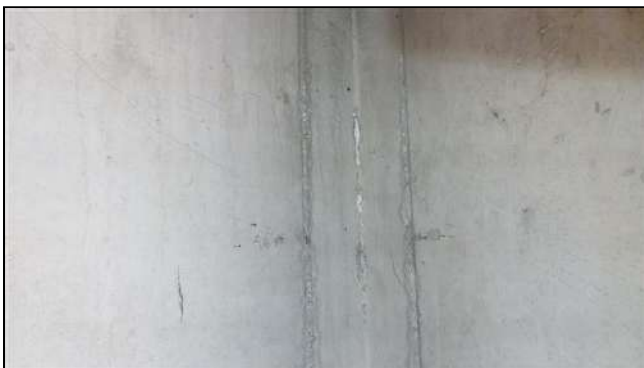
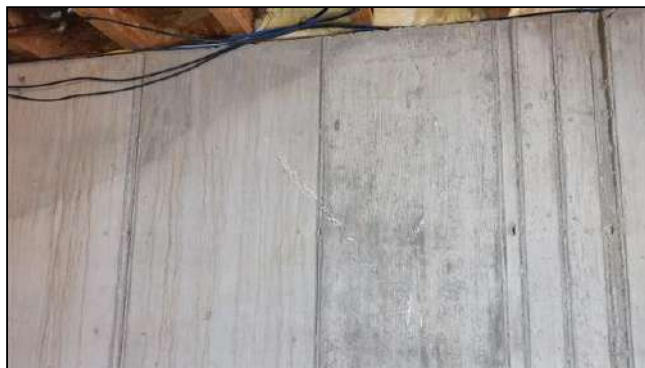
7.0 There are several areas where evidence of previous moisture entry can be seen on the basement walls.

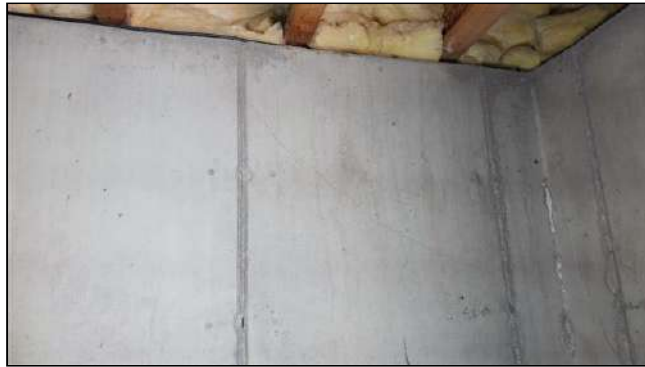
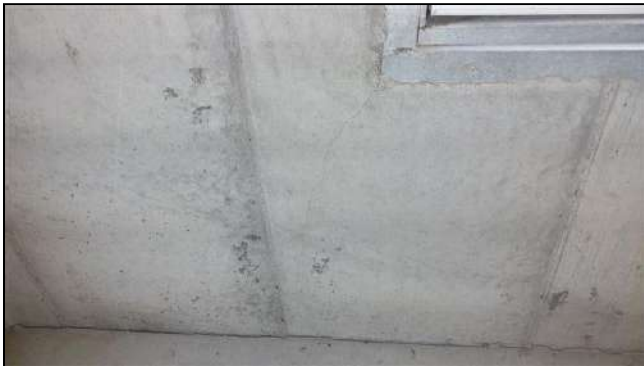
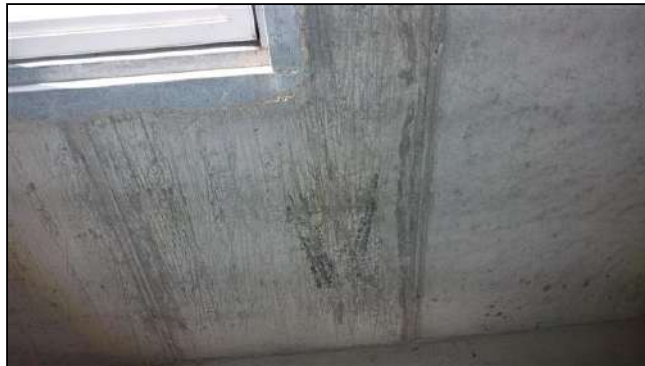
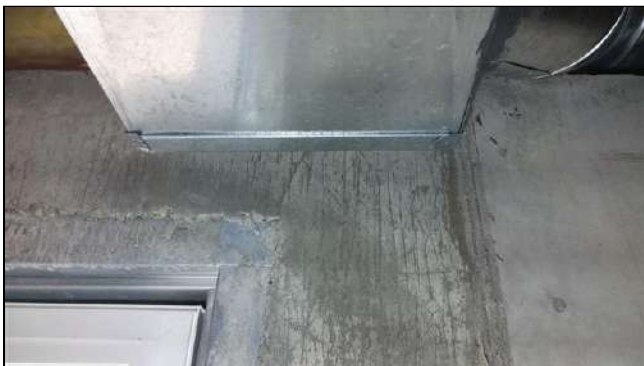
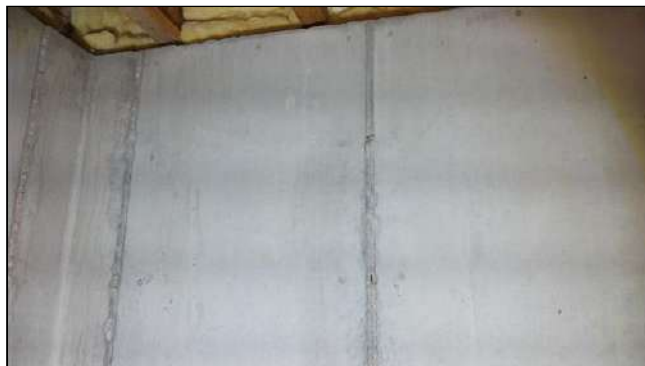
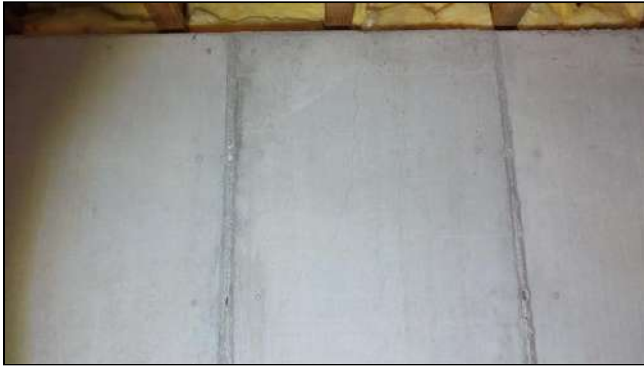
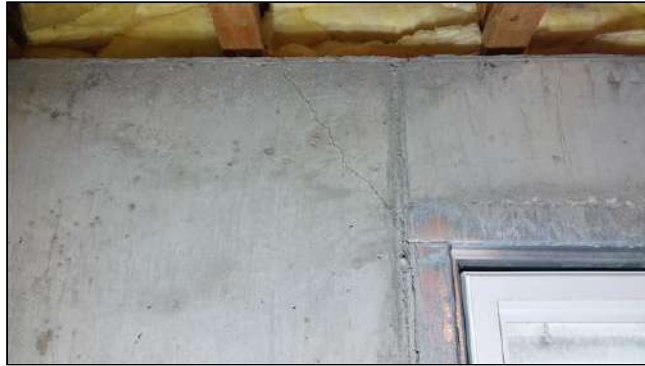
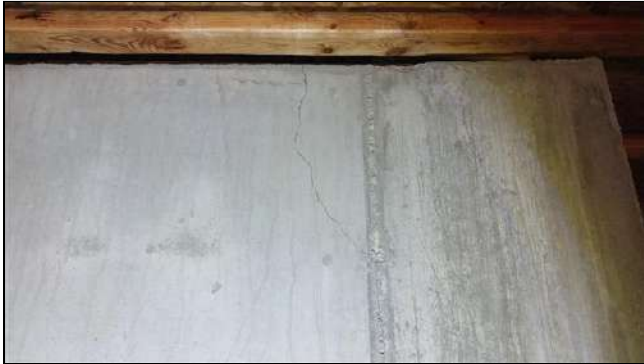
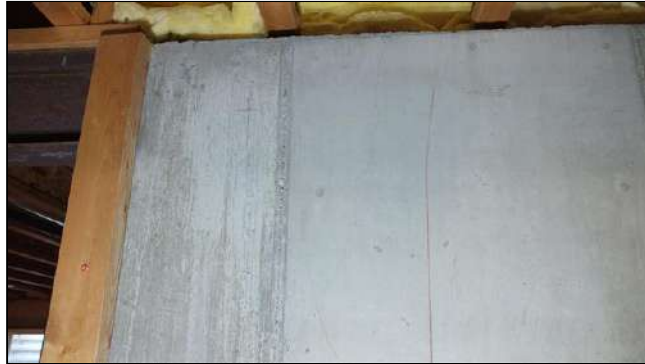
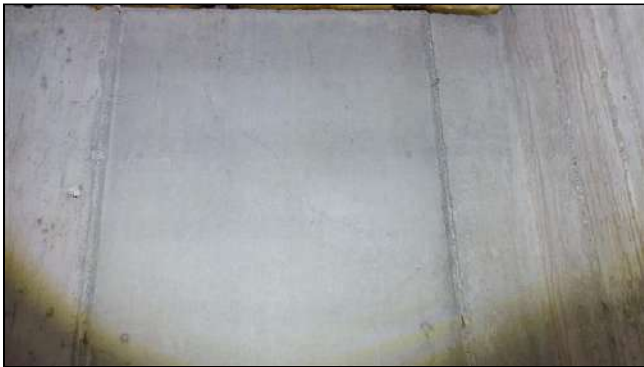
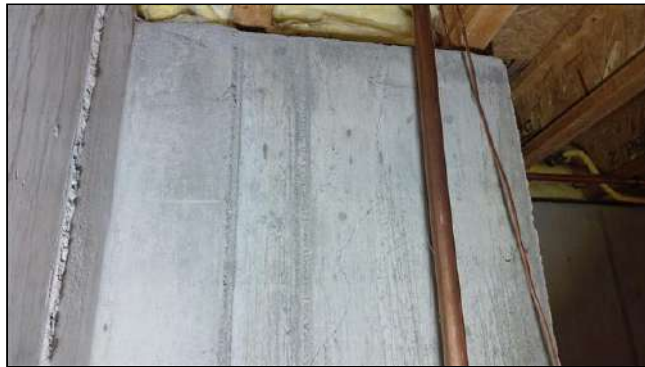
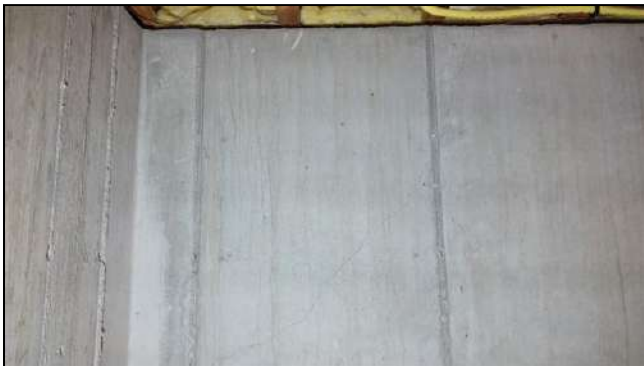
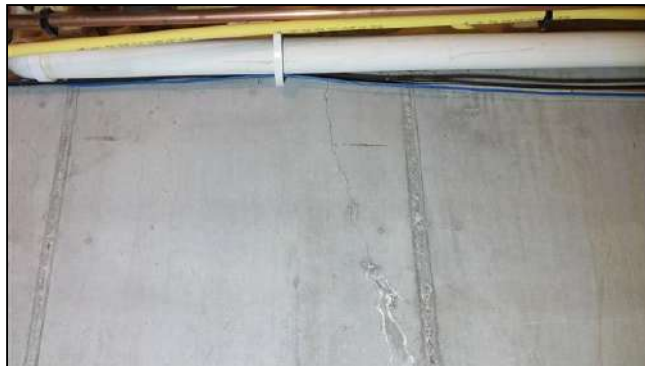
7.1 Small cracks do not represent a structural concern at the moment.

Recommend sealing the cracks to establish a baseline - monitor for any future movement.

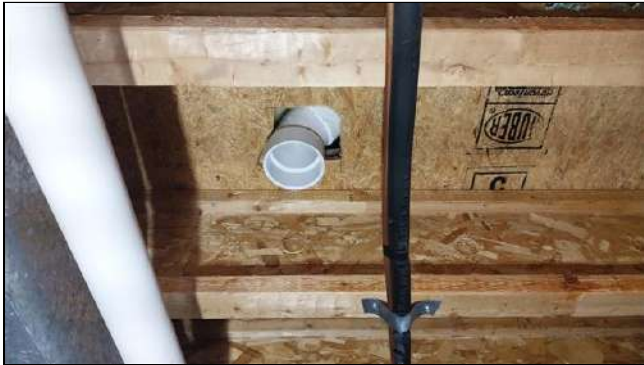
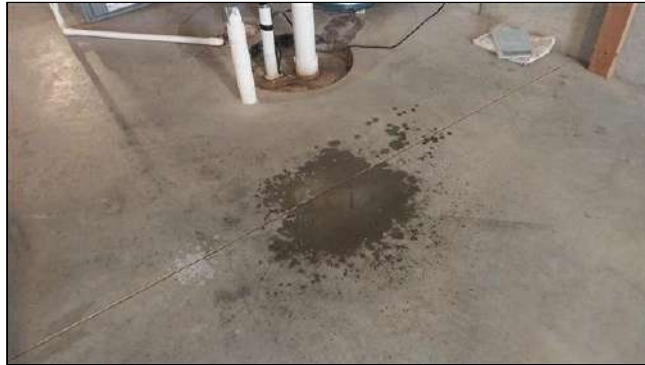
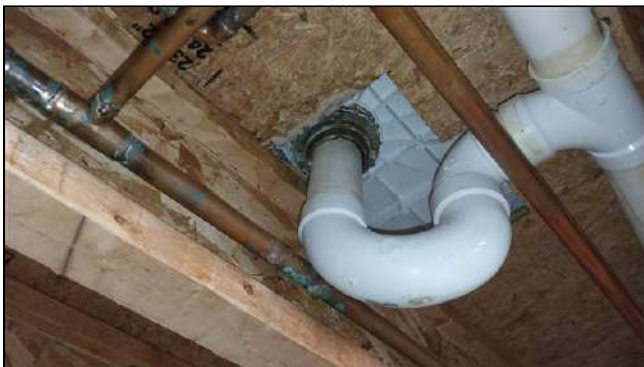
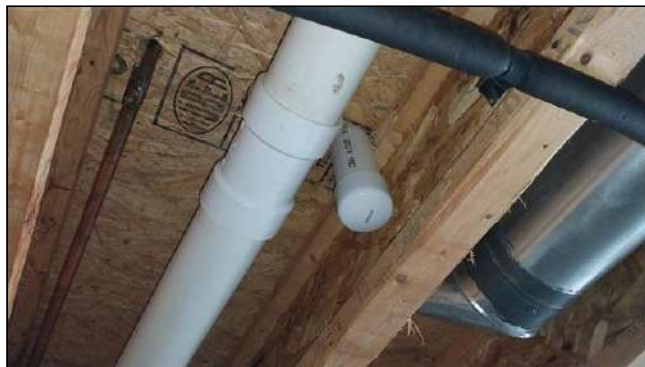
8.0 There is an open 3" PVC line in the basement. Unknown what this is for. Radon?. Likely the same open pipe can be seen in the attic. Recommend capping one end so that cold air is not falling into the basement.

Leakage can be seen coming from the master shower drain.

There is a capped 2" line in the basement that is likely intended to be the vent line for the bathroom.
