INSPECTION REPORT
3895 Golden Eagle
Manhattan KS 66502

INSPECTED BY
Todd Thompson
Trust Inspection
Services

INSPECTION DATE
📅 5/14/2024
🕒

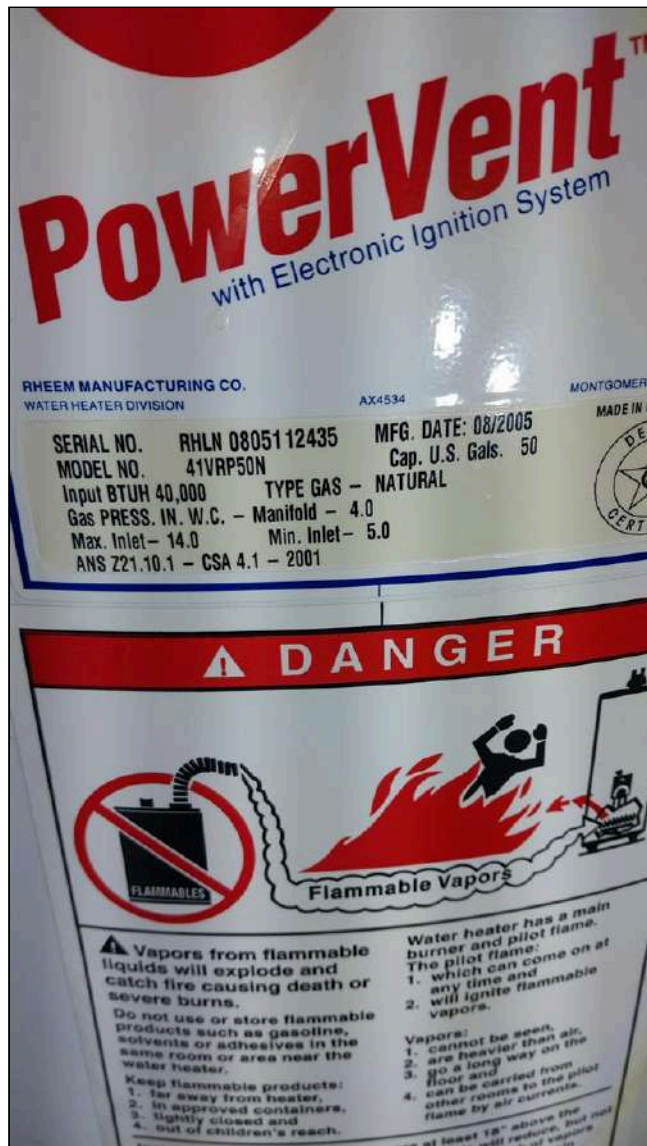
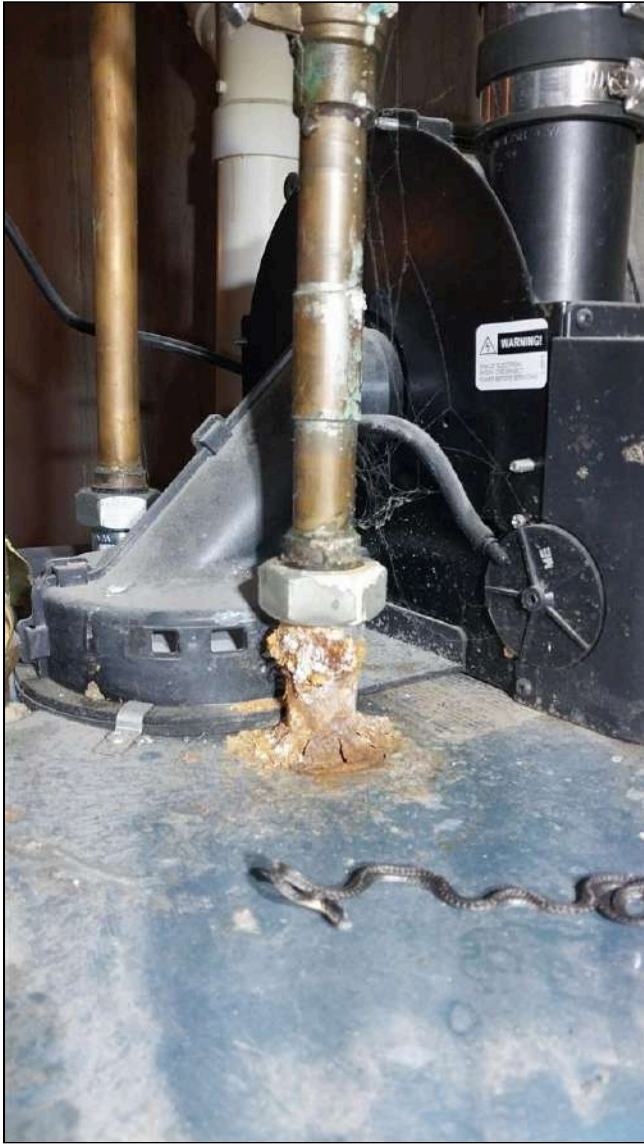
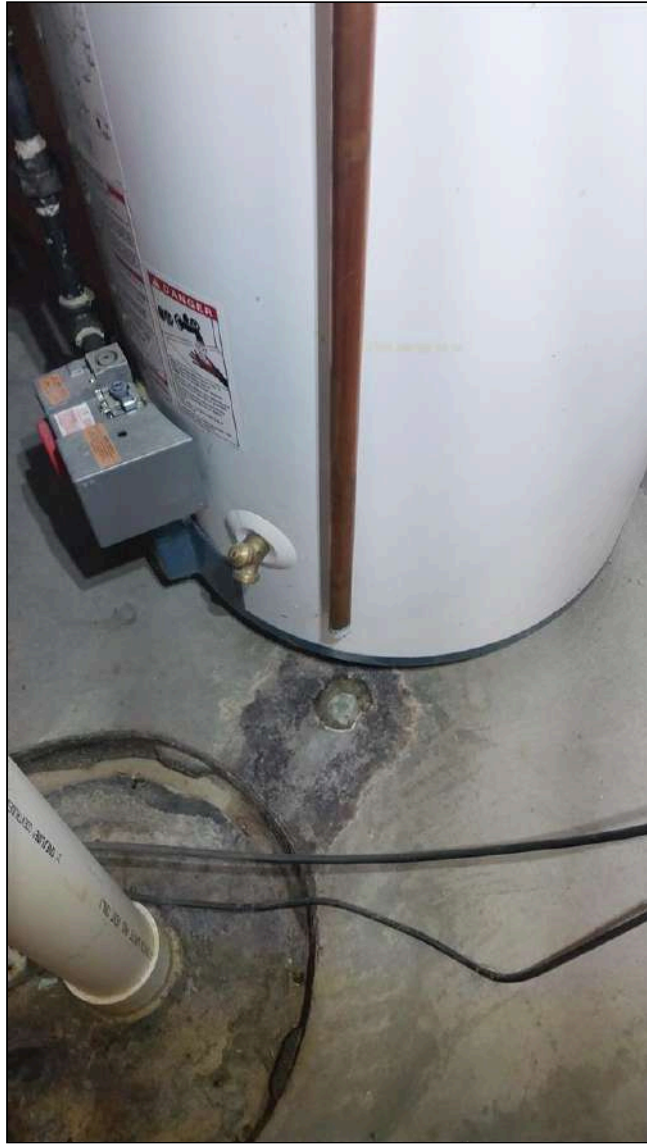
8.2 The 50 gallon gas water heater is located in the basement mechanical area

There's quite a bit of corrosion around the dielectric union, but no leakage was noted at time of inspection

There is a small amount of leakage from the pressure relief valve

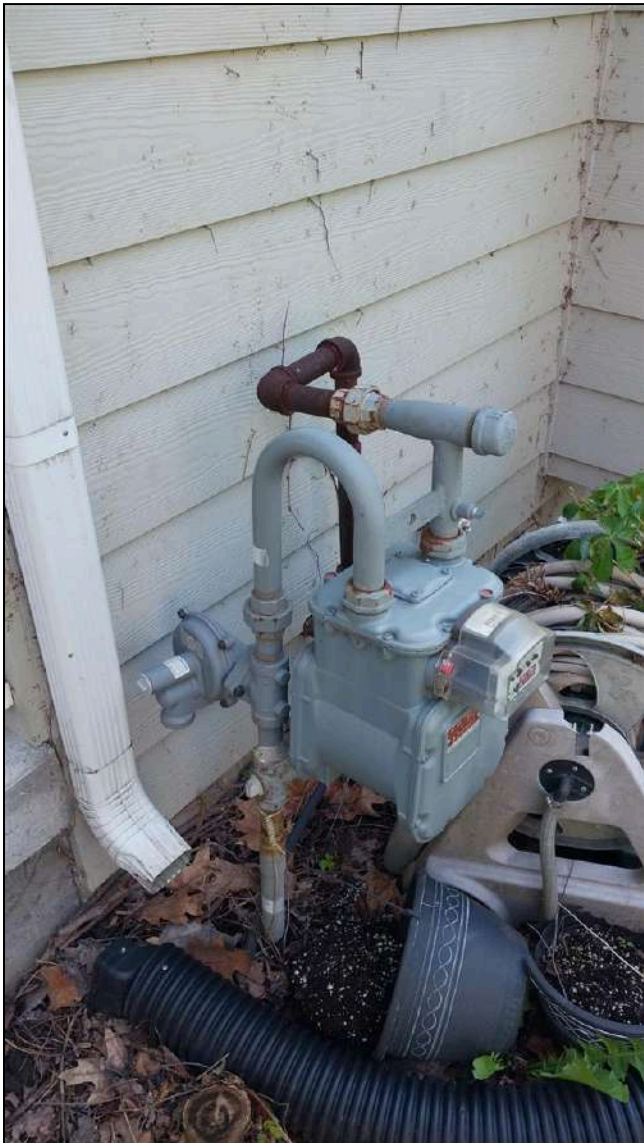
8.5 Item 1(Picture)

8.5 The gas service enters on the W side of the home

The pipe penetration needs to be sealed.

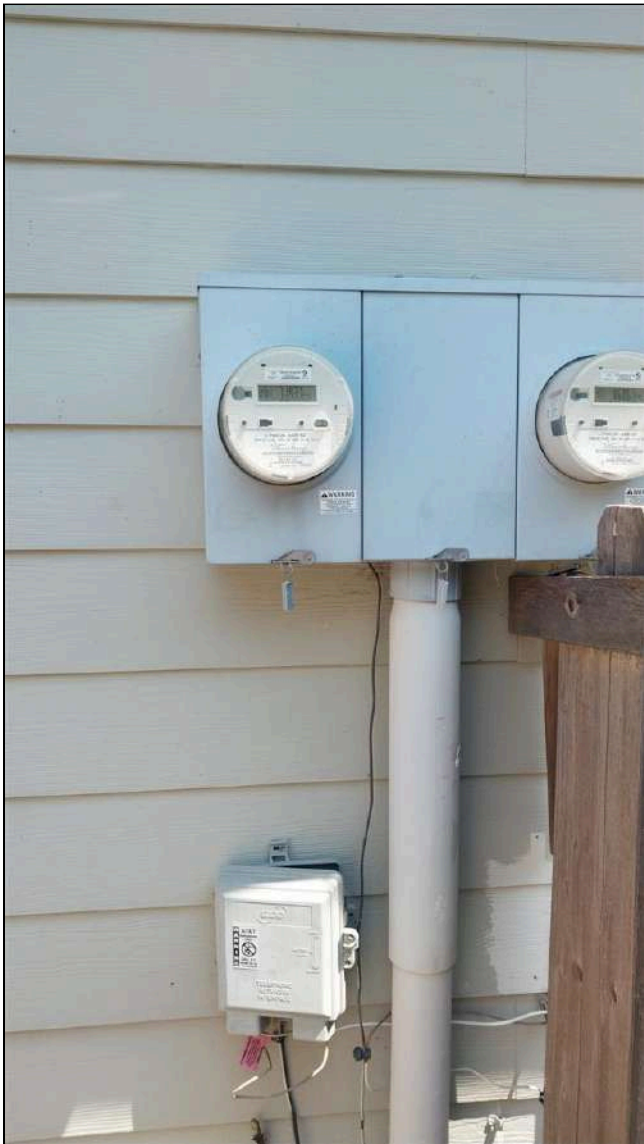
9.0 Item 1(Picture)

9.0 The electrical service enters on the south side of the home.

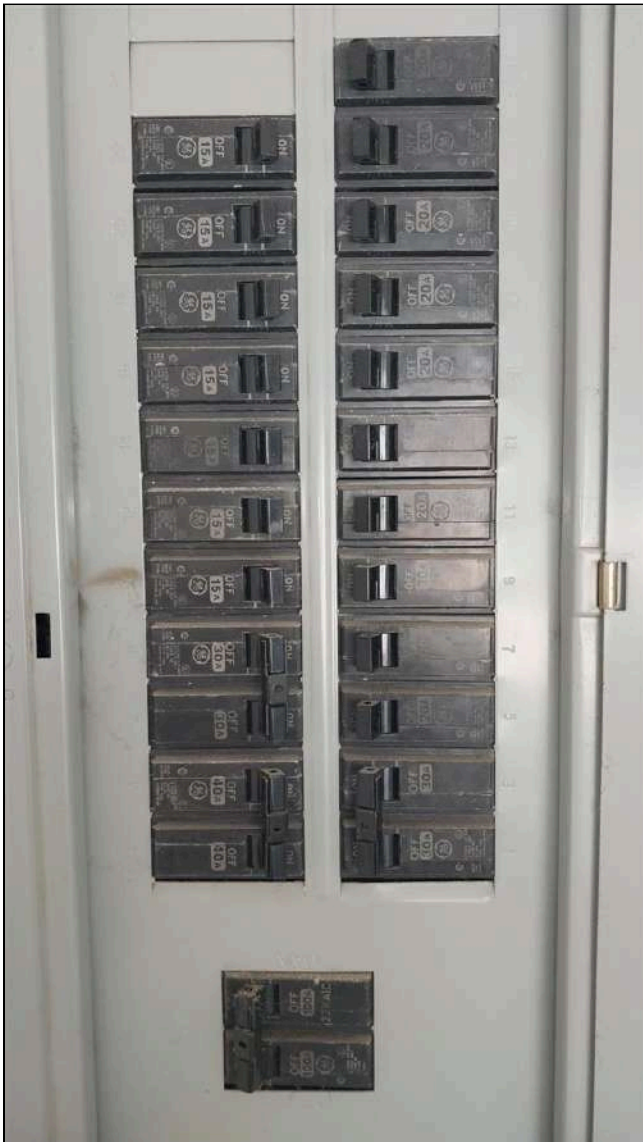
9.1 Item 1(Picture)

9.1 The 100 amp main breaker is located in the garage panel.

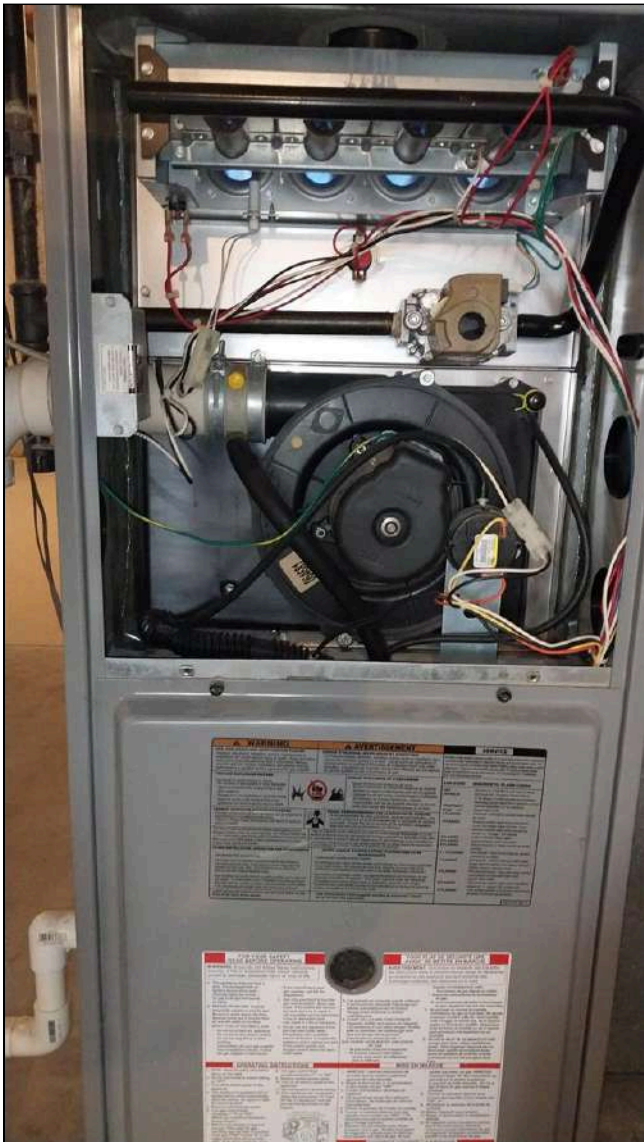
10.0 Item 1(Picture)

10.0 The 80,000 BTU high efficient gas furnace is located in the basement mechanical area.

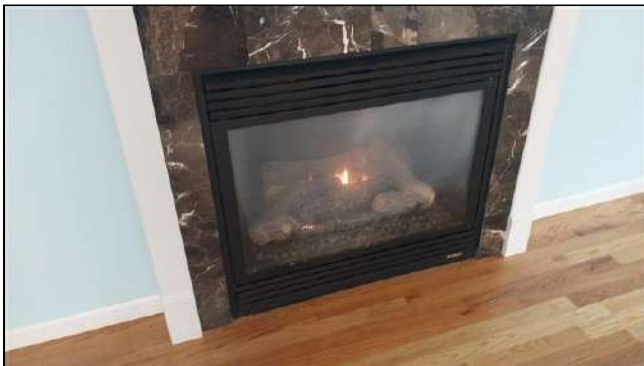
10.7 Item 1(Picture)

10.7 The living room gas fireplace operated properly.

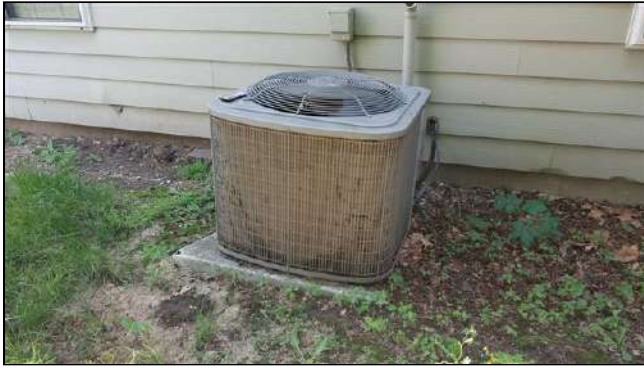
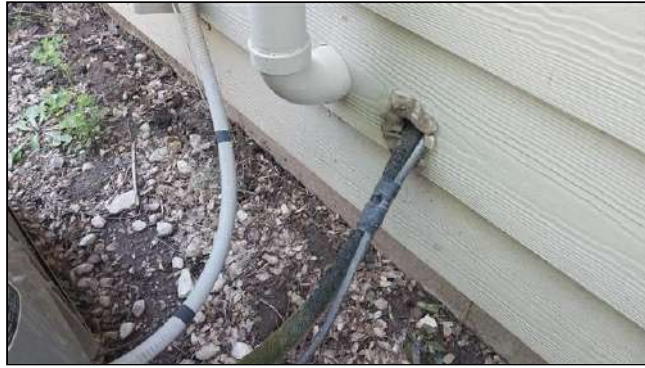
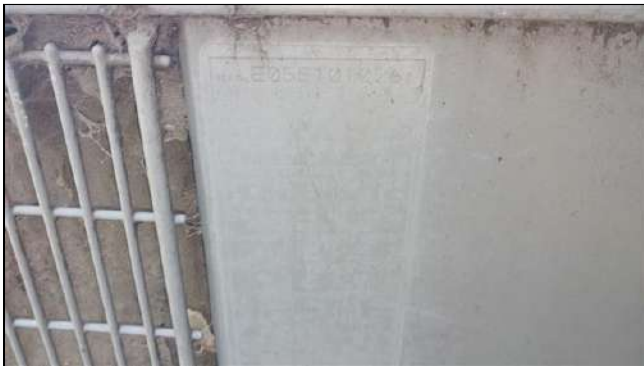
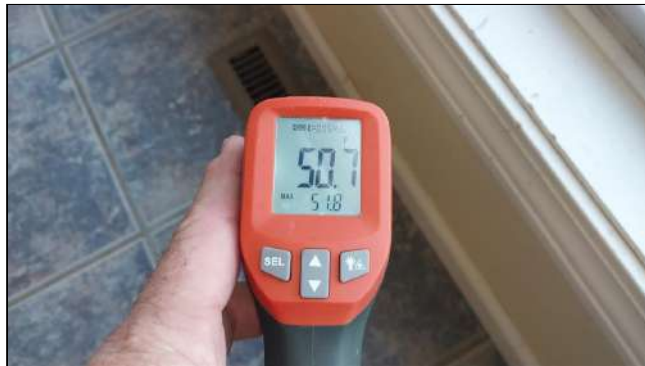
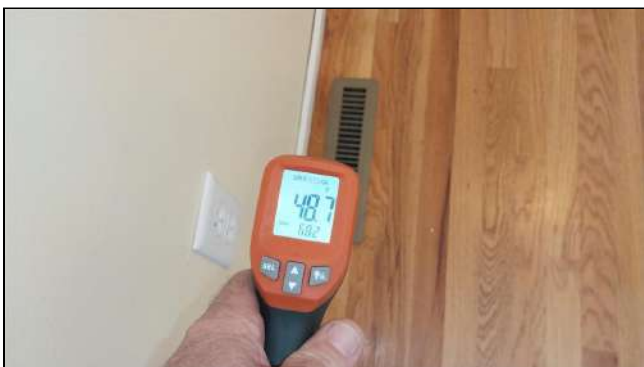
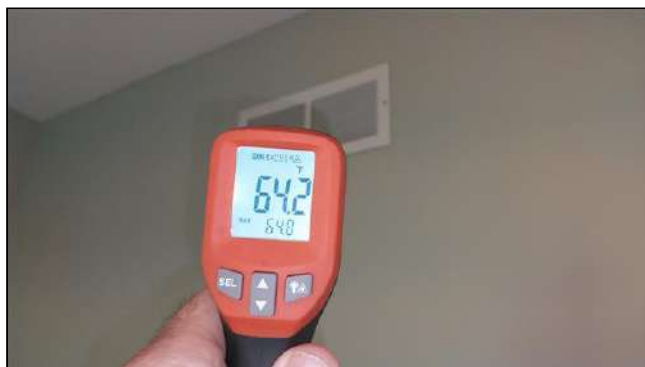
10.8 The AC unit is located on the west side of the home

The AC pad has settled and the unit leveled.

The temperature differential of 15+ degrees between the supply and the return air indicates that the AC unit is functioning properly
