Home Inspection Report

PROPERTY INSPECTED:
5125 Lewies Way
Shepherd, MT 59079

Date of Inspection: 04/23/2024

Inspection No. 45957-1-1041

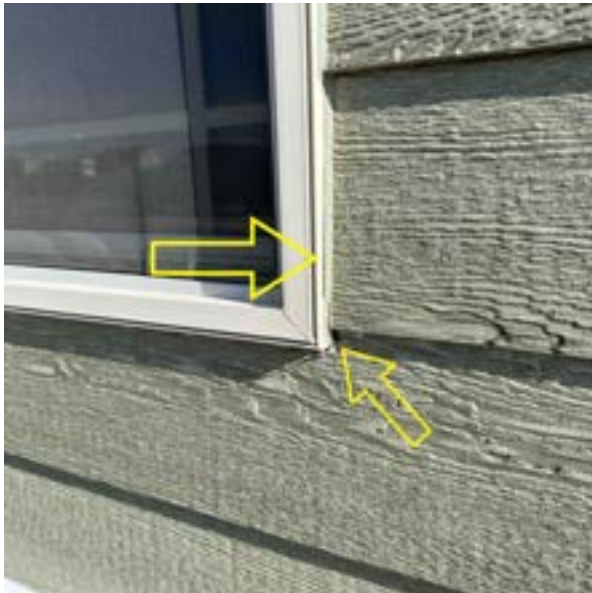
- Exterior East
- Exterior North
- Exterior South
- Exterior West

3.3.3 Ensure proper caulking and weather seal at all required locations and junctions such as windows, doors, dissimilar materials junctions, etc.

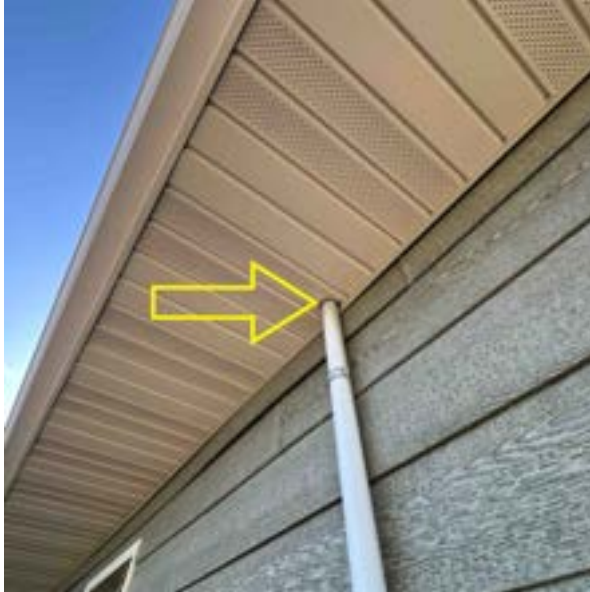
- Exterior North
- Exterior West

3.4.2 Seal gaps/holes/penetrations in soffit and fascia to prevent further damage and deter pest entry.

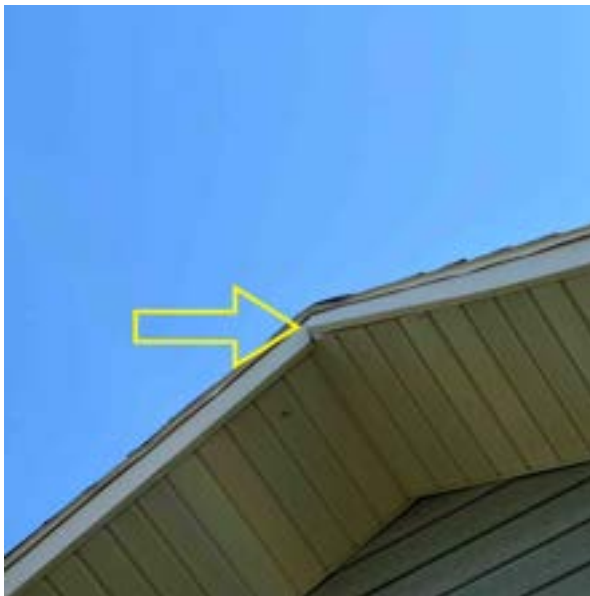
3.4.3 Secure loose soffit/fascia to prevent damage and deter pest entry. **(Shop)**

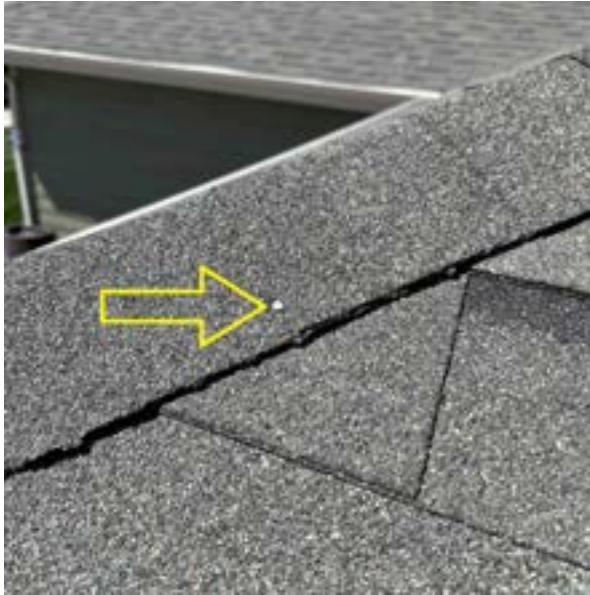
4.3.2 Seal all exposed nail heads to prevent deterioration and subsequent water intrusion.

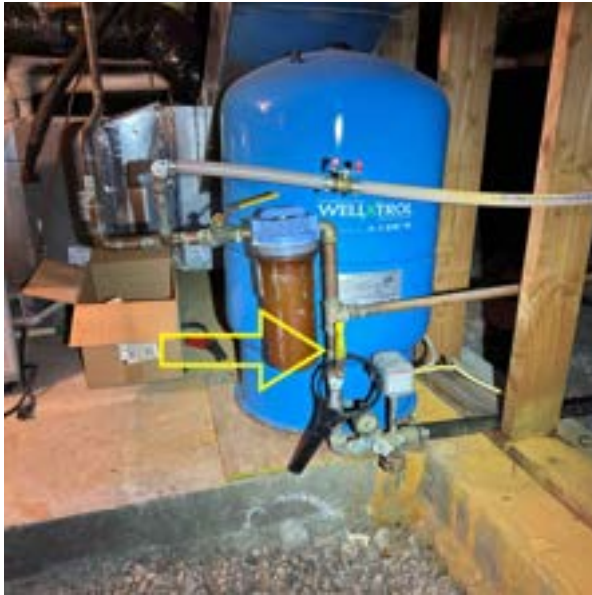
10.1.2 Location: **(Crawlspace)**

10.1.1 Inspected the visible portion of the house water main.

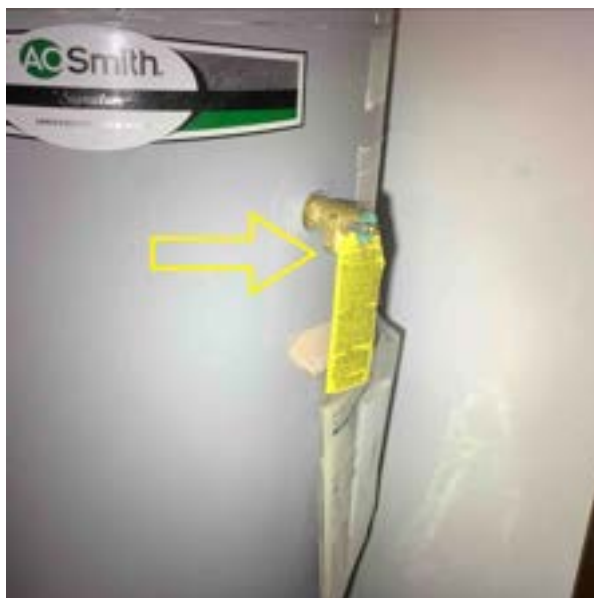
10.4.5 Install discharge tube at temperature pressure relief valve to extend to within 6" of the ground to prevent injury. **(Hallway)**

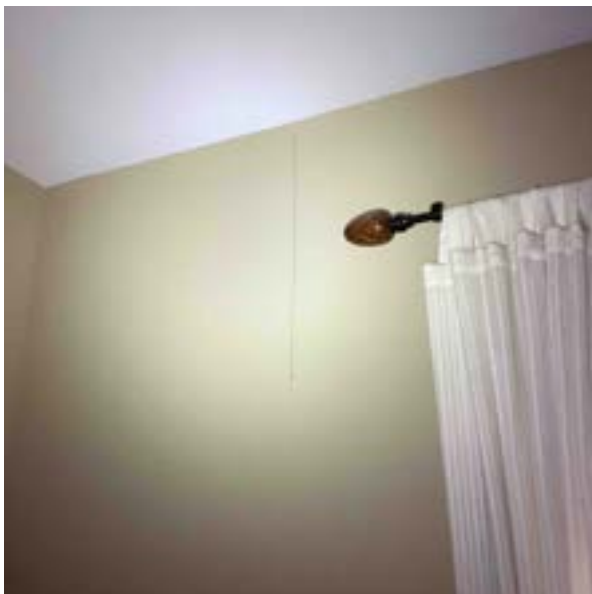
11.2.2 Further investigate cause and extent of staining/damage and correct as required. No moisture detected at time of inspection. **(Master Bedroom)**

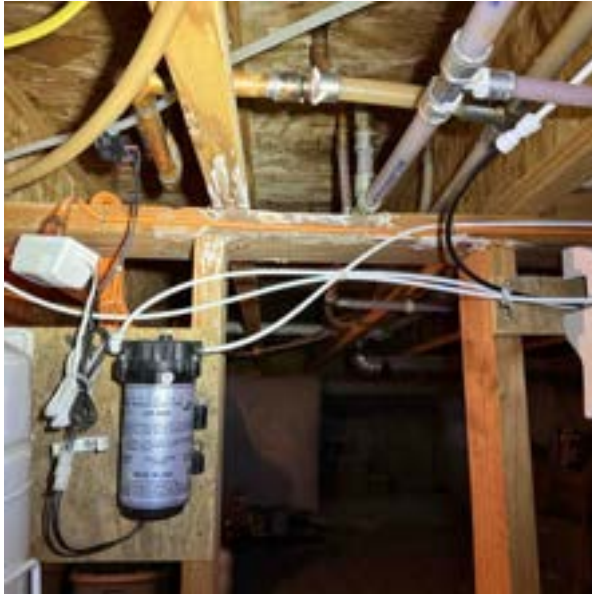
11.2.3 Further investigate cause and extent of staining/damage and correct as required. No moisture detected at time of inspection. **(Crawlspace)**
