## Inspection Report

1731 Bougainvillea  
Minden NV 88423

### Clear Choice Home Inspection Services

<b>Date:</b> 4/20/2023	<b>Time:</b> 08:30 AM	<b>Report ID:</b> BEA173
<b>Property:</b> 1731 Bougainvillea Minden NV 88423	<b>Customer:</b>	<b>Real Estate Professional:</b> Thomas Vander Laan Coldwell Banker

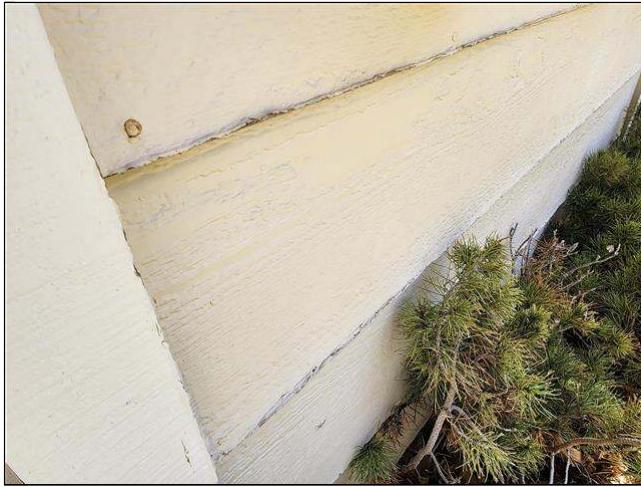
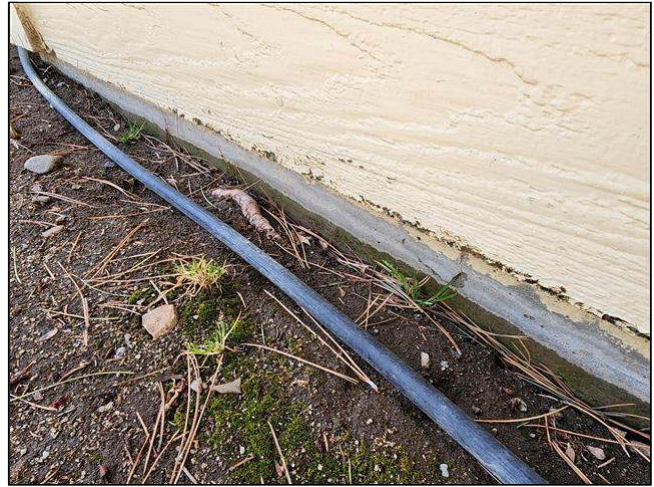
(1) Exterior wall cladding appears original to the home, and is Horizontal lap style OSB boards that appear in average condition for the age home for most areas. Normal aging and wear was noted, with slight deterioration at the lower edges, possibly from irrigation over-spray or roof run-off splashing on the ground. No major problems were noted with the siding materials, and appears properly secured to wall framing.

1.1 Item 1(Picture) normal wear/age on siding

1.1 Item 2(Picture) normal wear/age on siding

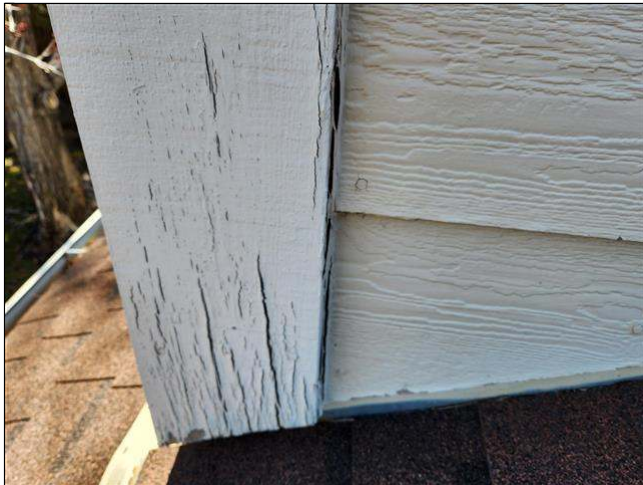
1.2 Item 1(Picture) chimney trim boards

Fireplace chimney trim boards need to be secured tightly, caulked in seams and dry weathered cracks, and painted for moisture protection.

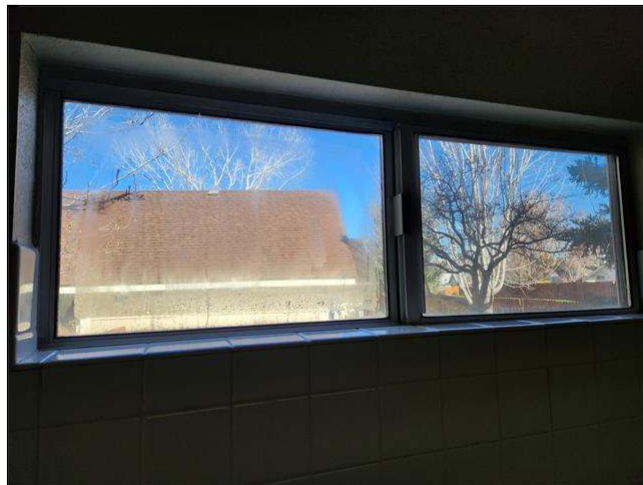
(1) Window is cloudy/condensation (lost seal) at the South guest bedroom, SW guest bedroom, Living room North wall, West guest bathroom, Master bedroom and bathroom windows. This is a cosmetic issue for your information. In order to correct the cloudy appearance of glass, a replacement of glass pane or the unit will be necessary. A qualified person should repair or replace as needed.

1.4 Item 2(Picture) cloudy windows

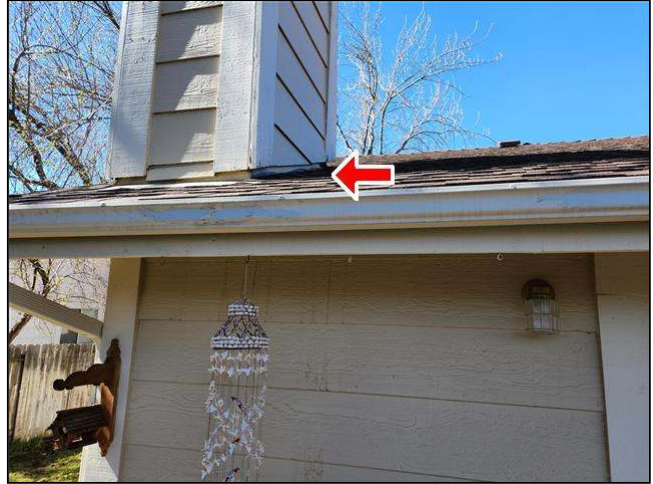
(2) NOTE: There are signs of past leaking noted at the Northeast corner area, with drip stains noted on siding and soffit blocking. This may have been caused from "ice dams" from this past winter. There are no issues noted with roof covering materials or flashings.

2.1 Item 2(Picture) no problems with roofing or flashings

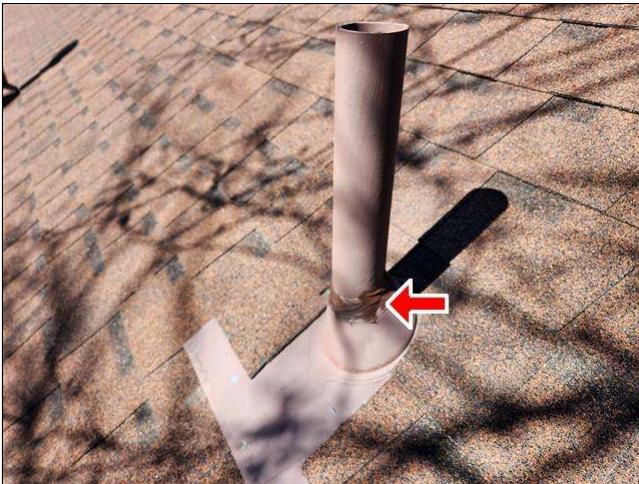
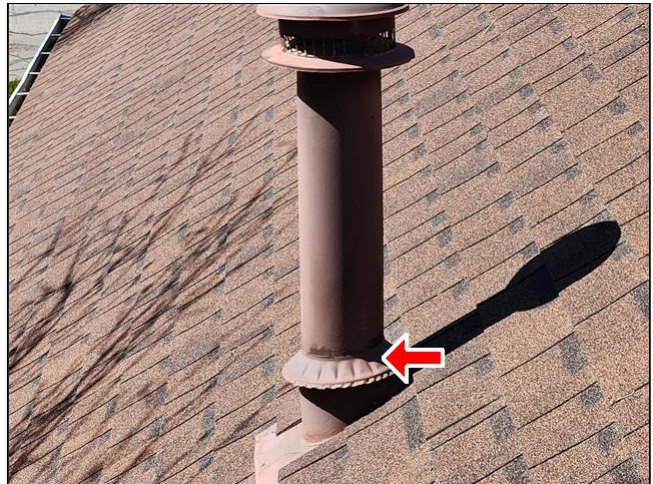
Plumbing and furnace vent pipes are sealed well against flashings to prevent moisture intrusion into attic framing areas.

2.3 Item 1(Picture) plumbing vent pipes sealed well

2.3 Item 2(Picture) flue pipes sealed well

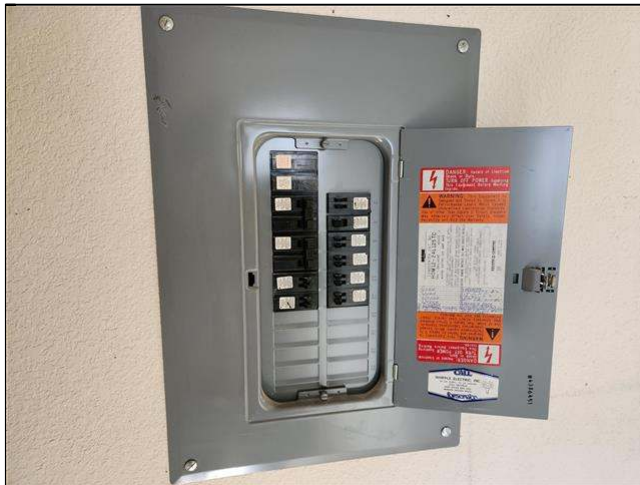
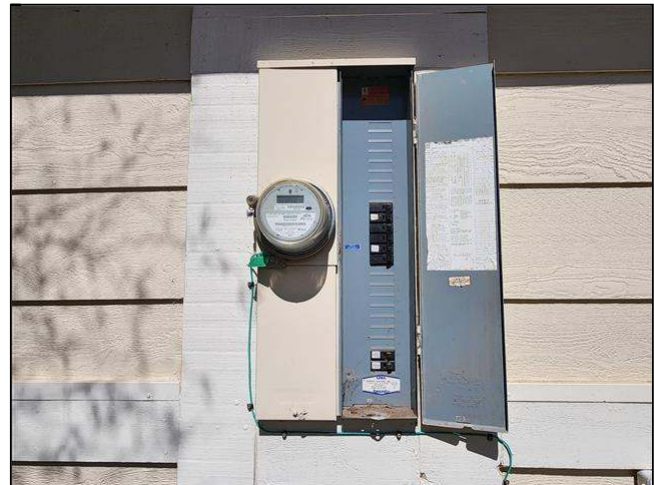
The Main and Distribution Panels are well labeled for circuit identification. "Dead front" cover appears serviceable. No problems noted.

4.1 Item 1(Picture) distribution panel

4.1 Item 2(Picture) main electrical panel

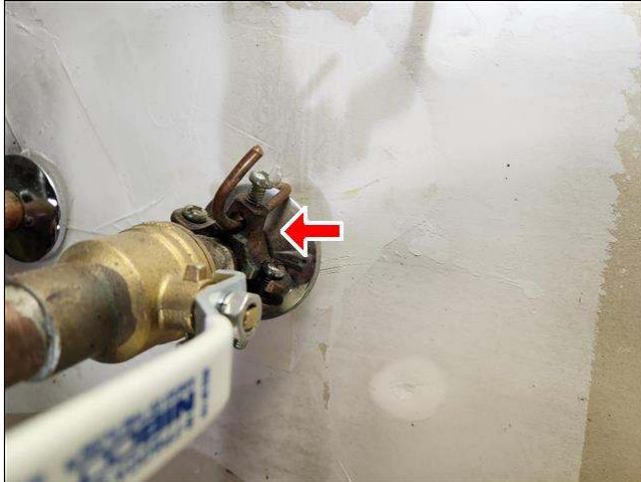
The Grounding system for the Main Service Panel is not visible due to construction materials. However, there is a Grounding wire present in the Panel, and there is a Bonding wire present at the cold water pipe, which are important for proper grounding (safety) of the home.

4.3 Item 1(Picture) bond to plumbing

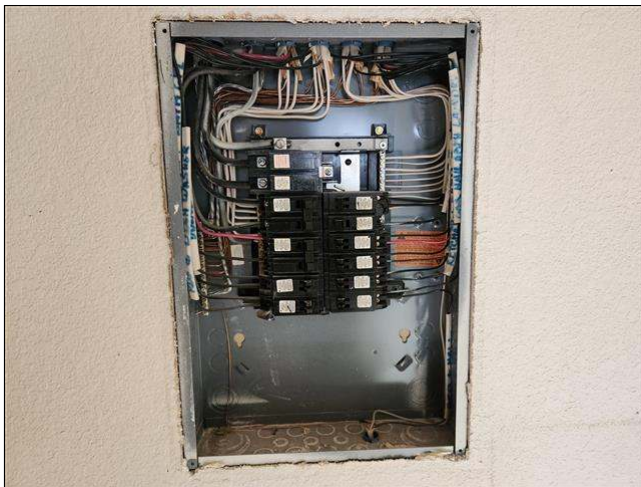
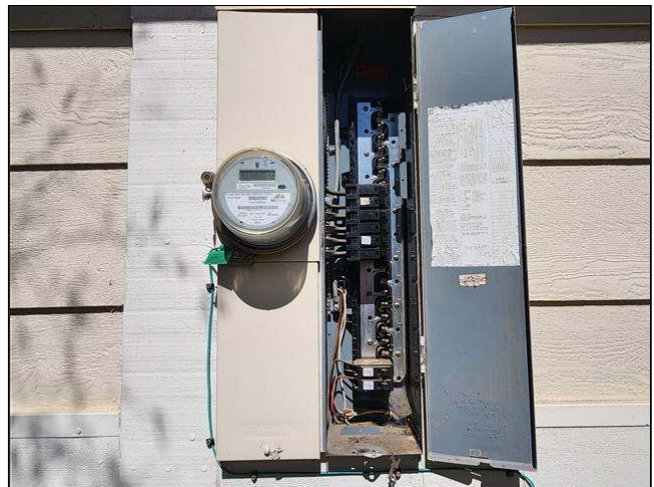
The circuit conductors appear in good condition, and are properly sized for their prospective overcurrent devices. No "double tap" circuit breakers or burned connections noted.

4.4 Item 1(Picture) distribution panel conductors

4.4 Item 2(Picture) main panel conductors

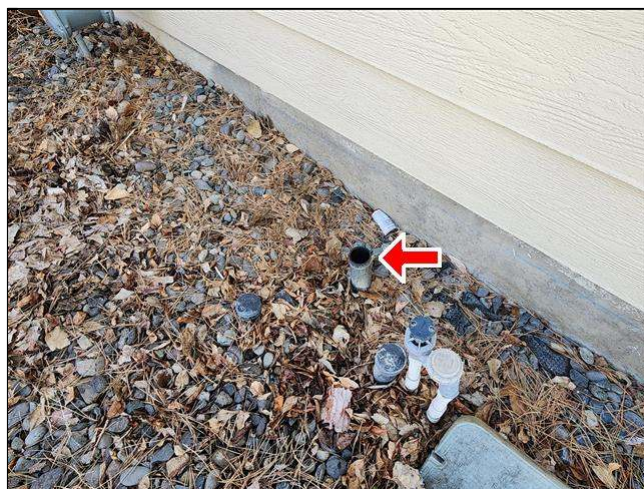
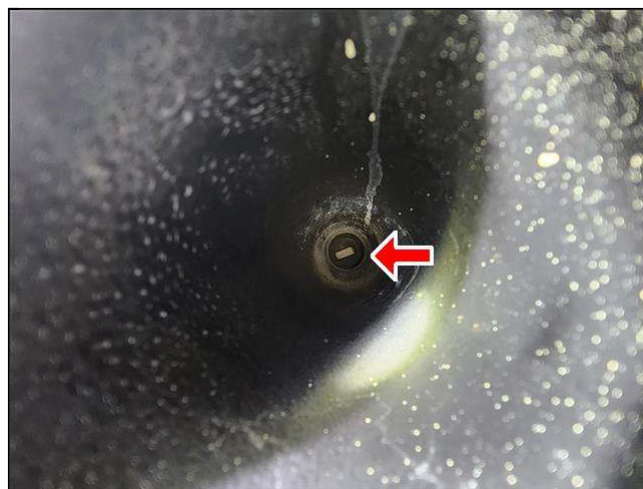
There are a couple main water shut-off locations. With the water meter at front of property (for emergencies), and at side yard to left of house. Note: Both of these locations will require a water key tool to operate.

5.0 Item 1(Picture) main water shut-off location

5.0 Item 2(Picture) main water shut-off valve

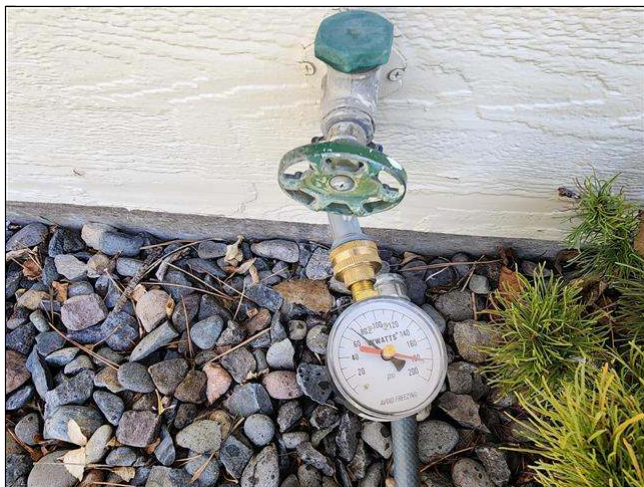
The water pressure was tested at the front hose bib, pressure was 70 psi at time of inspection.

5.2 Item 1(Picture) water pressure at front hose bib

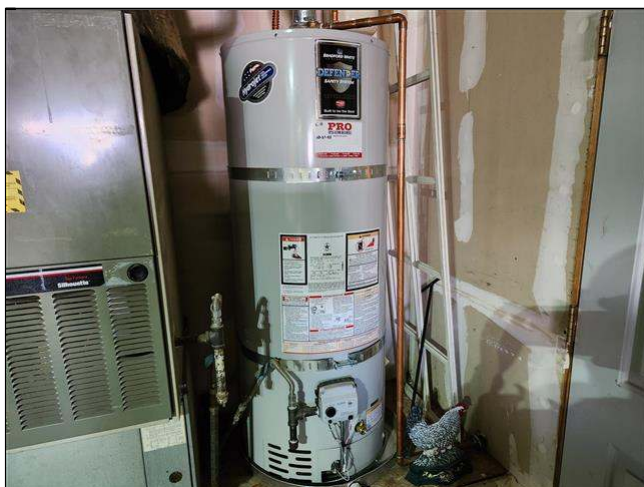
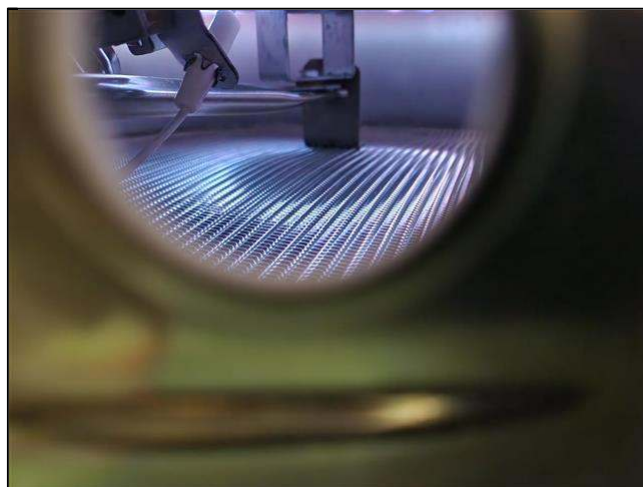
(1) Temperature and Pressure Relief valve is piped to the exterior of the house, or within 6 inches of the floor (for safety). Water Heater is strapped with approved strapping material, and is setting on a pedestal minimum of 18" above the garage floor. Drip leg is installed in the gas line, water and fuel shut-off valves are present. Water heater operated as intended with no abnormal noises or leaks noted. No problems noted at time of inspection... Manufactured in 2021 by Bradford-White.

5.4 Item 1(Picture) water heater

5.4 Item 2(Picture) water heater burner compartment

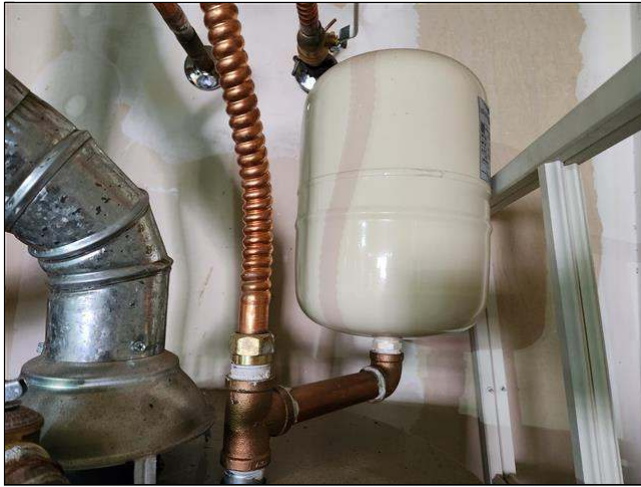
(2) Your water heater does have a "Thermal Expansion tank" installed to prevent a possible leak at the Temperature and Pressure relief valve, or "pop-off" valve, by absorbing the excessive pressure built-up in the water heater.

5.4 Item 3(Picture) thermal expansion tank

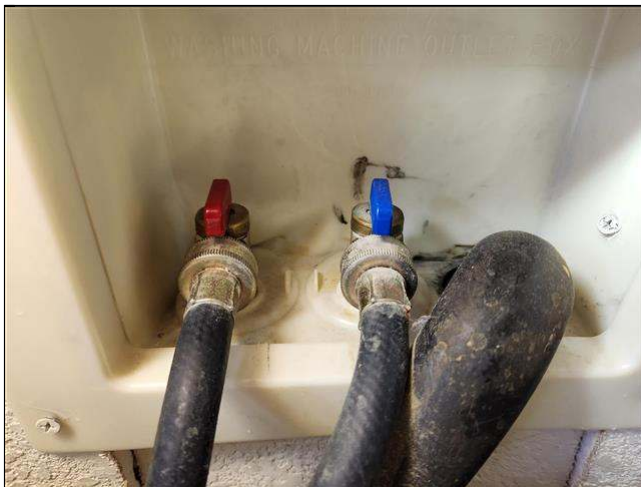
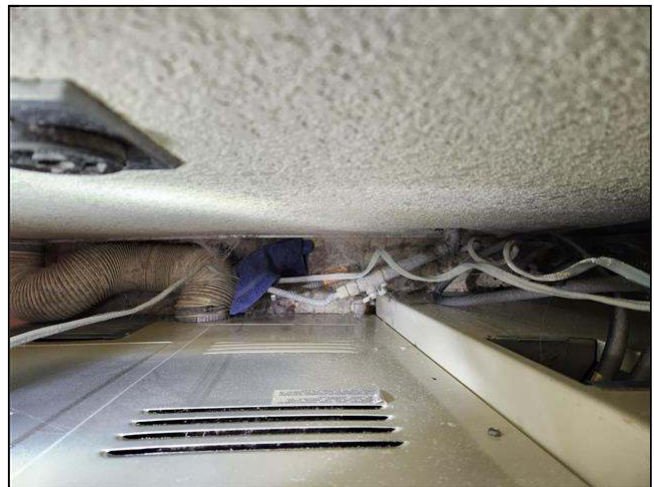
Washer and dryer hook-ups were inspected, with no problems noted. Dryer is electric powered with rigid metal venting installed in the crawlspace. Washer drain is 2" diameter, Hot and Cold hook-ups with no problems noted.

5.6 Item 1(Picture) laundry hook-ups

5.6 Item 2(Picture) laundry hook-ups

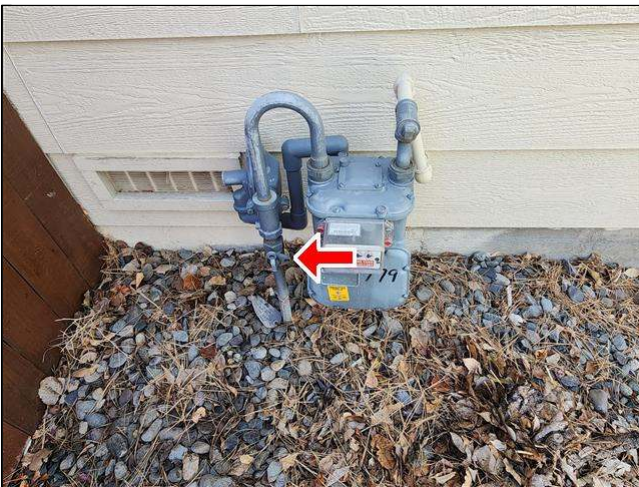
Located at the West side of the house with the gas meter. No problems noted.

5.11 Item 1(Picture) main fuel shut-off valve

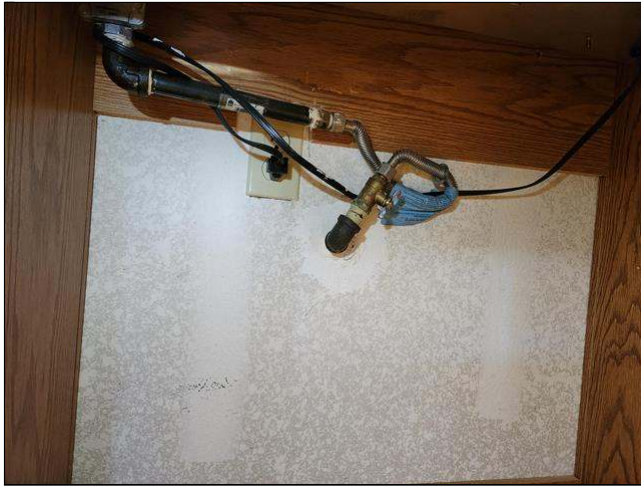
(1) The gas Range was inspected at all burners and settings. The Electric double Oven was inspected at all heating elements and random settings. No problems noted at time of inspection.

6.2 Item 1(Picture) under cooktop range

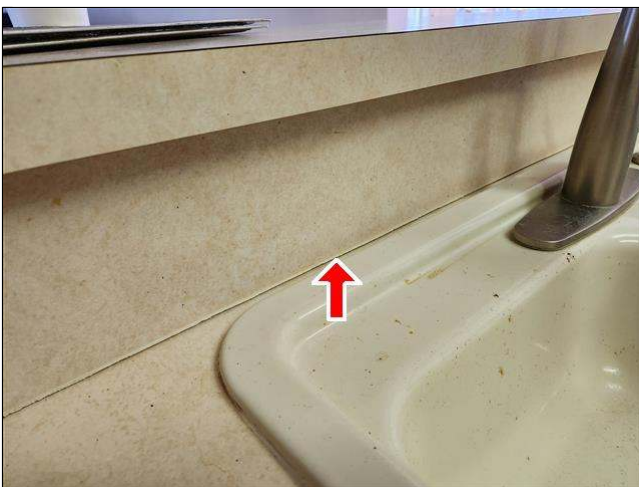
7.4 Item 3(Picture) caulking at kitchen

(1) Recommend caulking maintenance along backsplash at Kitchen Countertop (also master bathroom). This is a small maintenance repair that should be done to prevent moisture intrusion behind cabinet.

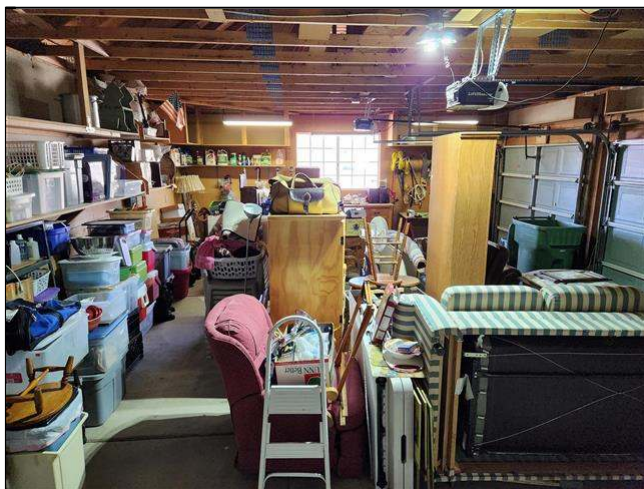
Garage, as seen at time of inspection.

8.0 Item 1(Picture) view of garage

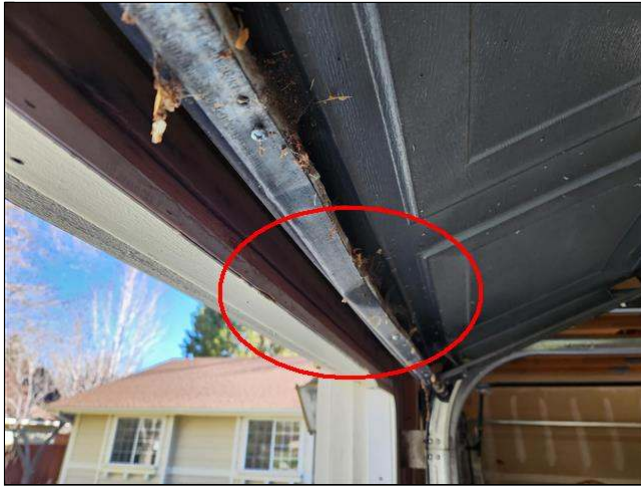
NOTE: Both garage doors show signs of physical damage to the lower panels (creased), however the doors open and close as intended. **NOTE: small garage door lower panel is bent out at the bottom edge, and drags against the door header when opening.**

8.7 Item 3(Picture) drags framing header when opening

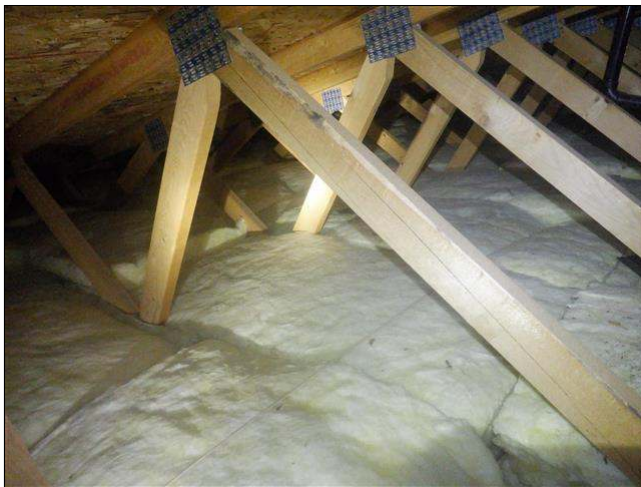
Attic insulation is Fiberglass Batt type approximately 9 to 10 inches thick (R30). No problems noted at time of inspection.

9.0 Item 1(Picture) view of attic insulation

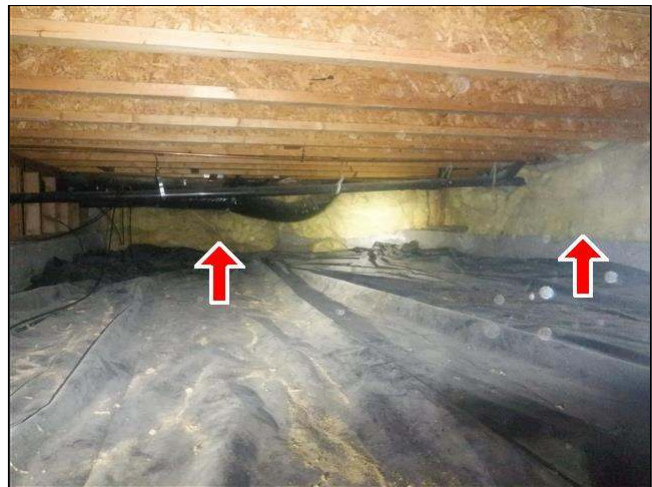
9.0 Item 2(Picture) view of crawlspace insulation

The crawlspace area is insulated on the perimeter of the foundation using R11 fiberglass Batts, no problems noted.

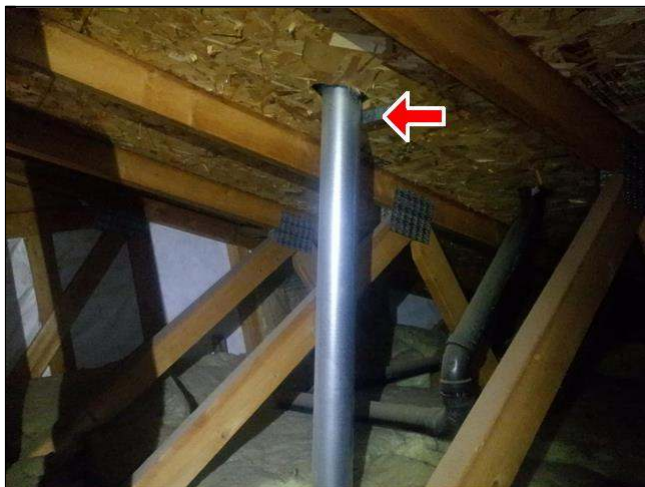
(2) Bathroom vents are properly ducted to the exterior of the home.

9.4 Item 1(Picture) properly vented to exterior

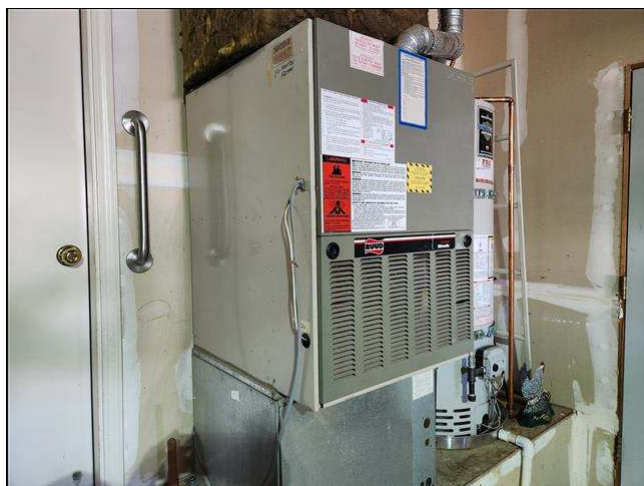
The heating equipment is original (31 years). The furnace is a vertical downdraft natural gas fired forced air unit, Rated at 125,000btu's, that operated as intended with normal operating controls. The burners have an even blue flame. Manufactured in 1992 by RUUD Heating.

10.0 Item 1(Picture) forced air furnace

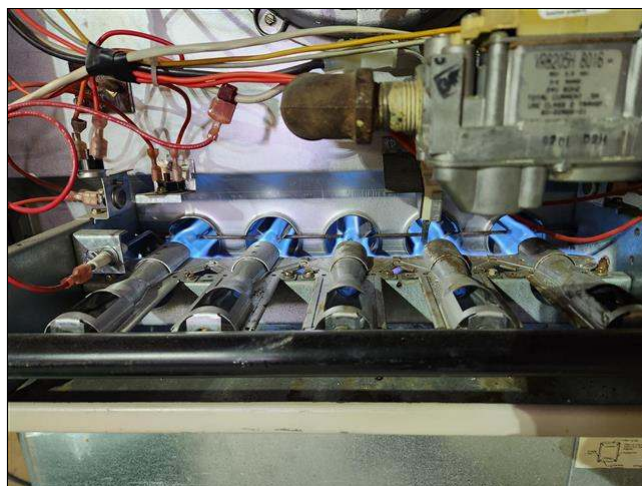
10.0 Item 2(Picture) furnace burners

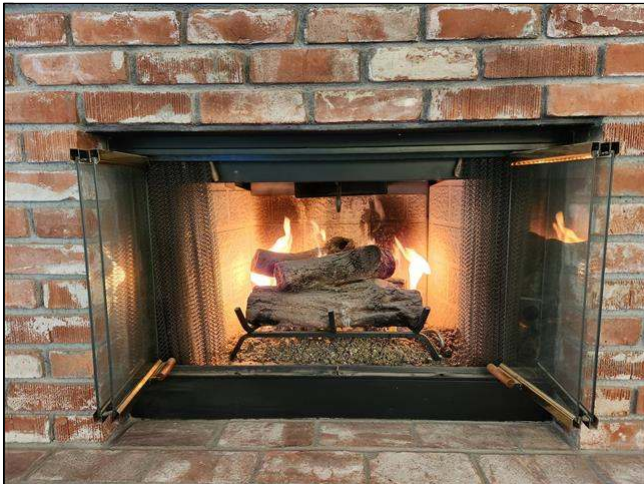
Fireplace appears in good operating condition, with firebricks appearing in good condition. Gas valve operated smoothly, and completely shut-off fuel to extinguish the flame. Damper operates smoothly, and remains in the "open" position.

11.0 Item 1(Picture) living room fireplace

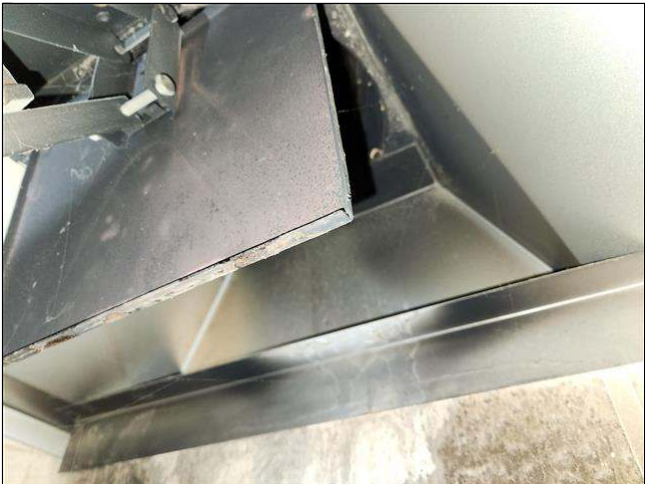
11.0 Item 2(Picture) fireplace chimney damper
