# Inspection Report

**Property Address:**  
2988 Del Rio Ln  
Minden NV 89423

**Clear Choice Home Inspection Services**

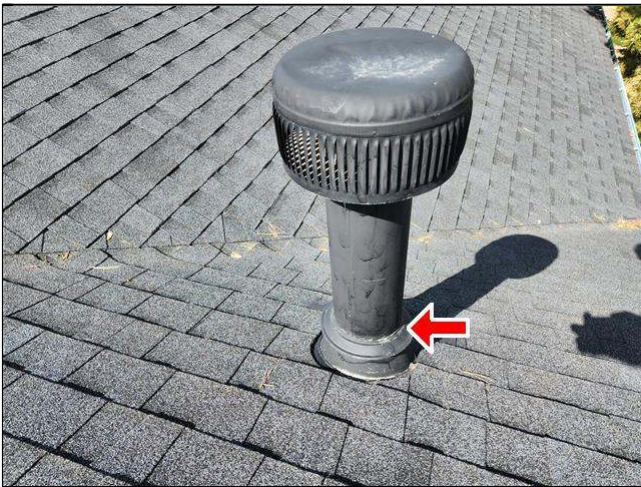
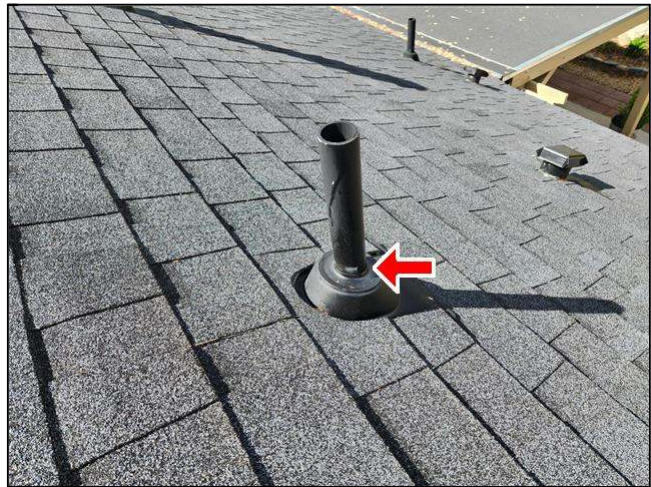
Plumbing and furnace vent pipes are sealed well against flashings to prevent moisture intrusion into attic framing areas.

2.3 Item 1(Picture) Plumbing and furnace vent pipes are sealed well

2.3 Item 2(Picture) Plumbing and furnace vent pipes are sealed well

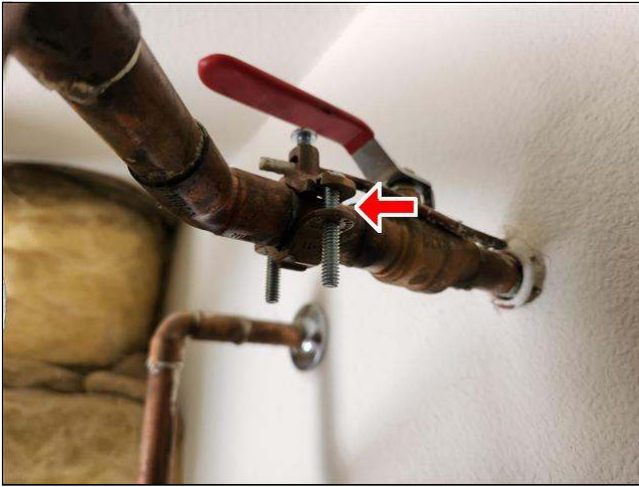
The Grounding system for the Main Service Panel is not visible due to construction materials. However, there is a Grounding wire present in the Panel, and there is a Bonding wire present at the cold water pipe, which are important for proper grounding (safety) of the home.

4.3 Item 1(Picture) bond to plumbing

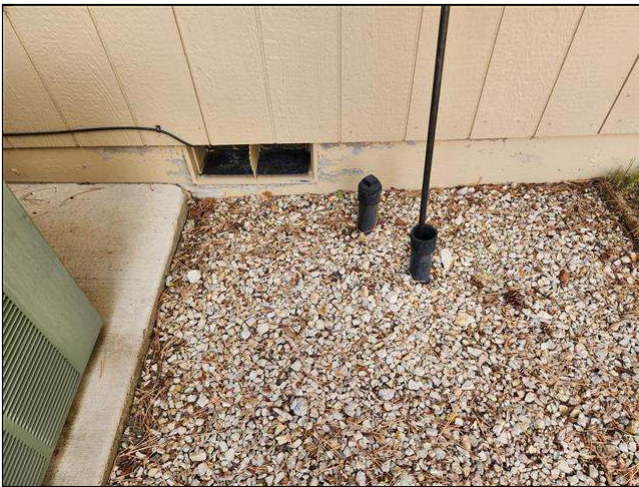
There are a couple main water shut-off locations. With the water meter at front of property (for emergencies), and at side yard to right of house. Note: Both of these locations will require a water key tool to operate.

5.0 Item 1(Picture) main water shut-off location

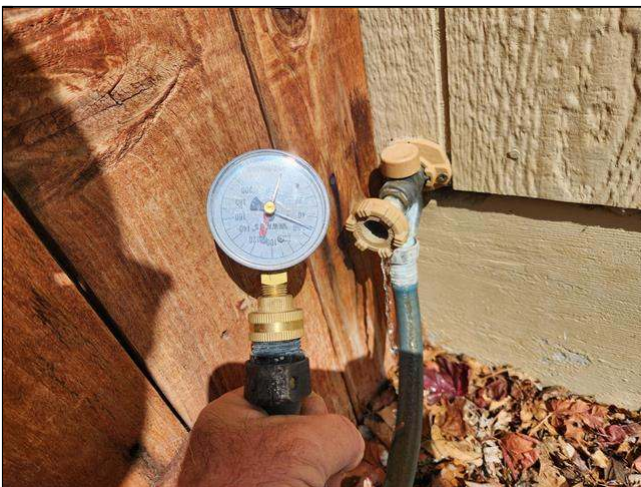
(1) The water pressure was tested at the front hose bib, pressure was 52 psi at time of inspection... Pressure regulator noted at the North side of crawlspace area, for future water pressure adjustments, if necessary.

5.2 Item 1(Picture) water pressure at front hose bib

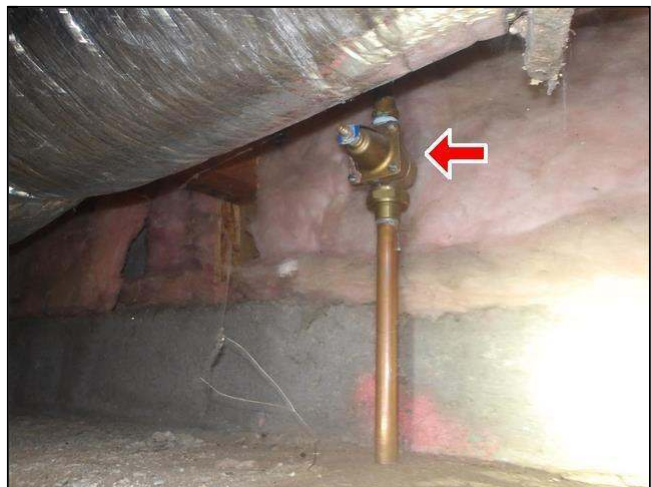
5.2 Item 2(Picture) Pressure regulator noted at the North side of crawlspace area

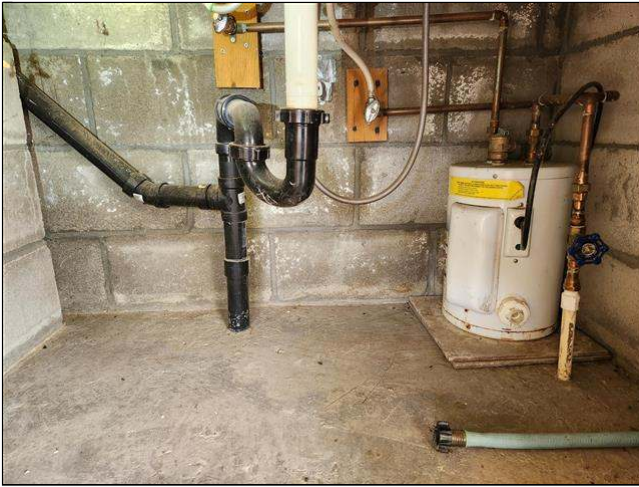
(2) NOTE: Exterior kitchen plumbing was not checked for proper operation. Water heater was unplugged, and could not be verified for proper operation during the inspection.

5.2 Item 3(Picture) Exterior kitchen plumbing

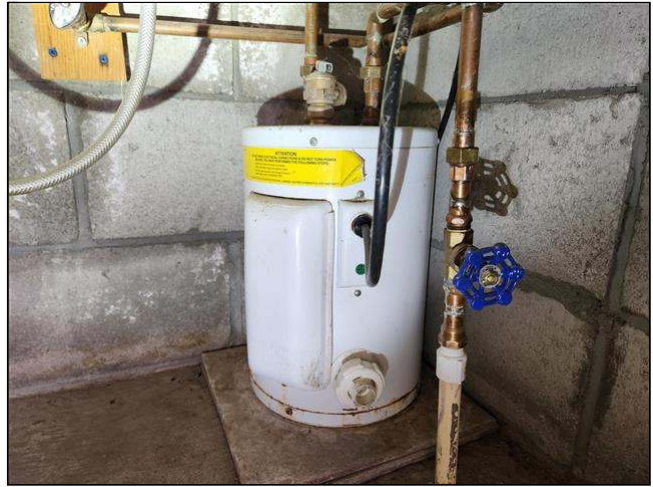
5.2 Item 4(Picture) Exterior kitchen plumbing

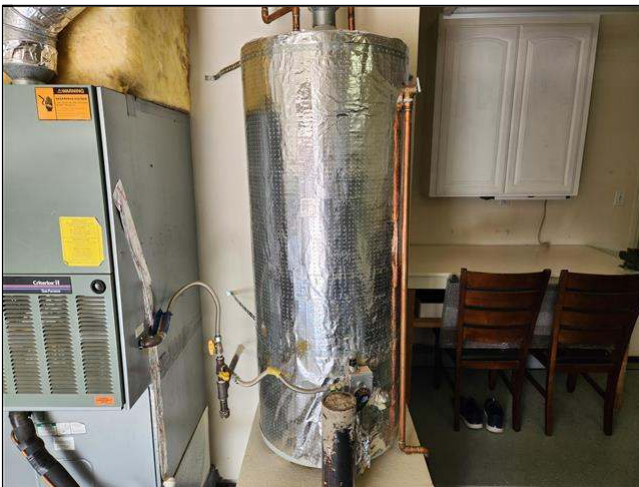
Temperature and Pressure Relief valve is piped to the exterior of the house, or within 6 inches of the floor (for safety). Water Heater is strapped with approved strapping material, and is setting on a pedestal minimum of 18" above the garage floor. Water and fuel shut-off valves are present. Water heater operated as intended with no abnormal noises or leaks noted. No problems noted at time of inspection... Manufactured in 2000 (NOTE: I was unable to view the Manufacturer and capacity due to being wrapped)

5.4 Item 1(Picture) water heater

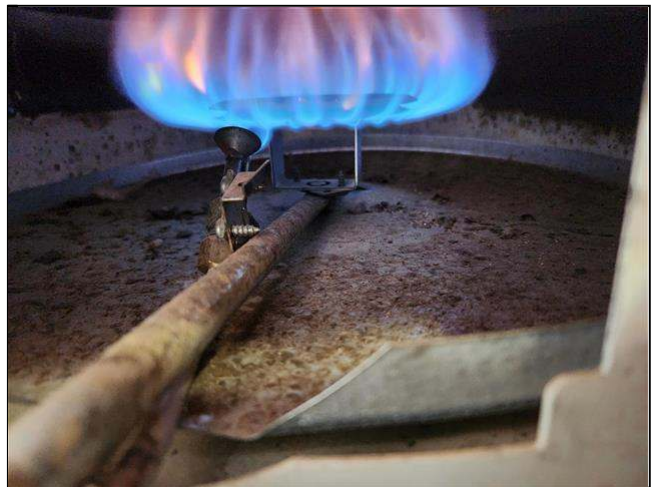
5.4 Item 2(Picture) water heater burner compartment

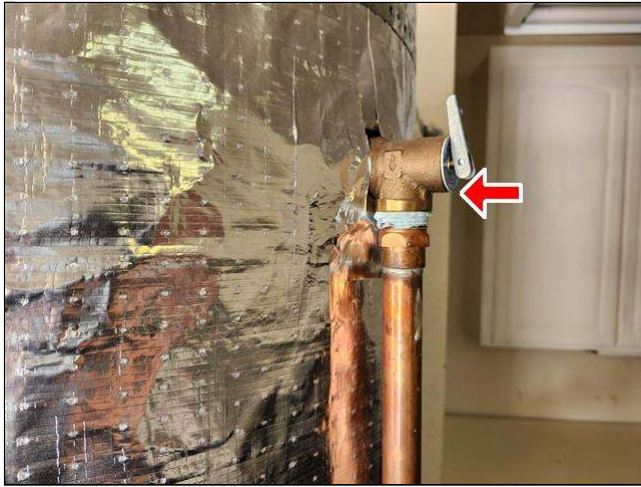
5.4 Item 3(Picture) Temperature and Pressure Relief valve

Temperature and Pressure Relief (TPR) valve should be checked Bi-Monthly for proper operation. A "sticking" valve could cause excessive pressure to build-up in the Water Heater, possibly causing damage to water heating unit. A valve that will not reseal when testing, is faulty as well. Recommend valve replacement by a qualified person if not operating properly.

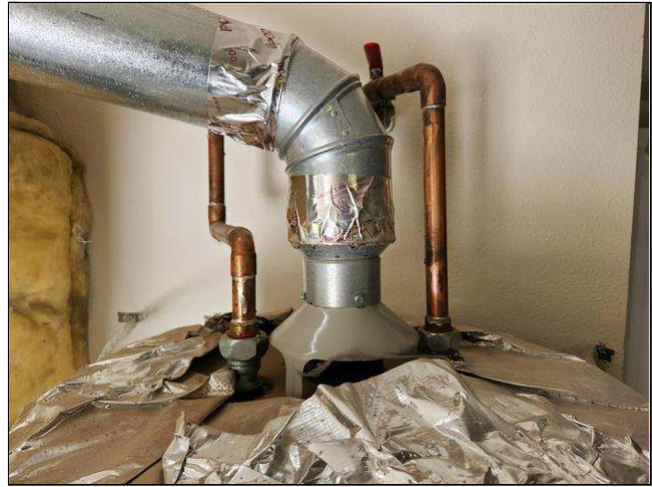
5.4 Item 4(Picture) water heater connections

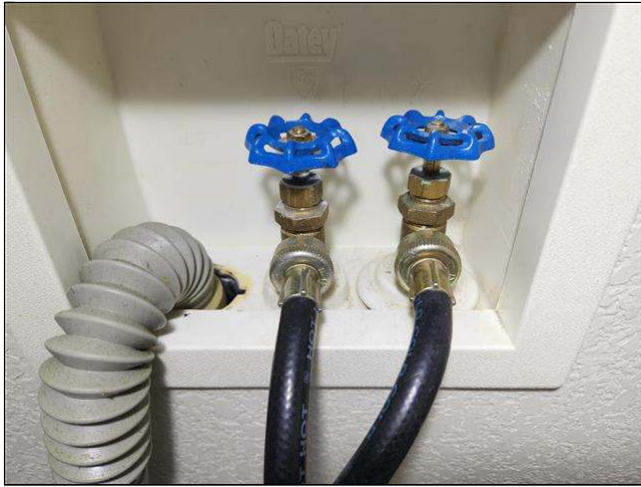
Washer and dryer hook-ups were inspected, with no problems noted. Dryer is electric or gas powered with rigid metal venting installed through the wall. Washer drain is 2" diameter, Hot and Cold hook-ups with no problems noted.

5.6 Item 1(Picture) laundry hook-ups

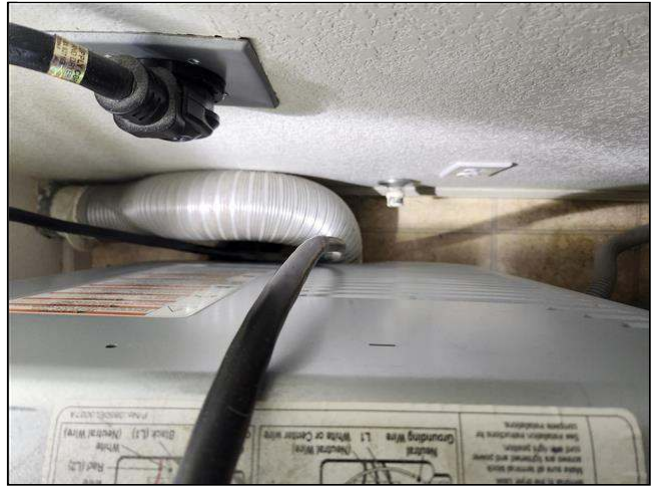
5.6 Item 2(Picture) laundry hook-ups

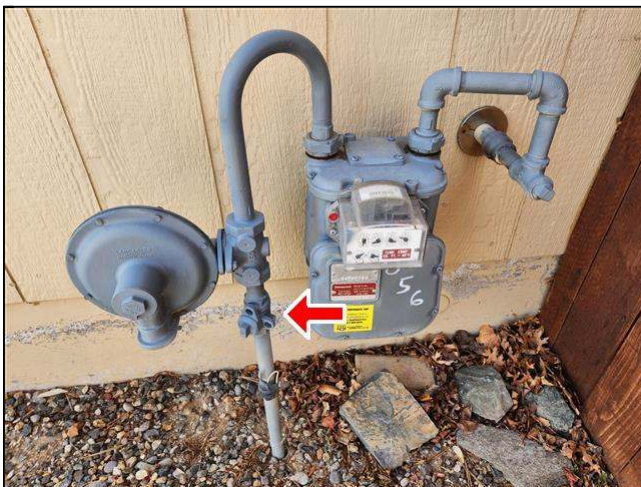
Located at the North side of the house with the gas meter. No problems noted.

5.11 Item 1(Picture) main fuel shut-off valve

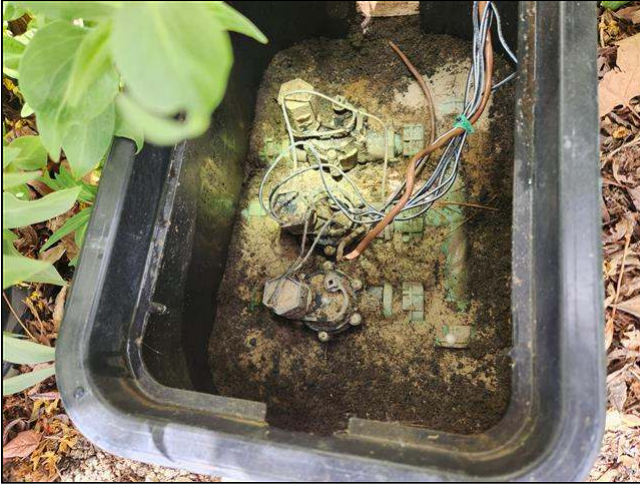
Sprinkler system inspection is beyond the scope of this Home Inspection. Irrigation boxes were opened and inspected for damage and/or major water leaks. No obvious problems noted at time of inspection.

5.13 Item 1(Picture) irrigation box/valves

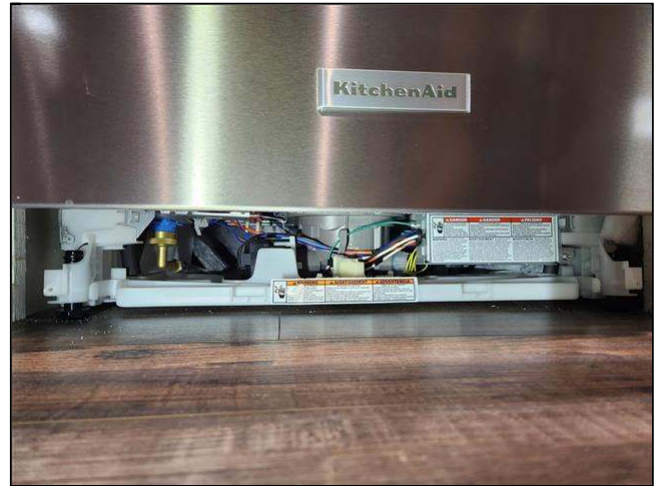
6.0 Item 2(Picture) dishwasher hook-ups

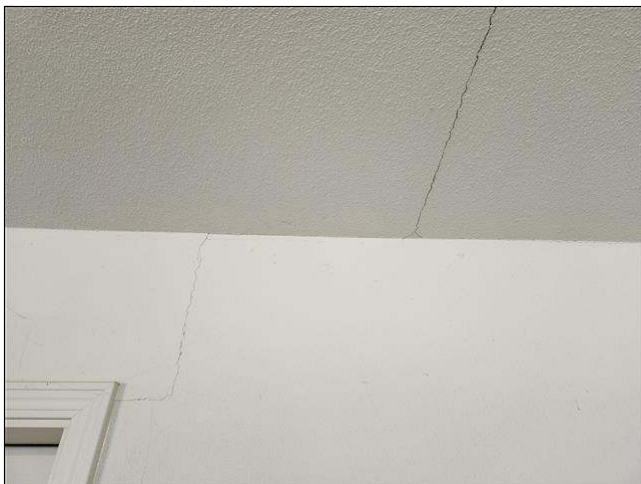
**Comments:** Inspected  
Ceilings finished with drywall, with typical settlement cracks, no problems noted.

8.2 Item 1(Picture) typical settlement cracks

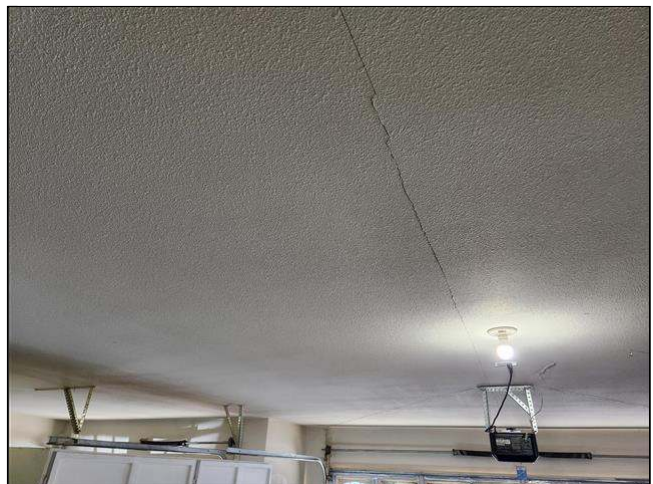
8.2 Item 2(Picture) typical settlement cracks

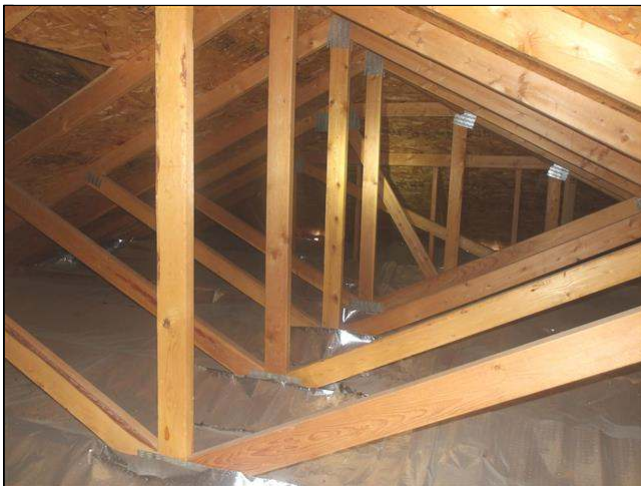
Garage attic area as seen at time of inspection... NOTE: Garage ceiling is NOT insulated, however uses foil covering to help reflect radiant heat.

8.11 Item 1(Picture) view of garage roof structure

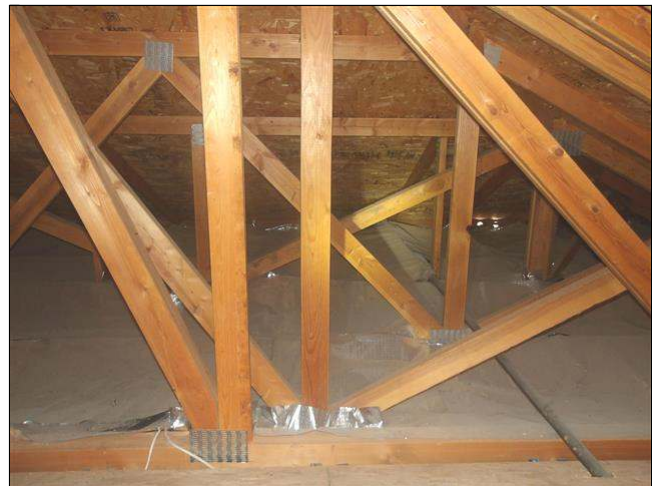
8.11 Item 2(Picture) view of garage roof structure

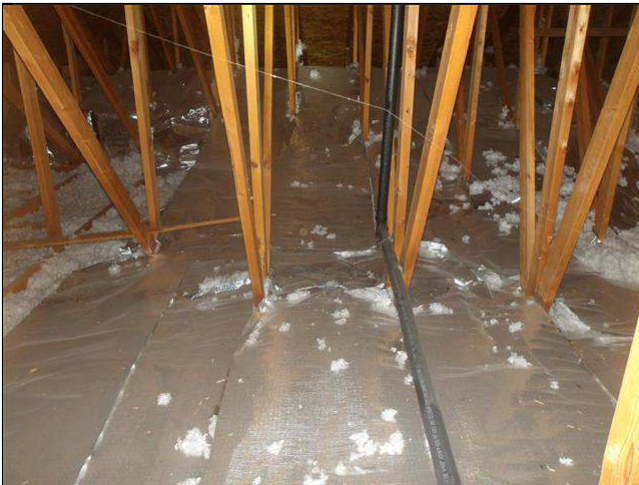
The attic insulation is blown-in, loose-fill, and is approximately 10 to 12 inches deep (R-30), with foil sheeting installed over the insulation to help block radiating heat. No problems noted.

9.0 Item 1(Picture) view of attic insulation

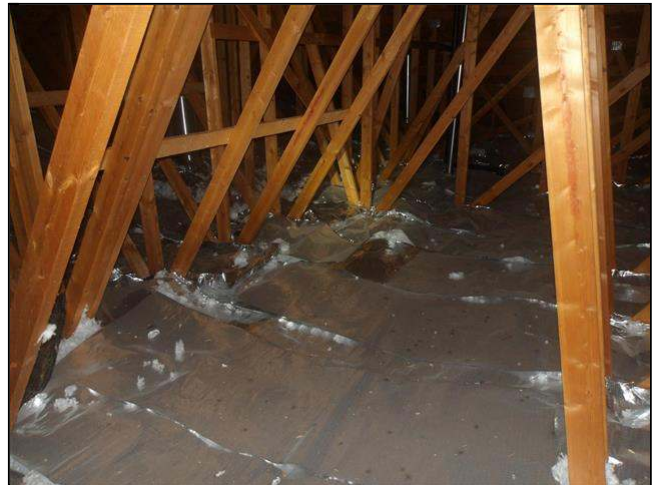
9.0 Item 2(Picture) view of attic insulation

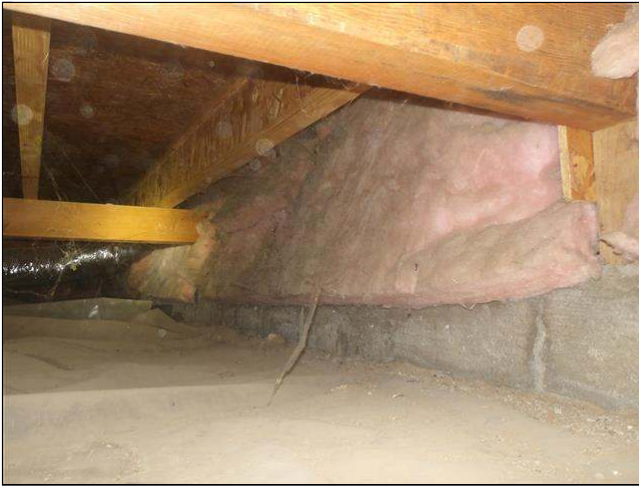
The crawlspace area is insulated on the perimeter of the foundation using R11 fiberglass Batts, no problems noted.

9.1 Item 1(Picture) view of crawlspace insulation

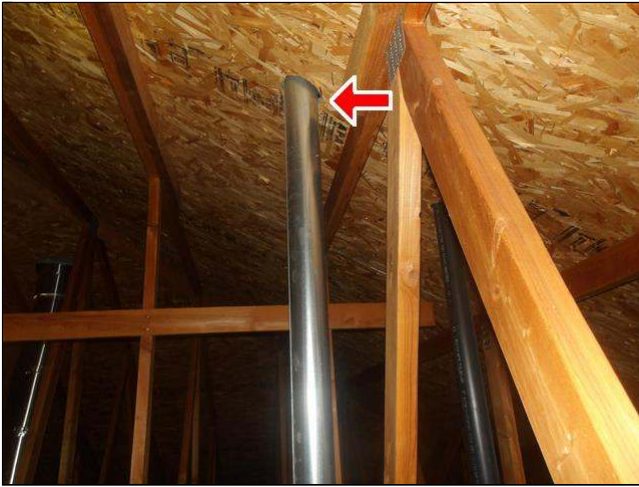
Bathrooms, Kitchen and Laundry vents are properly ducted to the exterior of the home.

9.4 Item 1(Picture) properly ducted to the exterior

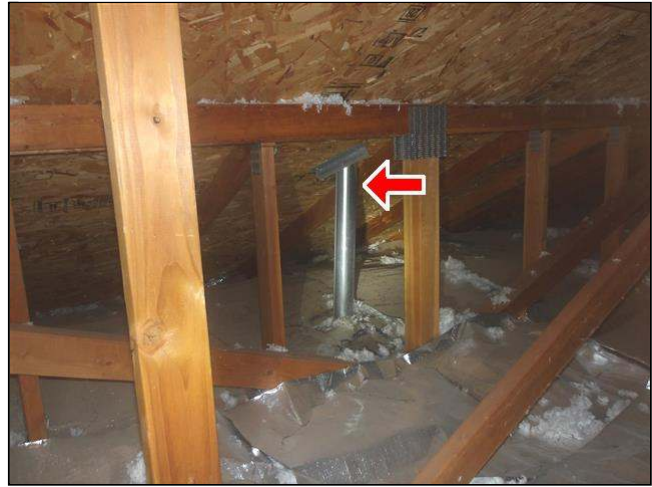
9.4 Item 2(Picture) properly ducted to the exterior

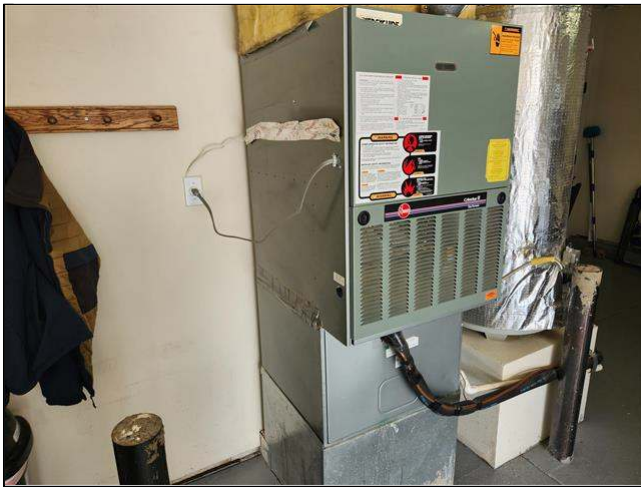
The heating equipment is original (26 years). The furnace is a vertical downdraft natural gas fired forced air unit, Rated at 125,000btu's, that operated as intended with normal operating controls. The burners have an even blue flame. Manufactured in 2000 by Rheem Heating.

10.0 Item 1(Picture) forced air furnace

Note: HVAC equipment can fail at anytime without warning. Regular service is important for efficient operation and to achieve maximum life from equipment. Most manufacturers recommend annual service.

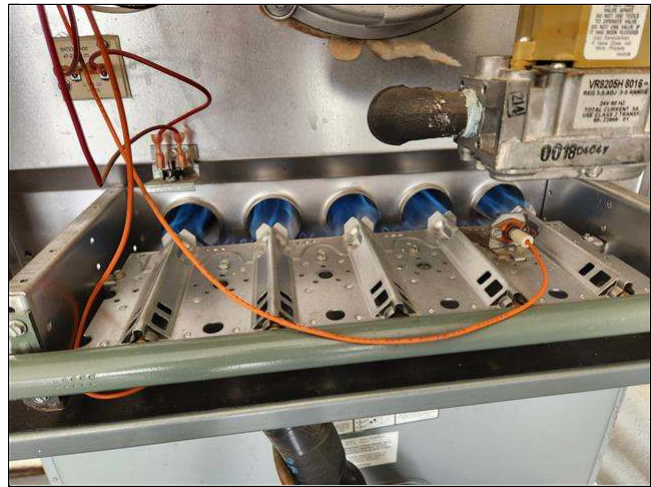
10.0 Item 2(Picture) furnace burners

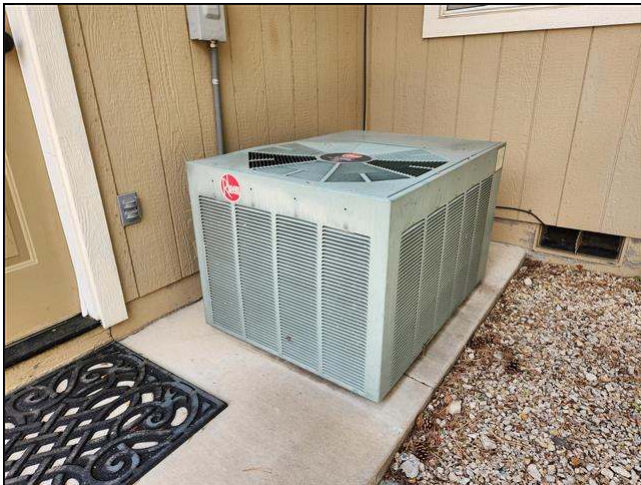
Performed a visual only inspection. The A/C was not tested for proper operation due to the outside air temperature being 49 degrees or less, and possibility of cooling equipment failure could occur. 60 degree minimum ambient temperature must be achieved for safe compressor operation. NOTE: Licensed HVAC Contractors possess the required knowledge and equipment to check operation of cooling system in cold weather. Recommend consulting an HVAC Contractor for further evaluation of cooling system as desired. We did not inspect this unit(s). Manufactured in 2000 by RHEEM.

10.5 Item 1(Picture) condensing unit

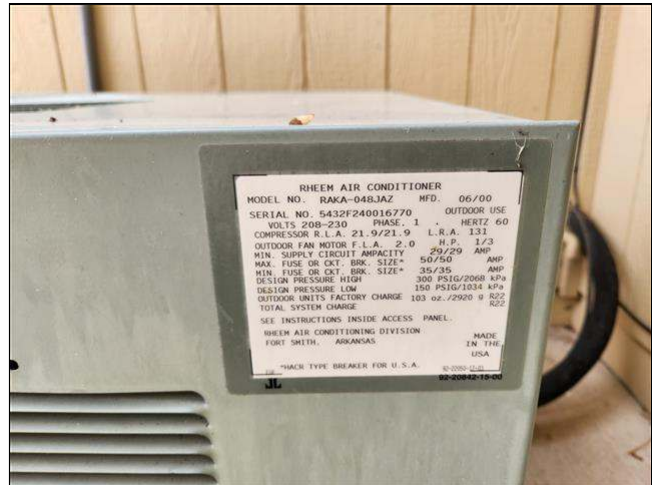
10.5 Item 2(Picture) manufacturer's label

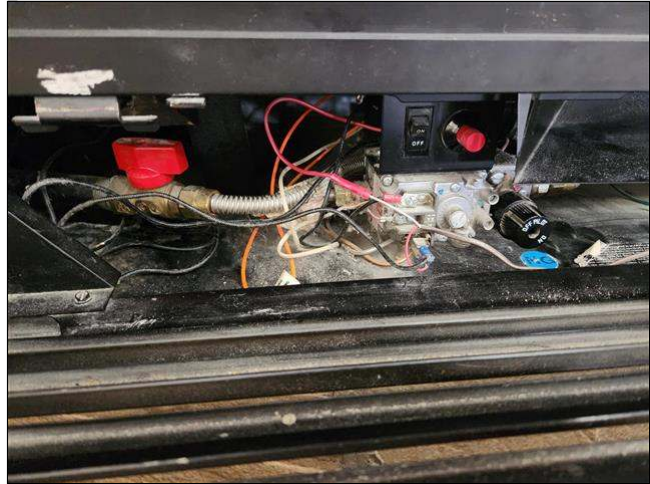
NOTE: I was unable to verify proper operation of the living room fireplace. PIEZO ignitor appears to function as intended, appears may be excessive air in the gas supply pipe. Recommend further evaluation of fireplace by a licensed Fireplace Contractor as needed.

11.0 Item 2(Picture) fireplace gas valve
