## Home Inspection Report

**1718 Iris Lane  
Billings, MT 59102**

**Date of Inspection: 08/16/2024**

Inspection No. 45957-1-1121

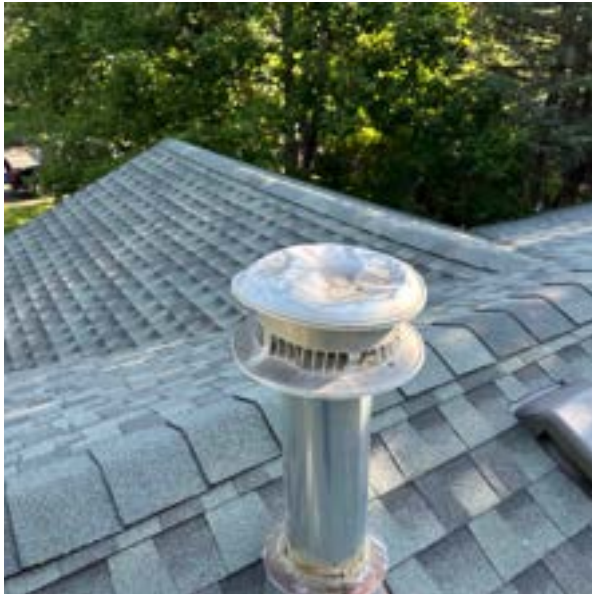
4.5.1 Corrosion

4.5.2 Replace damaged chimney cap to prevent further damage and moisture intrusion.

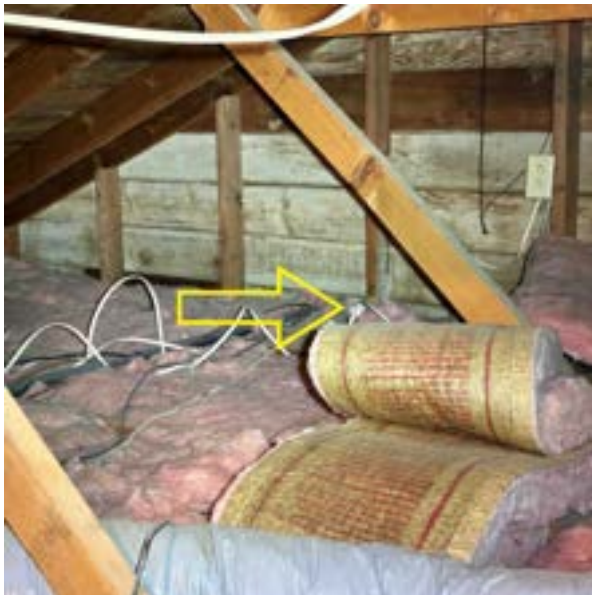
5.6.1 Stains noted - No moisture detected at time of inspection.

5.6.2 Seal cracks/gaps in attic sheathing to prevent moisture intrusion and subsequent damages. **(Attic)**

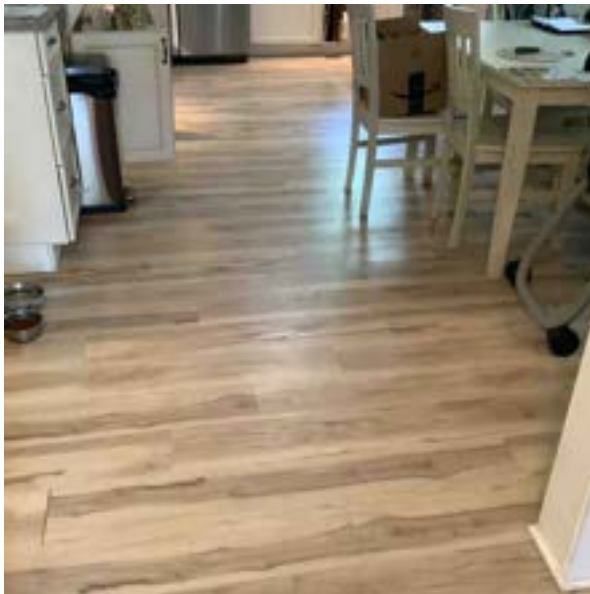
7.4.1 Stains

7.4.2 Further investigate cause of floor sloping and repair as required.

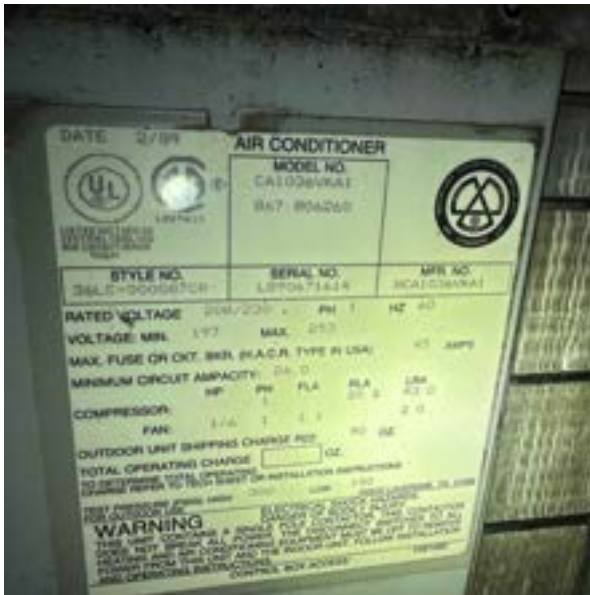
Data Plate: (Exterior East)

9.4.1 Exceeded Typical Life Expectancy - Budget to Replace

9.4.3 Age: 35

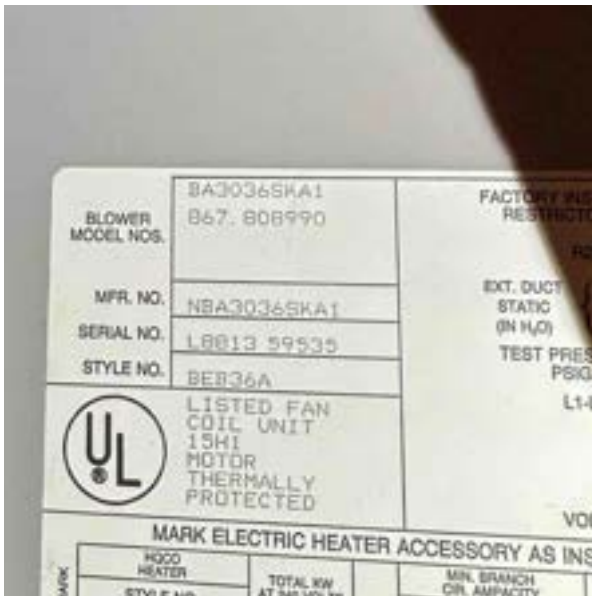
Data plate: **(Attic)**

⦿ Exceeded Typical Life Expectancy - Budget to Replace

9.6.1 Age: 36

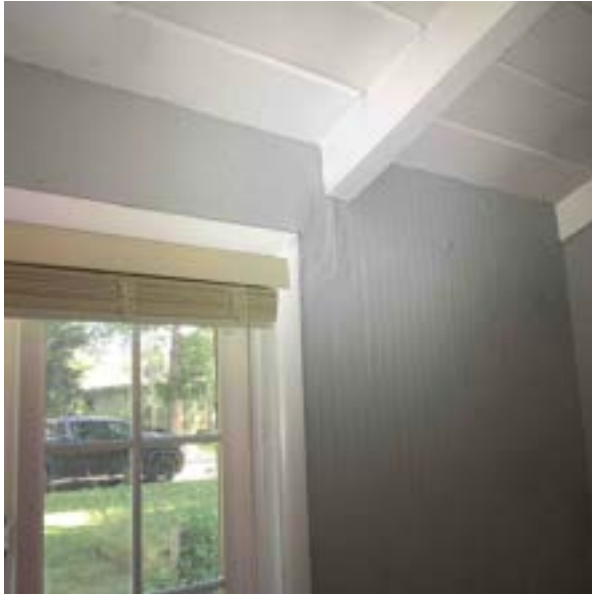
## 11.2.1 Staining

11.2.2 Further investigate cause and extent of staining/damage and correct as required. No moisture detected at time of inspection. **(Living Room)**

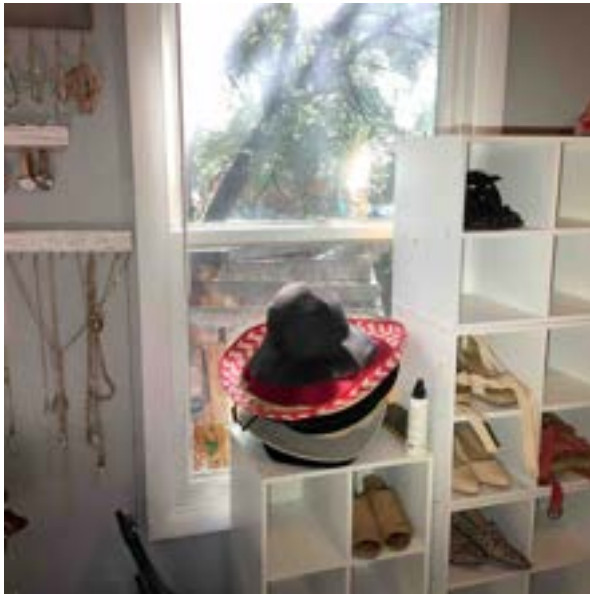
- Basement Living Room
- Basement Southwest Room
- Laundry area
- Northeast Bedroom
- Southeast Bedroom

11.3.1 Binds - Adjust/Repair

11.3.4 Repair/adjust window trim to reduce window binding and regain intended operation.

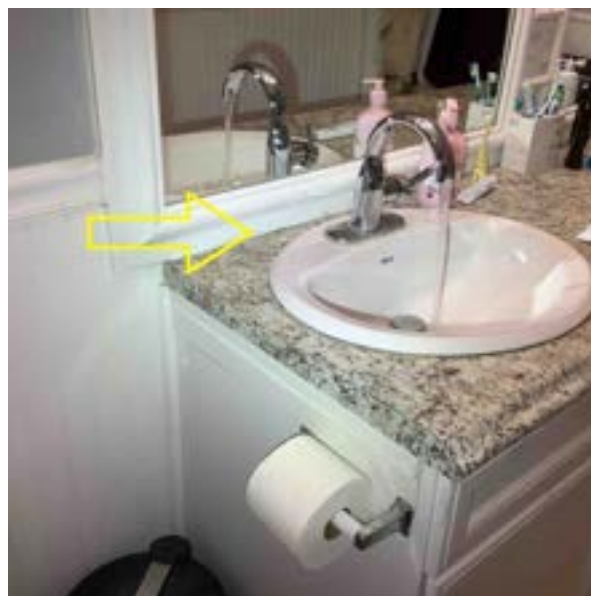
- 1st Floor Hall Bathroom
- Kitchen

11.7.4 Previous water damages noted - No moisture detected at time of inspection.

11.7.5 Recaulk counters to prevent moisture intrusion and subsequent damages.
