Inspection Report

Property Address:
1840 Ty Lane
Minden NV 88423

Clear Choice Home Inspection Services

Date: 5/17/2024	Time: 08:00 AM	Report ID: HER184
Property: 1840 Ty Lane Minden NV 88423	Customer: Herbert Mitchell Megan Horan	Real Estate Professional: Thomas Vander Laan Coldwell Banker

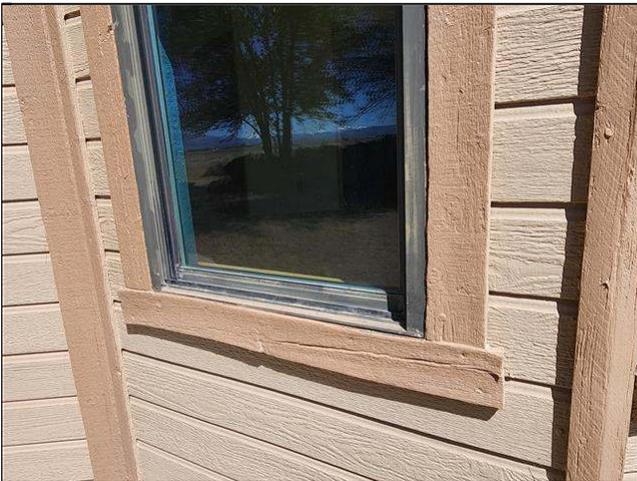
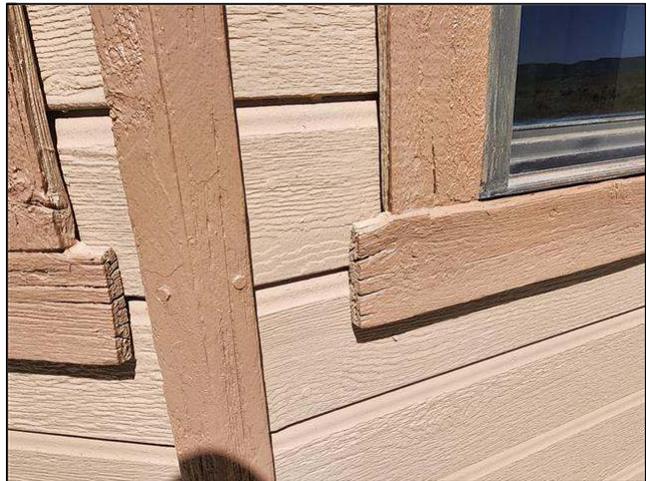
South and East facing window trim boards show advanced wear from Sun exposure, however are currently well painted for protection.

1.2 Item 1(Picture) south/east window trim

1.2 Item 2(Picture) south/east window trim

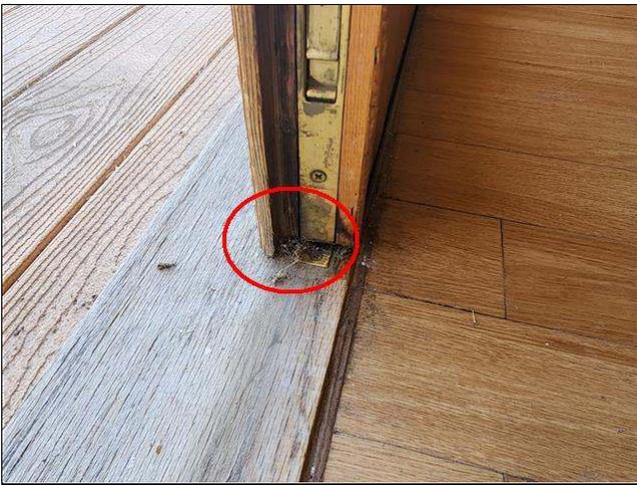
🏠 (2) Double door at rear entry to home, needs exterior trim board cut back for clearance of the metal floor hardware.

1.3 Item 2(Picture) exterior trim board contacts hardware

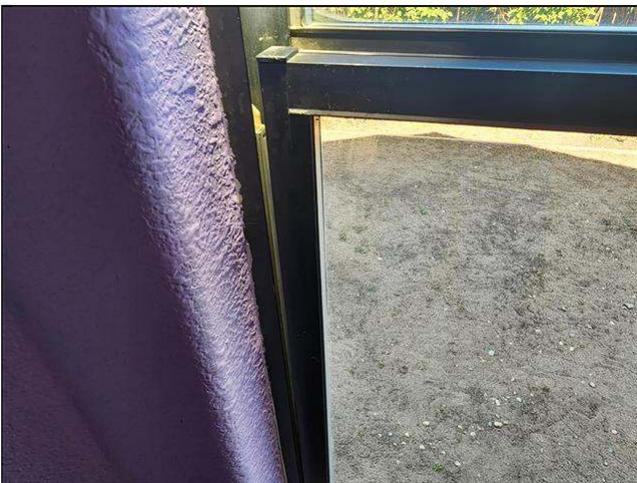
🏠 (1) Single hung window at Southwest guest bedroom falls out of track when opening.

1.4 Item 1(Picture) single hung window at SW guest bedroom

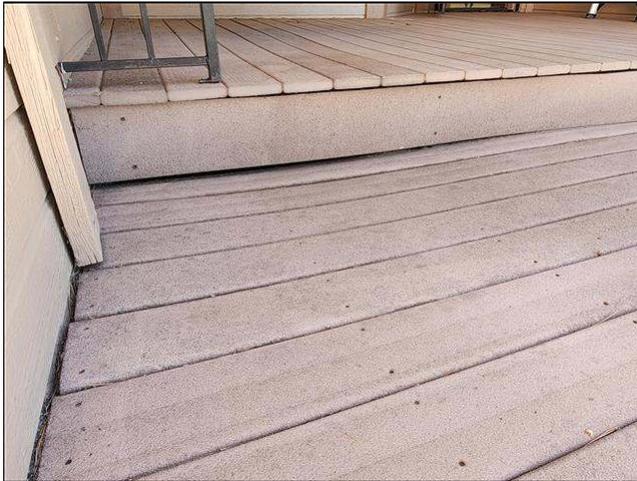
(1) Main entry step framing appears may be damaged from moisture absorption, due to roof drainage valley discharging onto step. Framing is not visible through the step boards. Recommend further evaluation by a qualified person as needed.

1.6 Item 1(Picture) sagging step framing

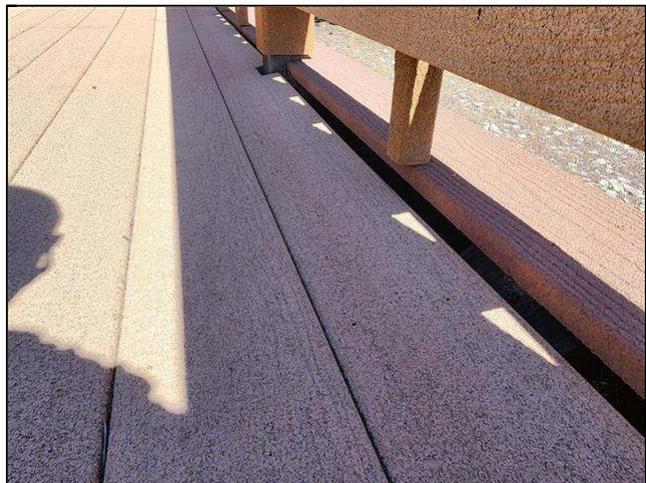
(2) Outer deck framing at rear deck rim joist area, shows settlement and separation. Recommend further evaluation by a qualified person as needed.

1.6 Item 3(Picture) deck framing separation

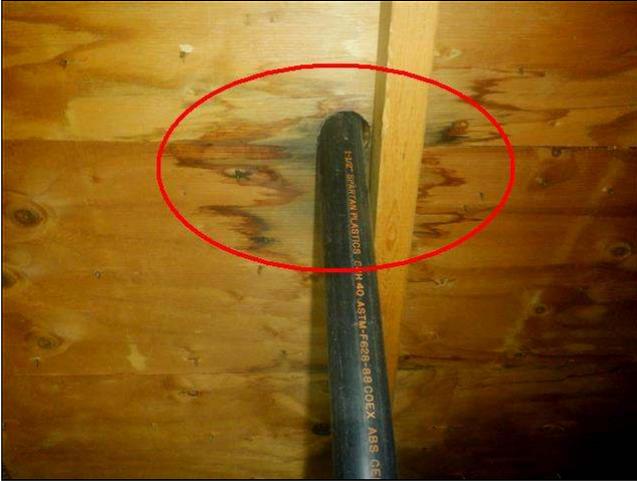
(2) There are a few plumbing vent pipe roof penetrations with failing/deteriorated rubber boots. Recommend replacement of boot seals to prevent moisture intrusion to roof framing areas. NOTE: Leaking moisture around these vent pipes is causing moisture staining at the underside of the roof sheathing plywood.

2.3 Item 5(Picture) moisture stains from leaking moisture around pipes

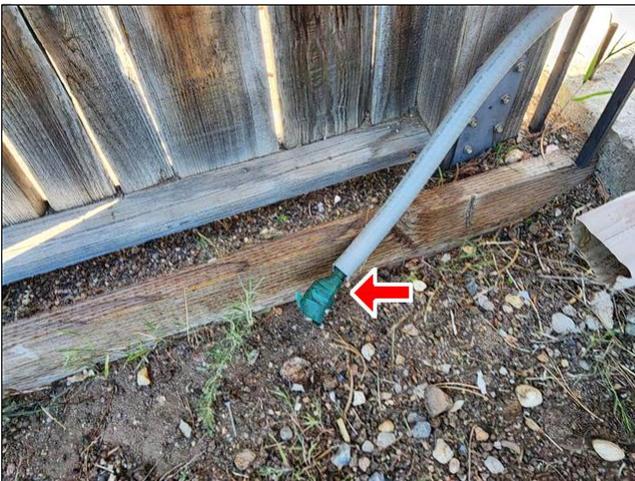
- 🏠 (3) Loose wire ends need placing inside a box with a cover-plate at the exterior Spa location. A qualified licensed electrician should perform repairs that involve wiring.

4.5 Item 3(Picture) exterior spa location

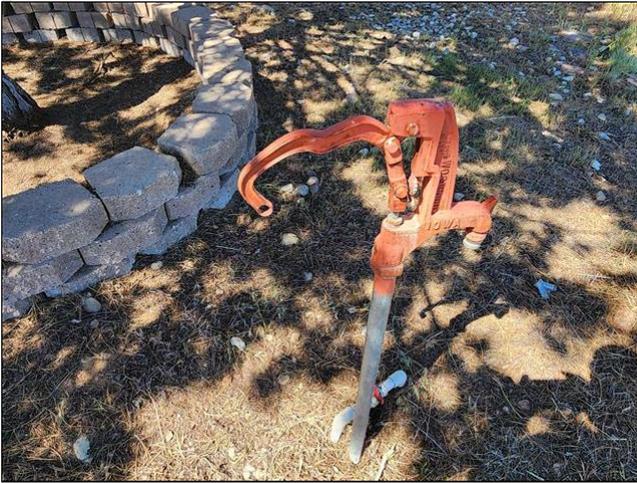
NOTE: Yard hydrant at rear yard was non-operational at time of inspection.

5.1 Item 1(Picture) non-operational yard hydrant at back yard

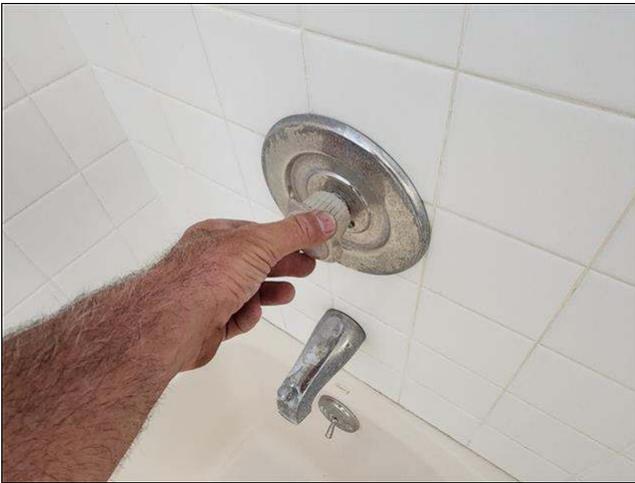
🏠 (2) Shower control valve at Guest Bathroom does not function properly, Handle spins completely around with no "stop".

5.5 Item 2(Picture) guest bathroom shower control valve

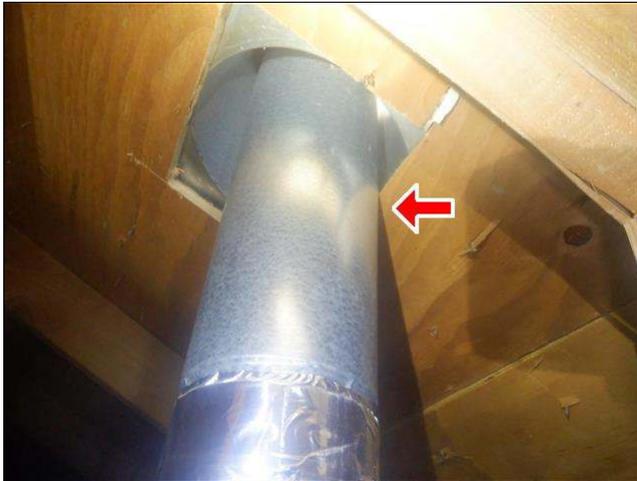
Water heater flue pipe does not maintain the required 1" clearance to combustible materials. Flue pipe is resting against the roof sheathing plywood, and needs repair to maintain the proper clearance.

5.8 Item 1(Picture) flue pipe does not have proper clearance

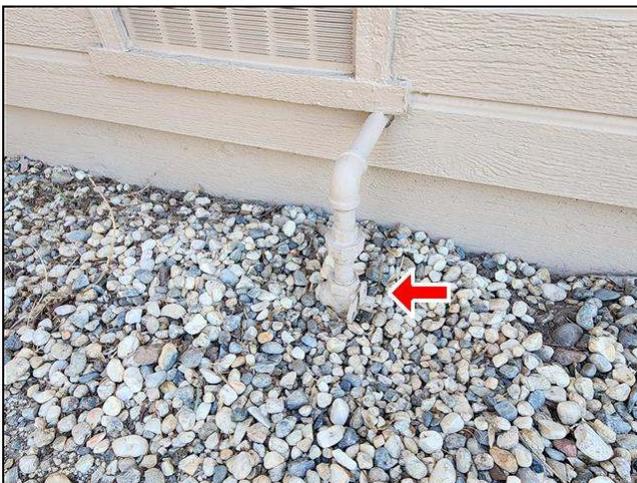
Main tank shut-off for fuel is located on top of the fuel storage tank, at the Northwest side of the house. Main fuel shut-off valve for house is located at the fuel pipe entrance to home, at the Northwest side of the house.

5.11 Item 1(Picture) main fuel shut-off for house

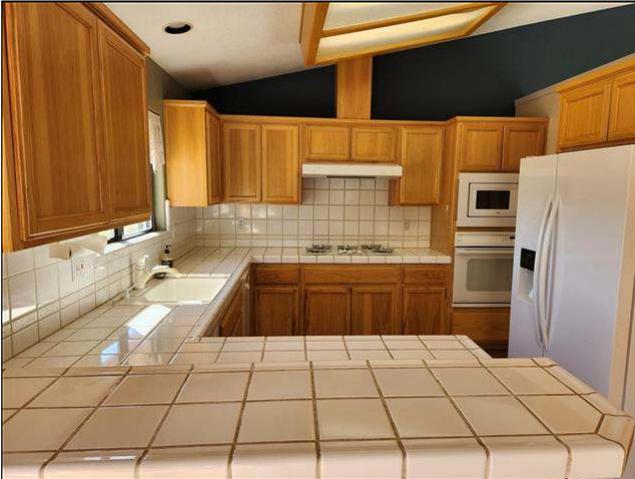
Kitchen, as seen at time of inspection.

6.0 Item 1(Picture) view of kitchen

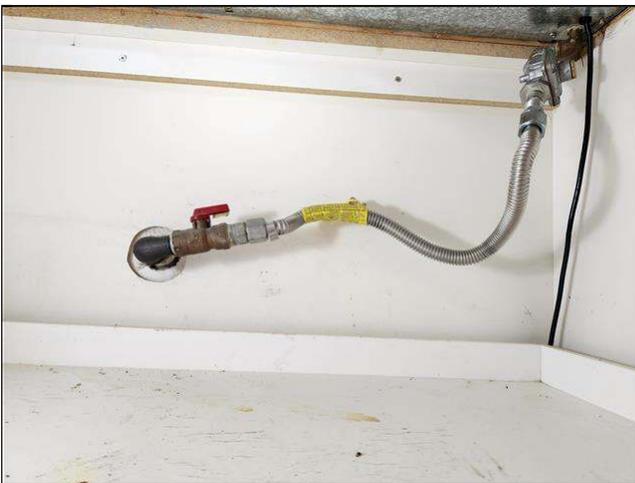
The Gas Range Cooktop was inspected at all burners and settings. The Electric Oven was inspected at all heating elements and random settings. No problems noted at time of inspection.

6.2 Item 1(Picture) under cooktop range

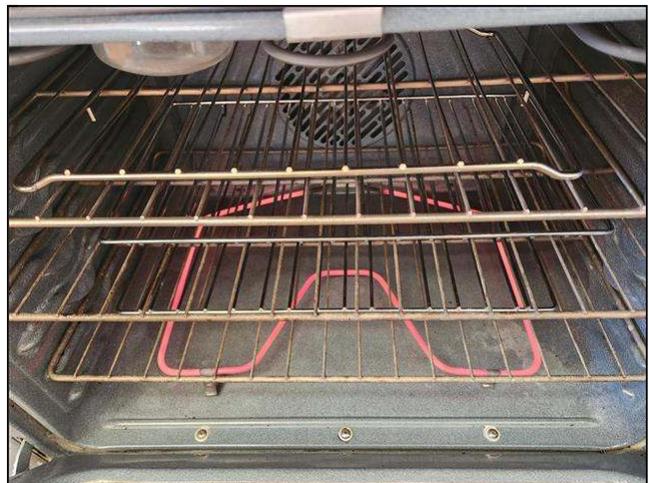
6.2 Item 2(Picture) oven heating elements

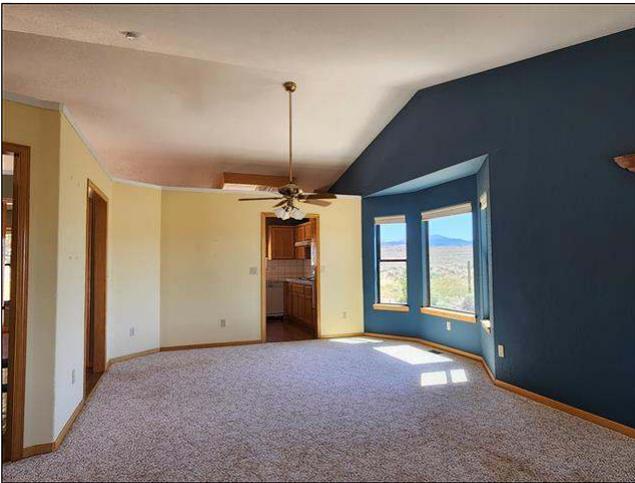
Interior, as seen at time of inspection.

7.0 Item 1(Picture) view of interior

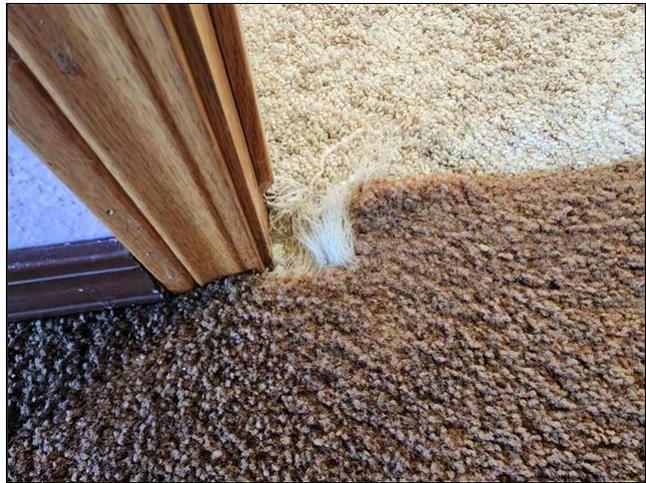
7.3 Item 3(Picture)

🏠 (2) There are a couple flaws in the carpet at the Southwest guest bedroom. Additional damaged carpet noted at the dining area floor (also stained).

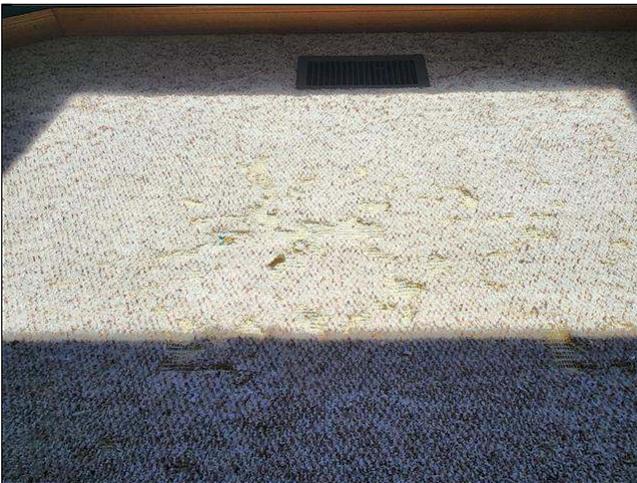
7.3 Item 4(Picture) dining area carpet

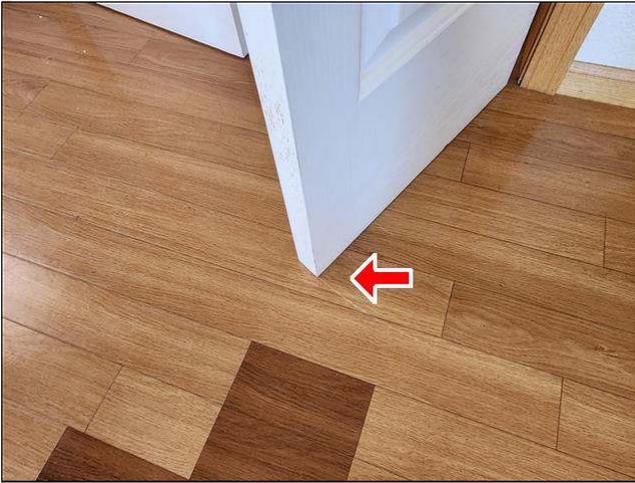
Main entry coat closet door drags on floor when opening, beginning to leave a scar on the floor.

7.5 Item 1(Picture) main entry coat closet door

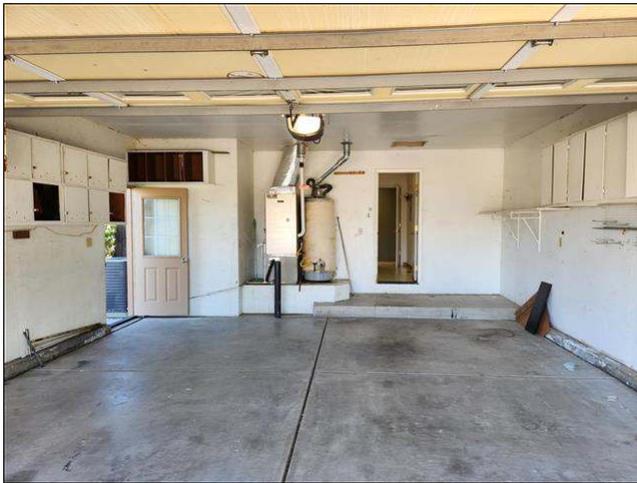
Garage, as seen at time of inspection.

8.0 Item 1(Picture) view of garage

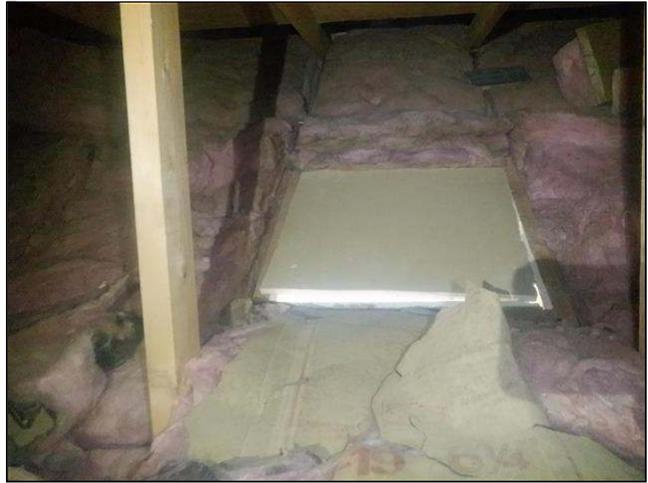
Ceilings finished with drywall... NOTE: Local codes for garage Fire-separation wall state the ceiling must be drywall with ALL seams taped. The scuttle hole installed at the garage does not access storage space, and is NOT needed due to original access located at the master bedroom closet. Recommend repair by a qualified person.

8.2 Item 2(Picture) scuttle hole not sealed

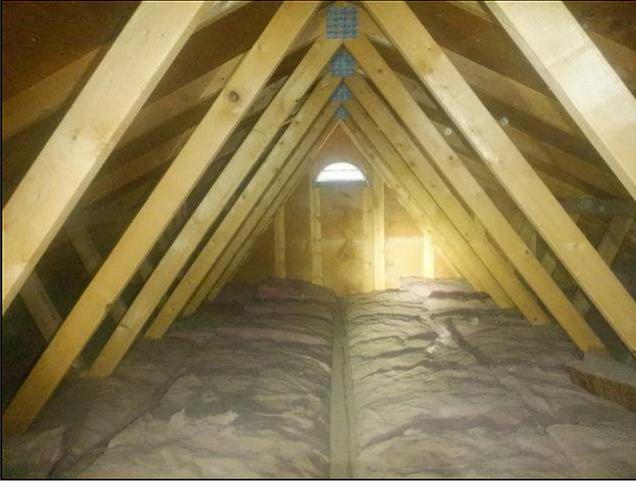
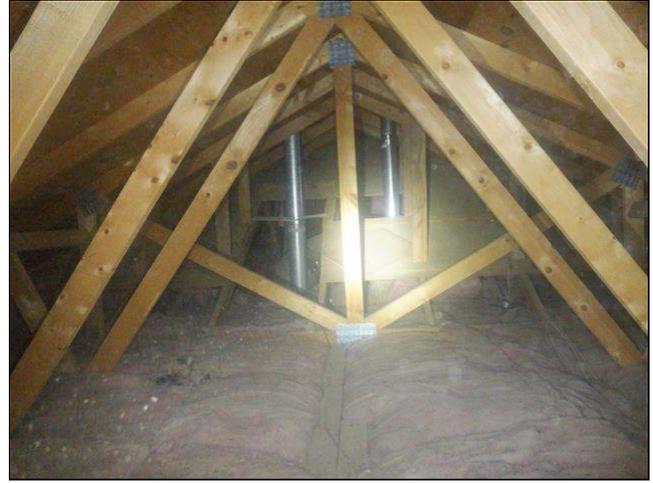
Garage attic area as seen at time of inspection. NOTE: Garage ceiling is insulated with R19 fiberglass bats.

8.10 Item 1(Picture) view of garage roof structure

8.10 Item 2(Picture) view of garage roof structure

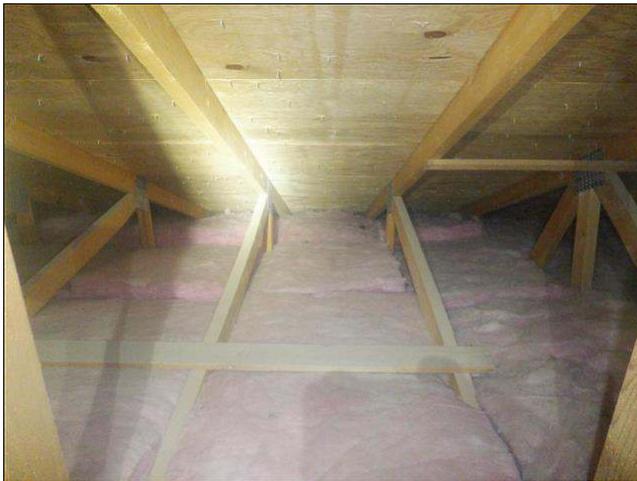
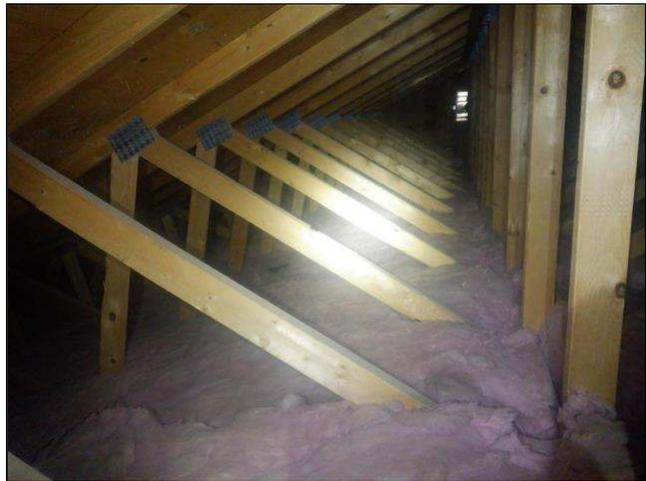
Attic insulation is Fiberglass Batt type approximately 12 inches thick (R38). No problems noted at time of inspection.

9.0 Item 1(Picture) view of attic insulation

9.0 Item 2(Picture) view of attic insulation

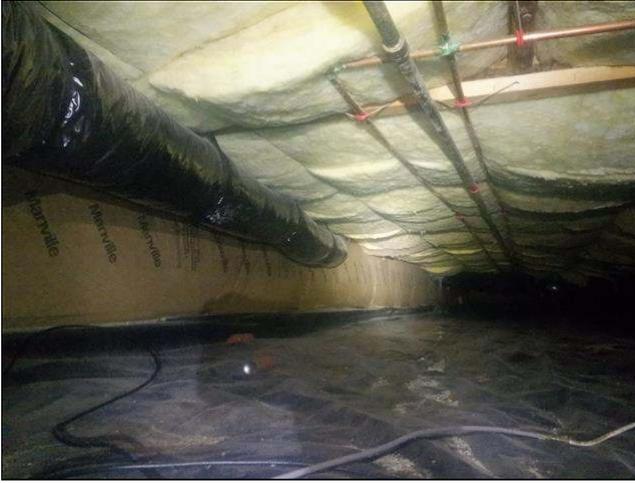
(1) The crawlspace area is insulated on the perimeter of the foundation using R13 fiberglass Batts, no problems noted.

9.1 Item 1(Picture) view of crawlspace and subfloor insulation

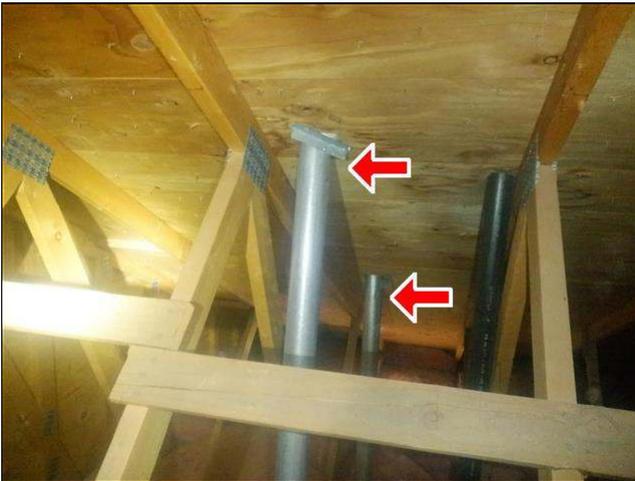
Bathrooms, Kitchen and Laundry vents are properly ducted to the exterior of the home.

9.4 Item 1(Picture) properly vented to exterior

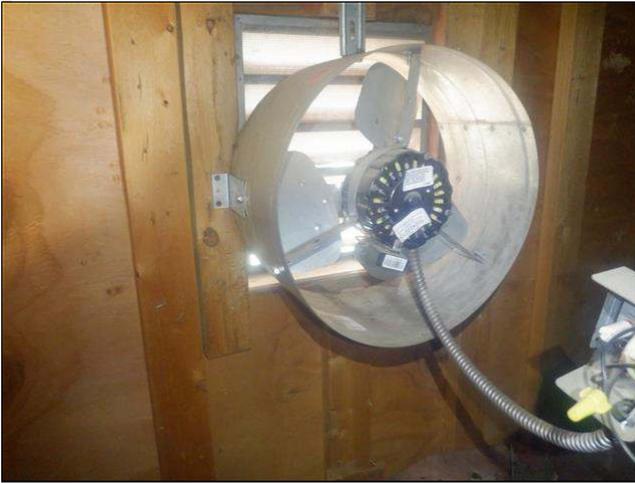
The home has a thermostatically controlled ventilation fan installed at the East gable vent. Fan started and operated, when manually adjusting the temperature setting down to 60 degrees. Normal temperature setting for the ventilation fan is set at 90 degrees. NOTE: Recommend installing cover for electrical connections.

9.5 Item 1(Picture) east gable vent attic fan

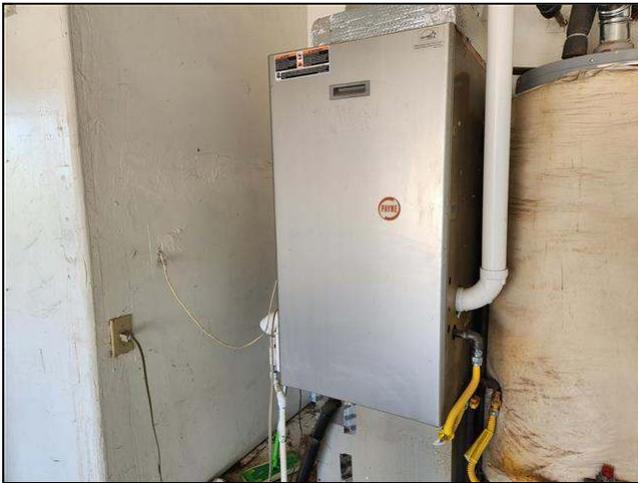
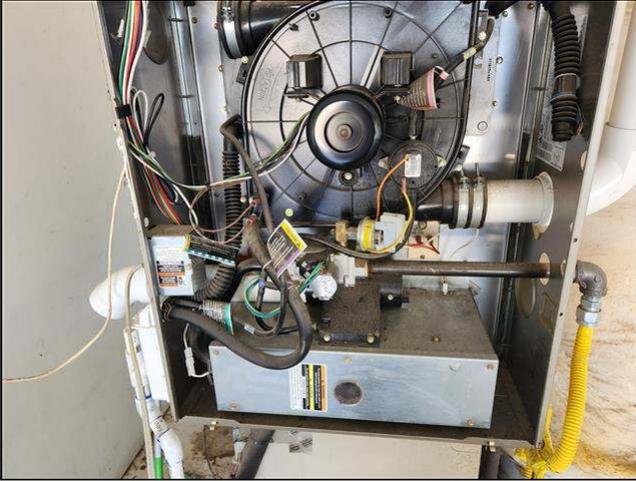
The heating equipment is NOT original (15 years). The furnace is a vertical downdraft propane gas fired forced air unit, Rated at 100,000btu's, that operated as intended with normal operating controls. The burners have an even blue flame. Manufactured in 2009 by PAYNE heating.

10.0 Item 1(Picture) forced air furnace

10.0 Item 3(Picture) forced air furnace

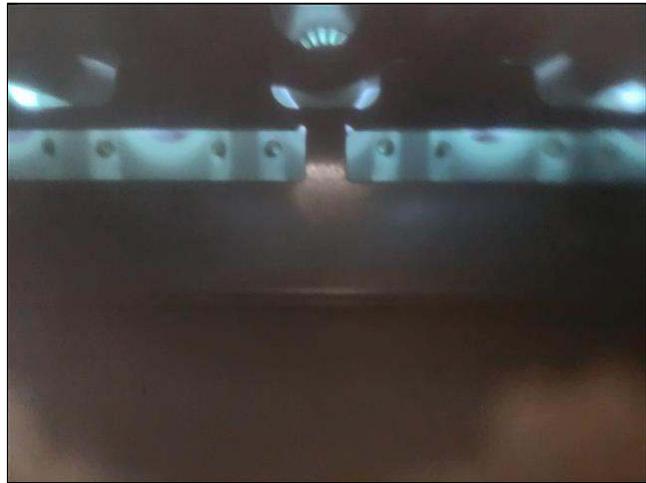
10.0 Item 2(Picture) furnace burners

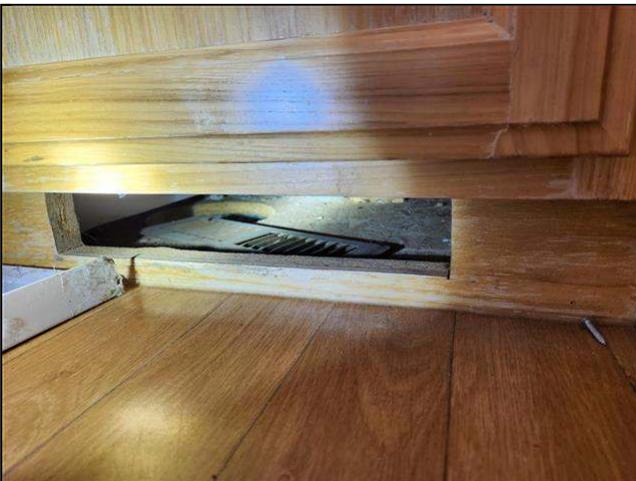
(2) NOTE: Heating register under kitchen sink cabinet needs to be resecured in place.

10.3 Item 1(Picture) heat register under kitchen sink

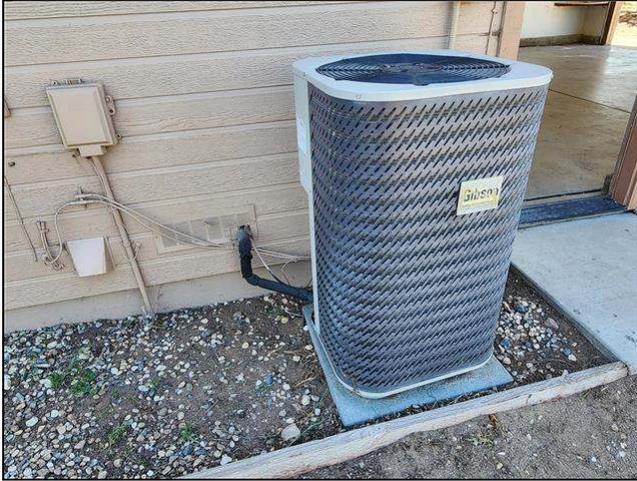
The ambient air test was performed by using thermometers on the air handler of Air conditioner to determine if the difference in temperatures of the supply and return air are between 14 degrees and 22 degrees which indicates that the unit is cooling as intended. The supply air temperature on your system read 56 degrees, and the return air temperature was 71 degrees (a/c cabinet temperature measured 71 degrees). This indicates the range in temperature drop is normal. Condensing unit operated as intended with normal operating controls, and no abnormal noises noted. Unit was manufactured in 2004 by NORDYNE.

10.5 Item 1(Picture) condensing unit

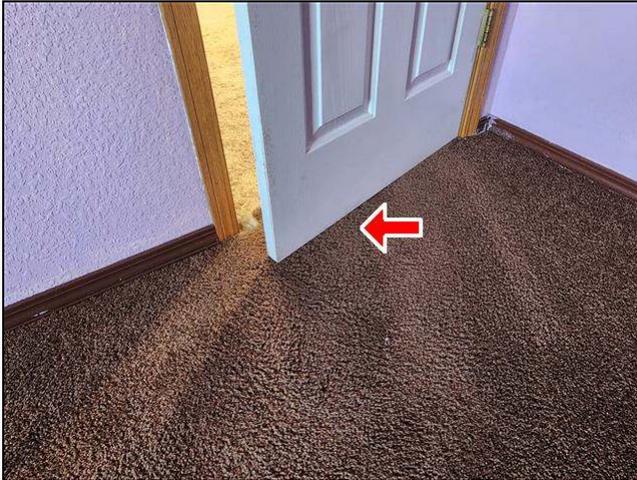
The interior bedroom door at SW guest bedroom is not undercut at the bottom to allow sufficient Return-Air for proper operation of the furnace blower. Recommend 1/2" minimum air gap beneath interior doors for proper return-air flow.

10.8 Item 1(Picture) bedroom door not under-cut

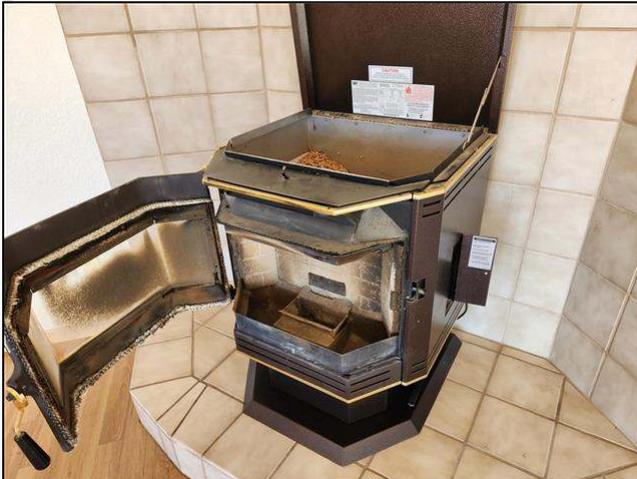
Pellet-stove appears operational, with proper clearances to combustibles. Flue pipe is fastened securely, door and seals appear serviceable. Auger feed, control and burner compartment appear in good condition. Recommend further evaluation by a qualified Fireplace Contractor as desired. Also, a couple cracked floor hearth tiles.

11.3 Item 1(Picture) family room pellet stove

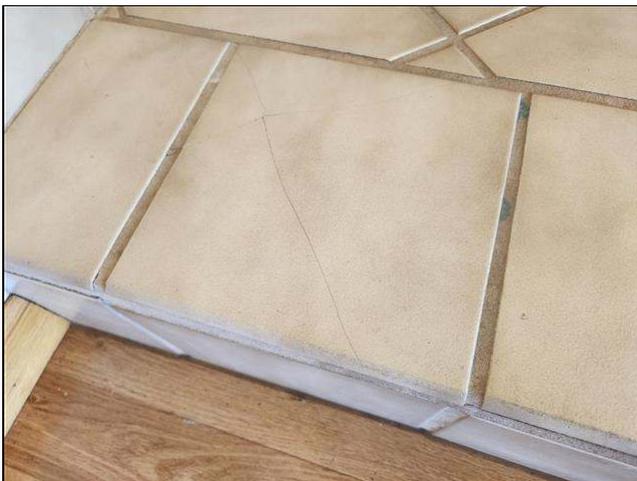
11.3 Item 3(Picture) cracked hearth tiles

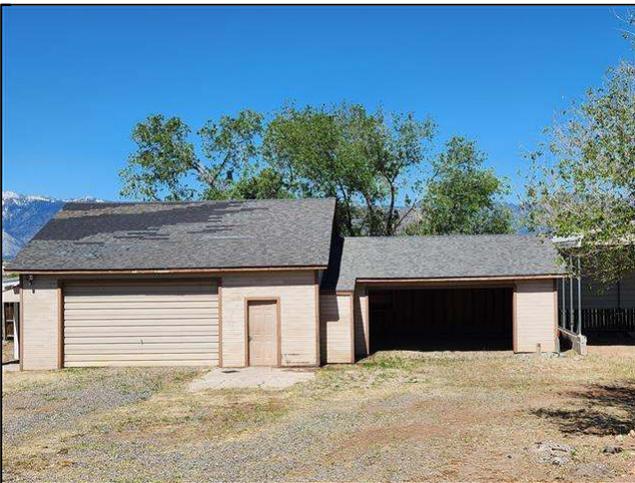
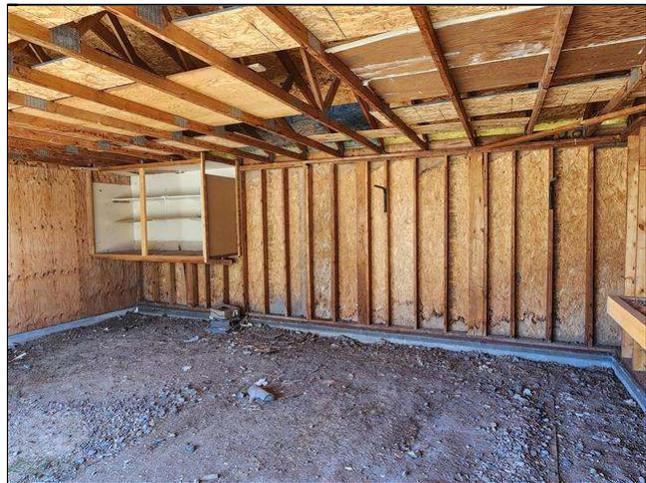
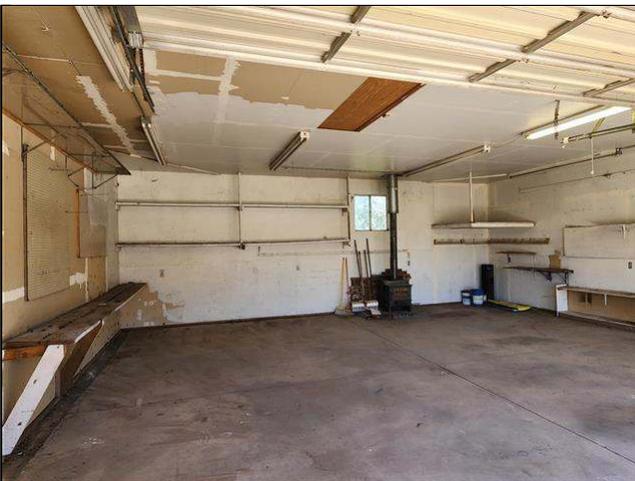
View of additional building, as seen at time of inspection.

12.0 Item 1(Picture) view of detached garage

12.0 Item 2(Picture) view of right side garage

12.0 Item 3(Picture) view of left side garage

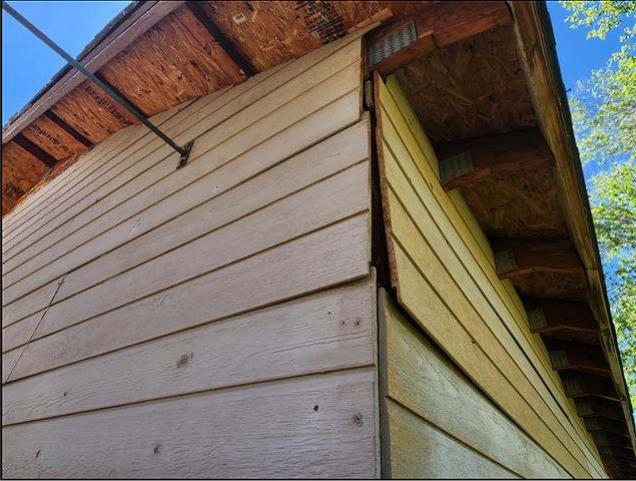
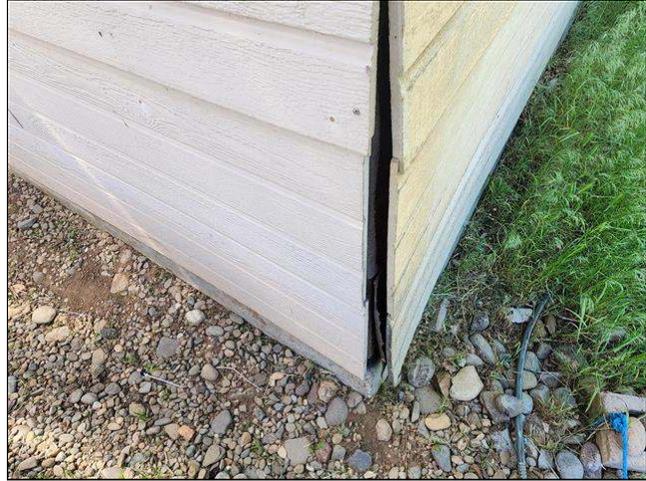
(1) Wall cladding needs to be secured to framing at the Right rear corner of building, and needs corner trim boards installed to prevent moisture intrusion into wall framing areas.

12.1 Item 1(Picture) right rear corner siding

12.1 Item 2(Picture) right rear corner siding

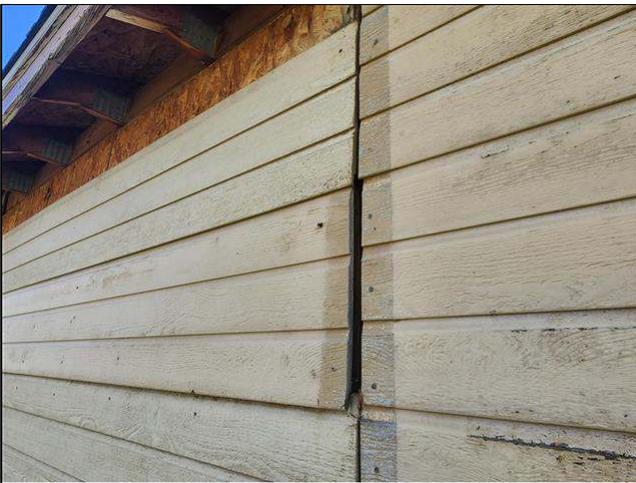
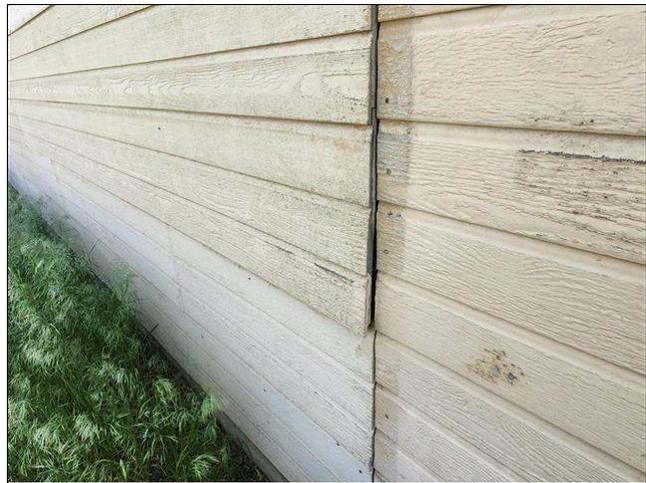
(2) Several sections of wall siding are not secured at rear wall of Right Side Garage.

12.1 Item 3(Picture) back wall siding

12.1 Item 4(Picture) back wall siding

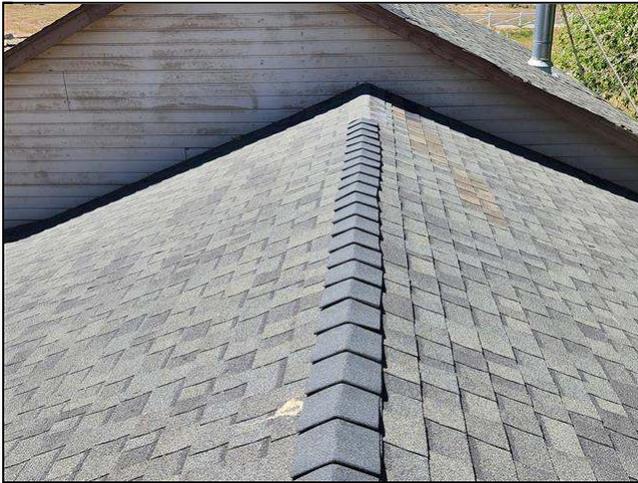
(1) Right Side Garage... The roof covering is a 30 year architectural, asphalt/fiberglass Composition shingle with much of it's life remaining. Typical loss of granules noted from shingles. No problems noted.

12.3 Item 1(Picture) right side roof covering

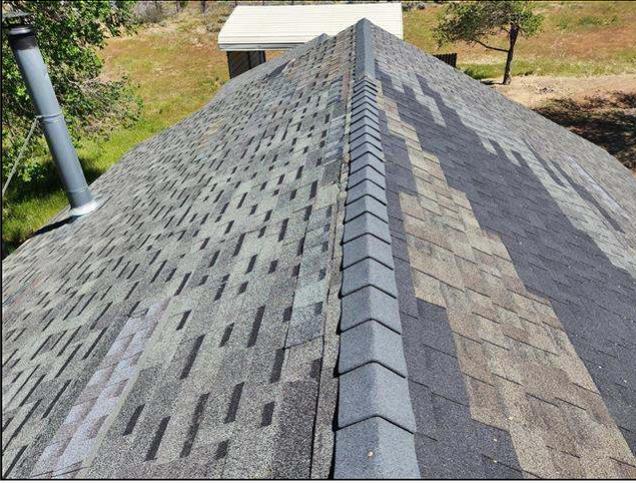
(2) Left Side Garage... The roof covering is a 30 year architectural, asphalt/fiberglass Composition shingle that appears to be at the end of it's useful life. Typical loss of granules noted from North slope shingles, however is more advanced at the South slope of roof, with exposed roof sheathing plywood noted. Recommend further evaluation of roof covering materials by a licensed Roofing Contractor.

12.3 Item 6(Picture) view of roof

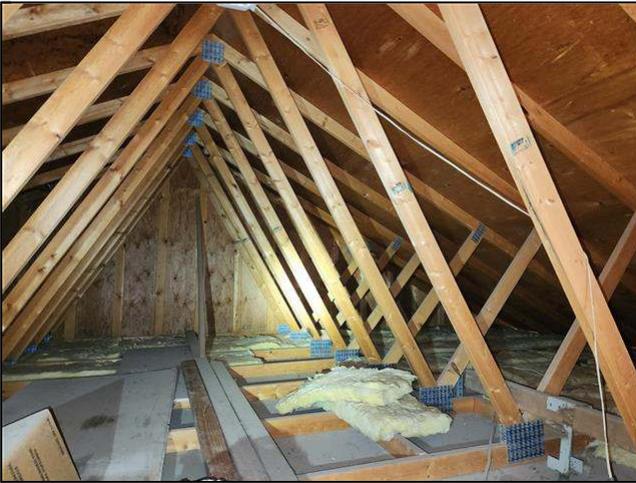
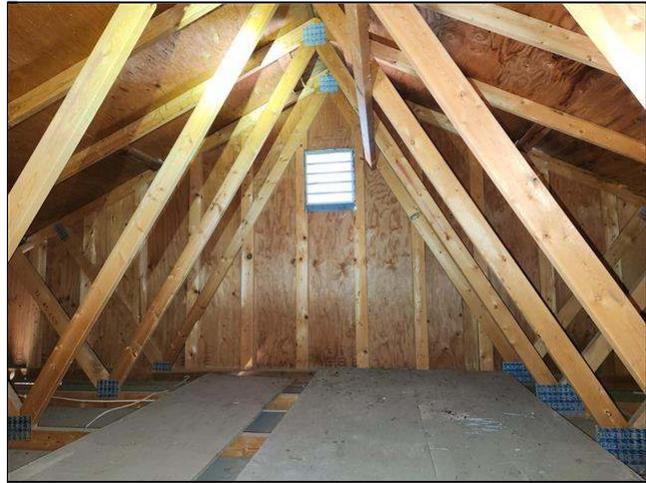
View of attic and roof structure area at time of inspection.

12.4 Item 1(Picture) view of roof structure

12.4 Item 2(Picture) view of roof structure

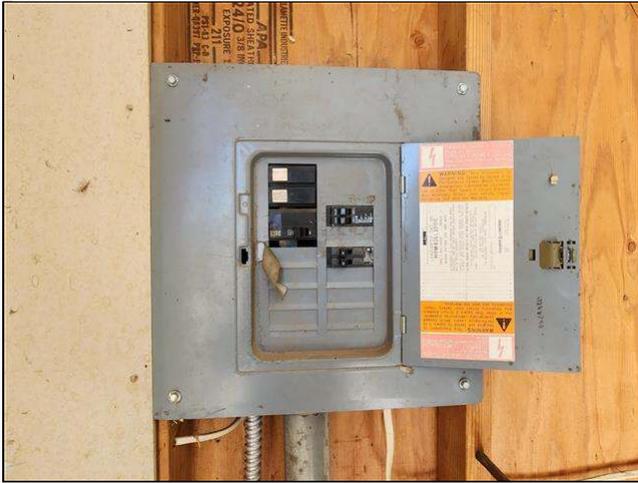
(1) Garage panel is well labeled for circuit identification, The circuit conductors appear in good condition, and are mostly properly sized for their prospective overcurrent devices. No "double tap" circuit breakers or burned connections noted. 30 amp service installed for garage.

12.6 Item 1(Picture) garage panel

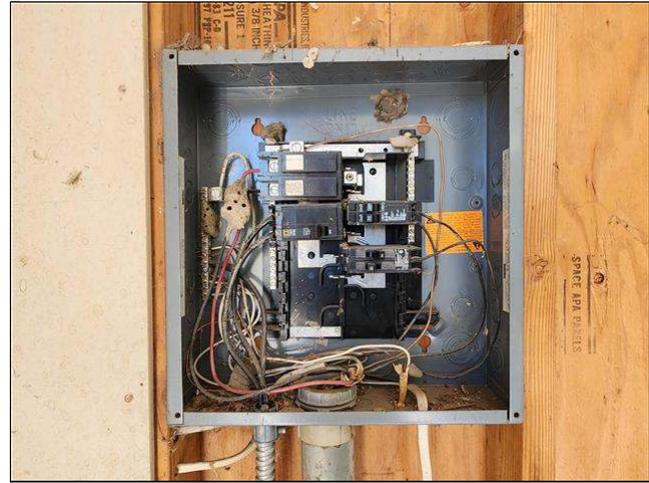
12.6 Item 2(Picture) garage panel conductors

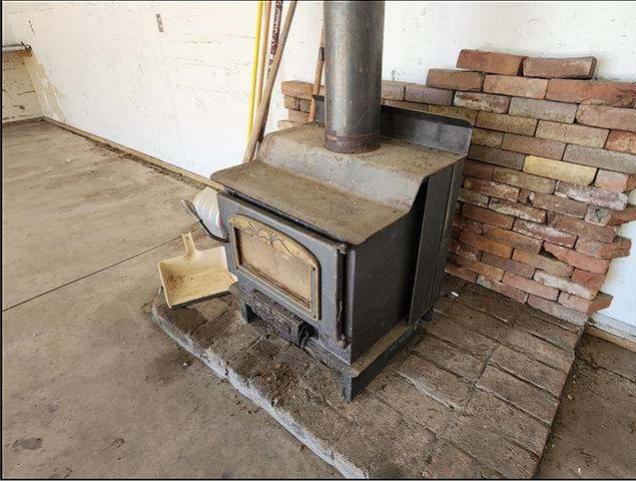
Shop/garage uses a woodstove for heating. No obvious problems noted, however recommend further evaluation of woodstove system by a licensed Fireplace Contractor as desired.

12.8 Item 1(Picture) garage woodstove

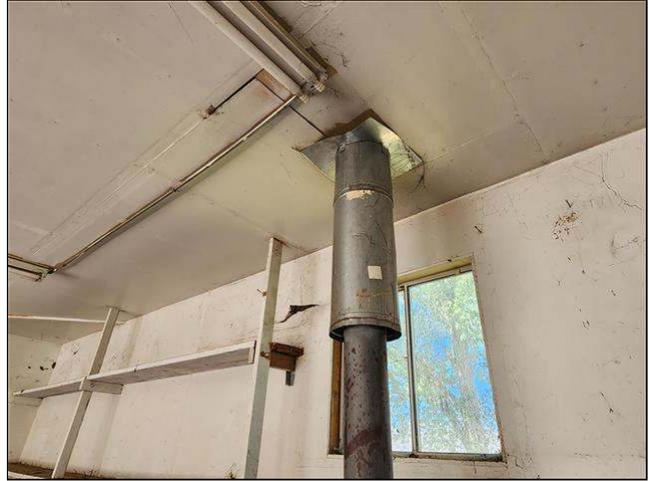
12.8 Item 2(Picture) woodstove pipe

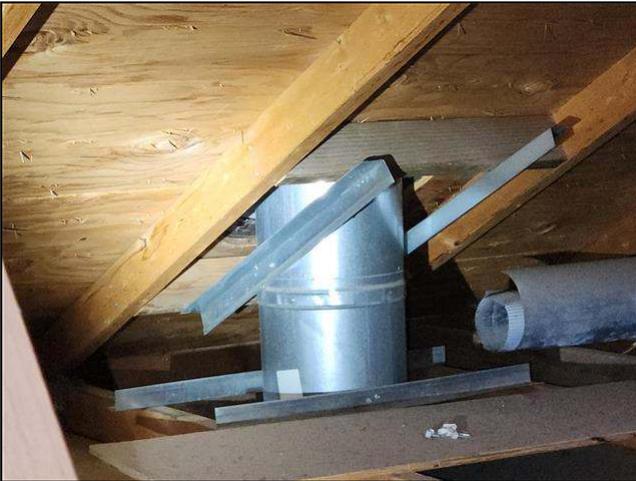
12.8 Item 3(Picture) triple wall pipe through attic/roof structure
