Inspection Report

Property Address:
2422 Hunterwood Ct.
Carson City NV 89706

Date: 3/6/2023	Time: 09:00 AM	Report ID: KIN242
Property: 2422 Hunterwood Ct. Carson City NV 89706	Customer:	Real Estate Professional: Thomas Vander Laan Coldwell Banker

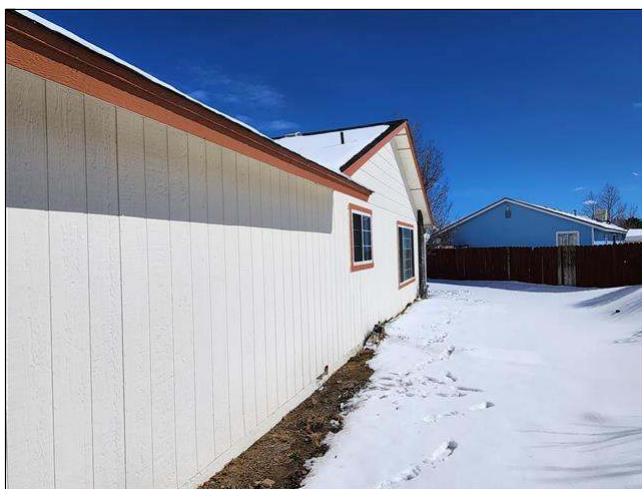
1.0 Item 1(Picture) view of exterior

Exterior, as seen at time of inspection.

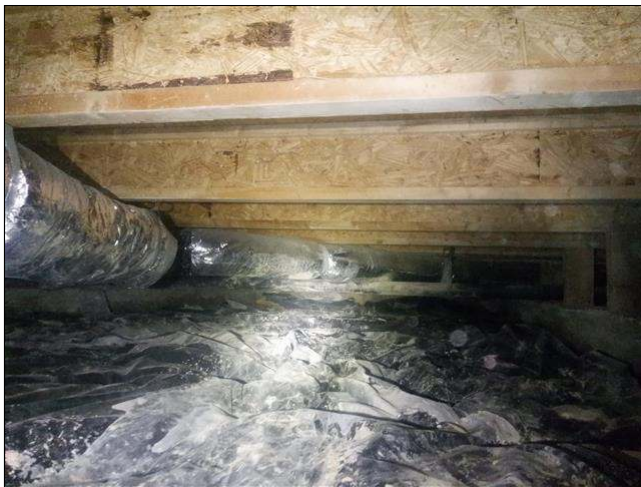
3.0 Item 1(Picture) view of crawlspace

Crawlspace, as seen at time of inspection.

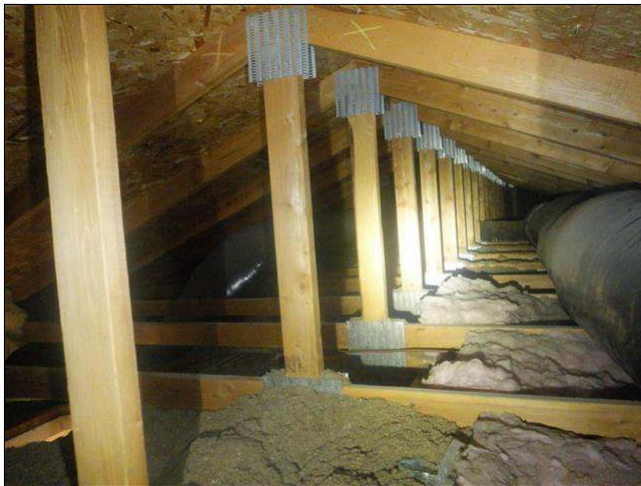
3.8 Item 1(Picture) view of attic

The Attic, as seen at time of Inspection.

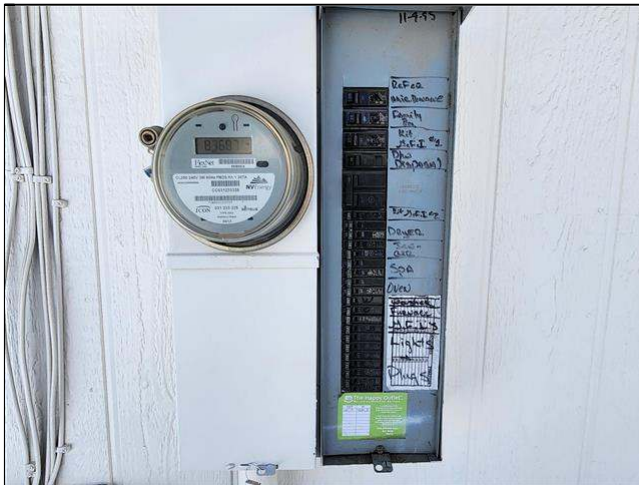
(1) The Main and Distribution Panels are well labeled for circuit identification. "Dead front" cover appears serviceable. No problems noted.

4.1 Item 1(Picture) main electrical panel

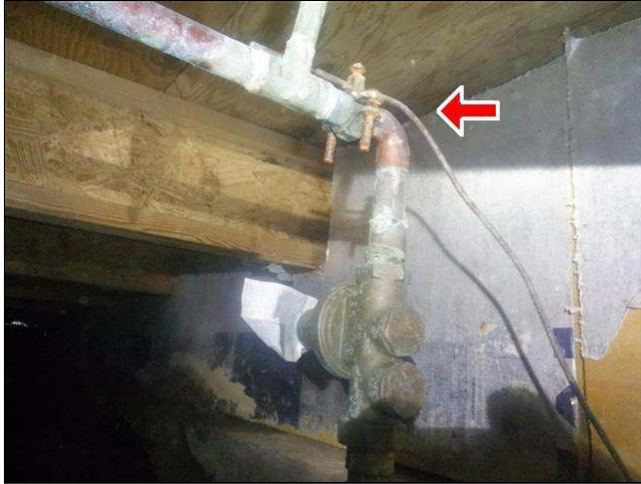
The Grounding system for the Main Service Panel is not visible due to construction materials. However, there is a Grounding wire present in the Panel, and there is a Bonding wire present at the cold water pipe, which are important for proper grounding (safety) of the home.

4.3 Item 1(Picture) bond to plumbing

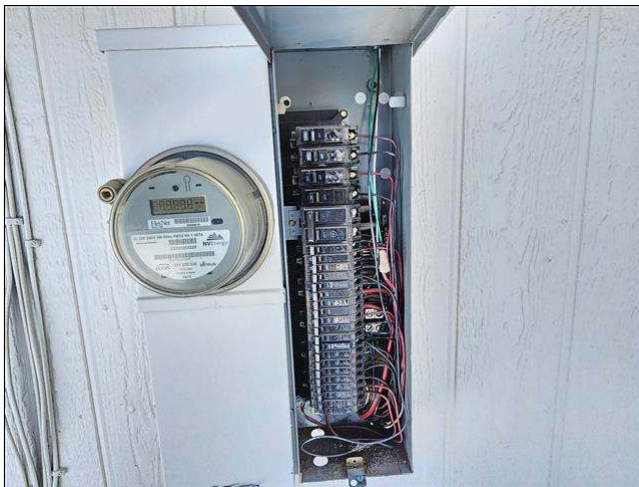
(1) The circuit conductors appear in good condition, and are properly sized for their prospective overcurrent devices. No burned connections noted.

4.4 Item 1(Picture) main panel conductors

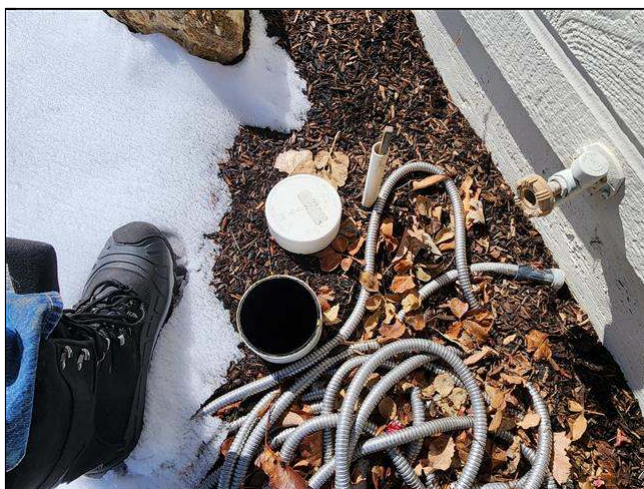
There are a couple main water shut-off locations. With the water meter at front of property (for emergencies), and at front yard to left of entry. Note: Both of these locations will require a water key tool to operate.

5.0 Item 1(Picture) main water shut-off valve location

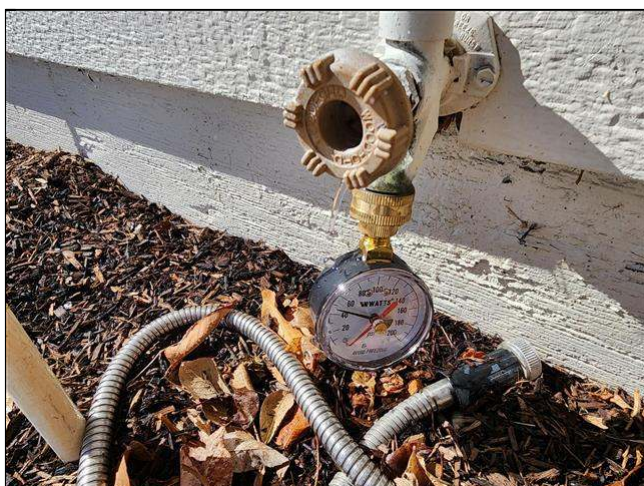
(2) The water pressure was tested at the front hose bib, pressure was 46 psi at time of inspection. .. Pressure regulator noted at the Northeast area of crawlspace, for future water pressure adjustments, if necessary.

5.2 Item 5(Picture) water pressure at front hose bib

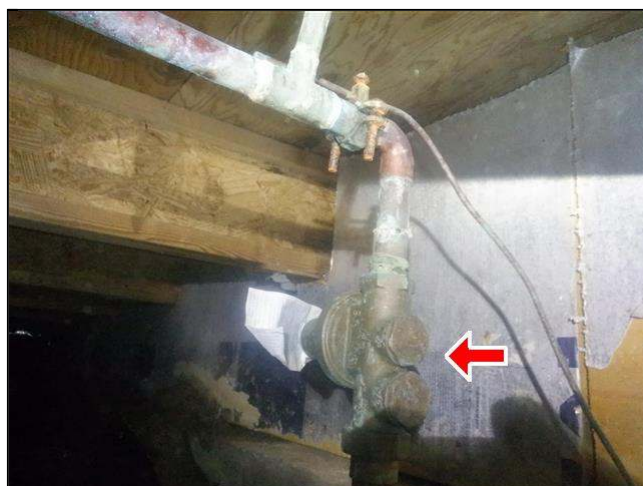
5.2 Item 6(Picture) pressure regulator in crawlspace

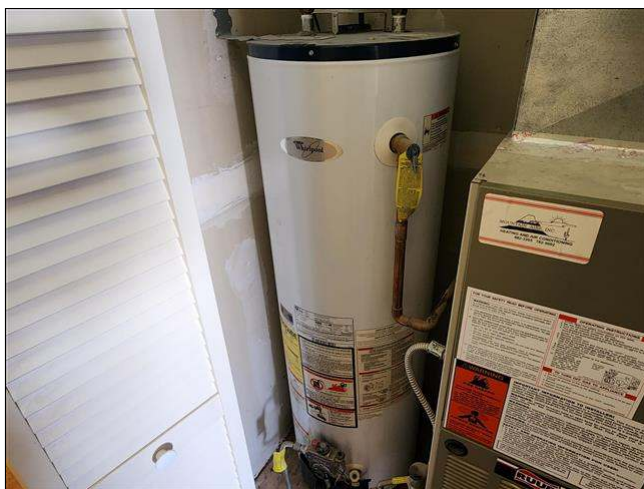
5.4 Item 1(Picture) water heater

Temperature and Pressure Relief valve is piped to the exterior of the house, or within 6 inches of the floor (for safety). Water Heater is strapped/secured, however not with approved strapping material, and is setting on a pedestal minimum of 18" above the garage floor. Drip leg is installed in the gas line, water and fuel shut-off valves are present. Water heater operated as intended with no abnormal noises or leaks noted. No problems noted at time of inspection... Manufactured in 2007 by US Craftmaster.

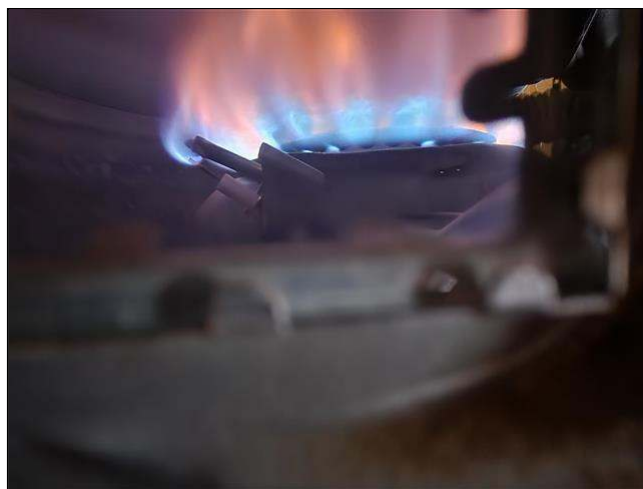
5.4 Item 2(Picture) water heater burner compartment

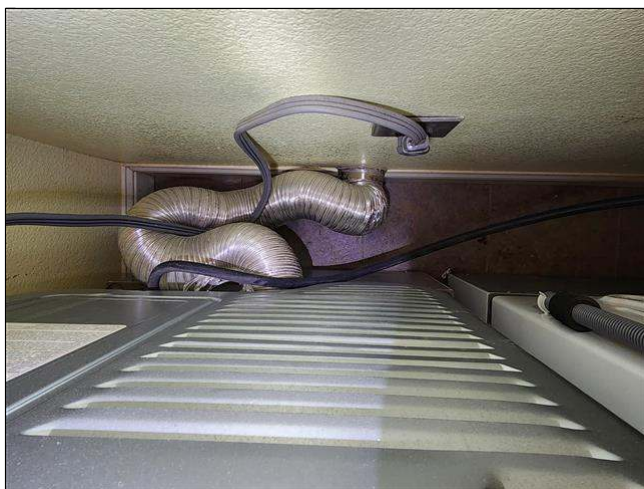
5.6 Item 1(Picture) laundry hook-ups

Washer and dryer hook-ups were inspected, with no problems noted. Dryer is electric powered with rigid metal venting installed in the crawlspace. Washer drain is 2" diameter, Hot and Cold hook-ups with no problems noted.

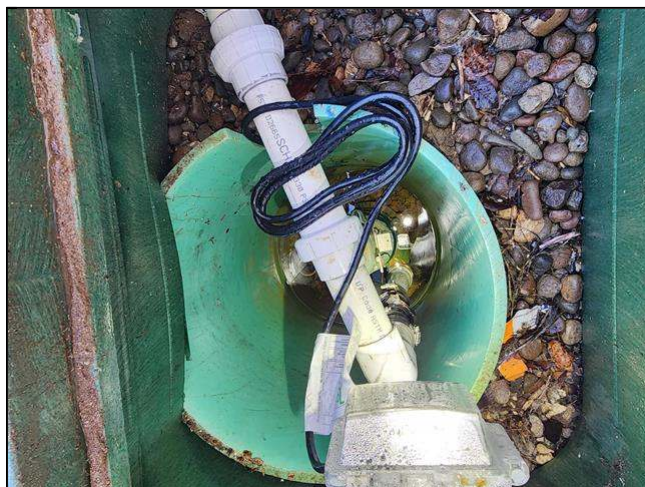
Sump Pump was noted at the North side exterior of the home, and functions as intended when manually lifting the float. NOTE: There is water pumping back into the sump pump well when pump is operating, causing the pump to operate for longer periods of time. Recommend further evaluation of system by a qualified person.

5.12 Item 1(Picture) north exterior sump pump

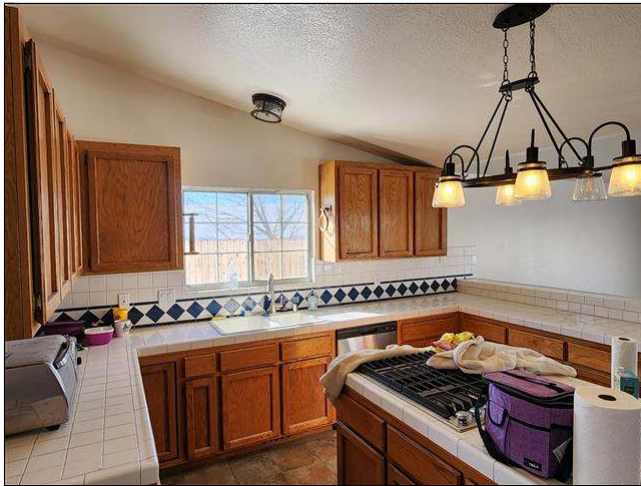
6.0 Item 1(Picture) view of kitchen

Kitchen, as seen at time of inspection.

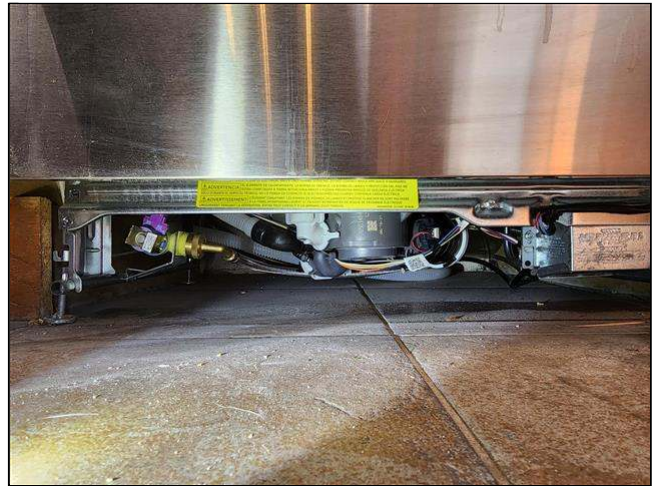
6.0 Item 2(Picture) dishwasher hook-ups

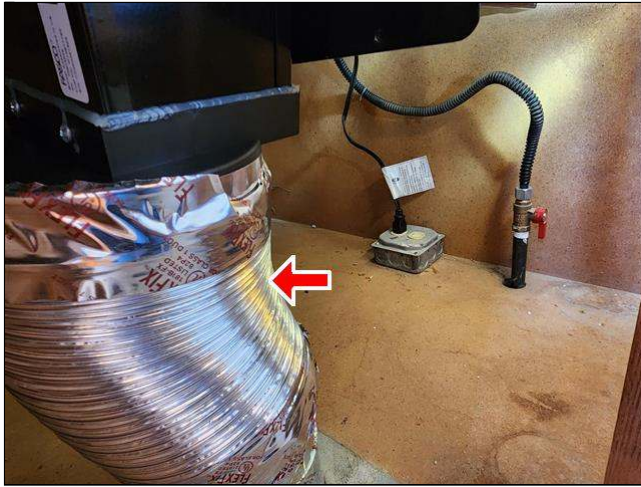
The range fan is built into the range cook top, and is a downdraft, vented through the floor. Operated as intended.

6.3 Item 1(Picture) downdraft built into range

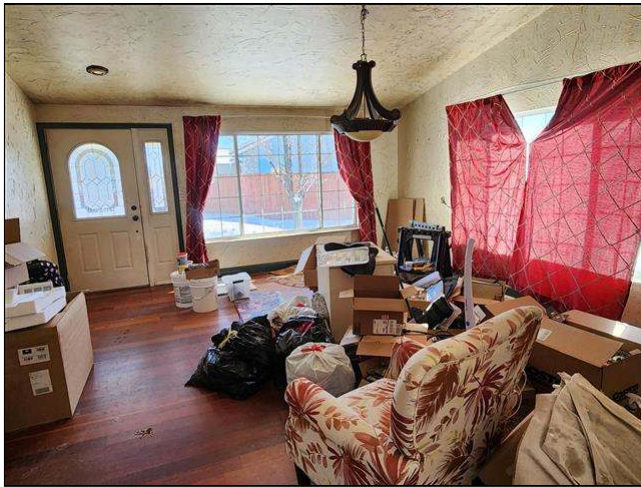
7.0 Item 1(Picture) view of interior

Interior, as seen at time of inspection.

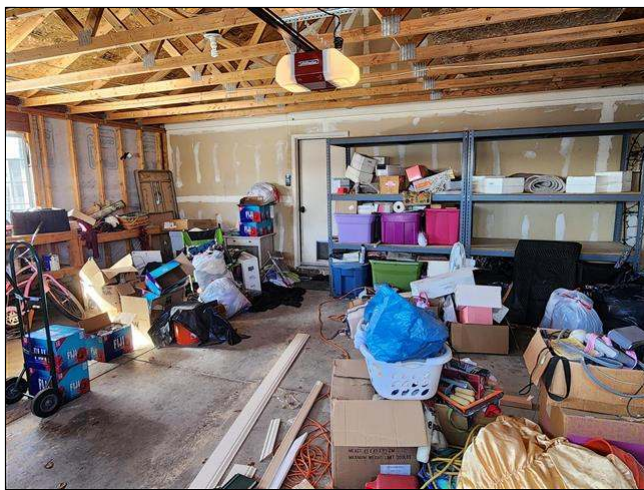
8.0 Item 1(Picture) view of garage

Garage, as seen at time of inspection.

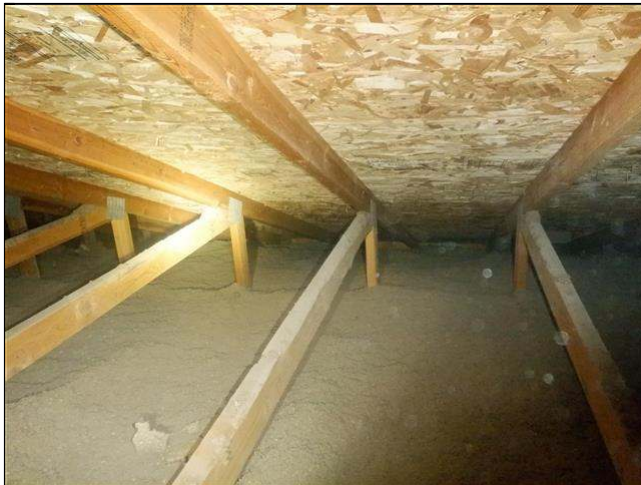
Cellulose insulation (recycled newspaper) is about eight inches thick or just under 30 R Value. (3.5 per inch) No problem noted.

9.0 Item 1(Picture) view of attic insulation

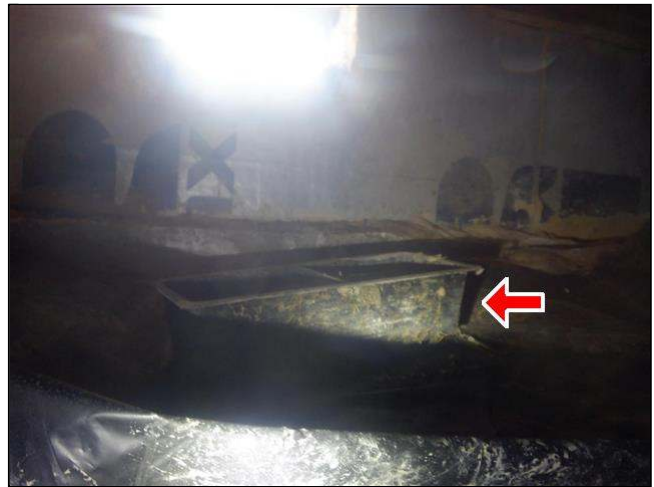
9.3 Item 2(Picture) foundation vent left side of home

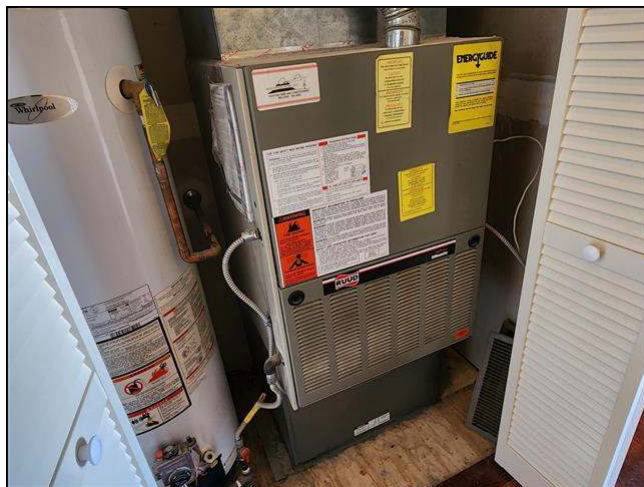
(1) The heating equipment is original (29 years). The furnace is a vertical downdraft natural gas fired forced air unit, Rated at 125,000btu's, that operated as intended with normal operating controls. The burners have an even blue flame. Manufactured in 1992/93 by RUUD Heating.

10.0 Item 1(Picture) forced air furnace

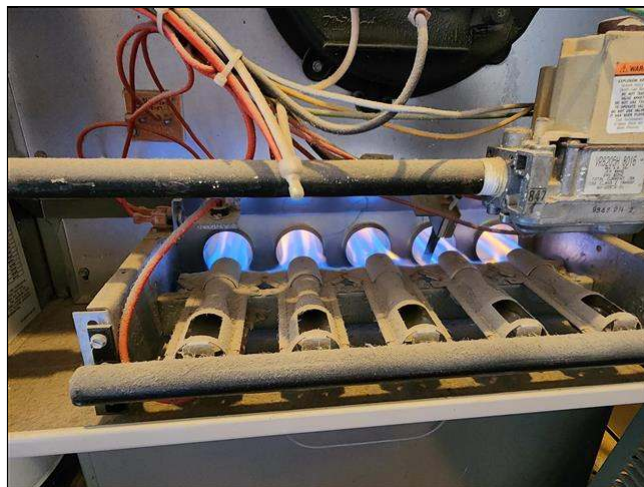
10.0 Item 2(Picture) furnace burners

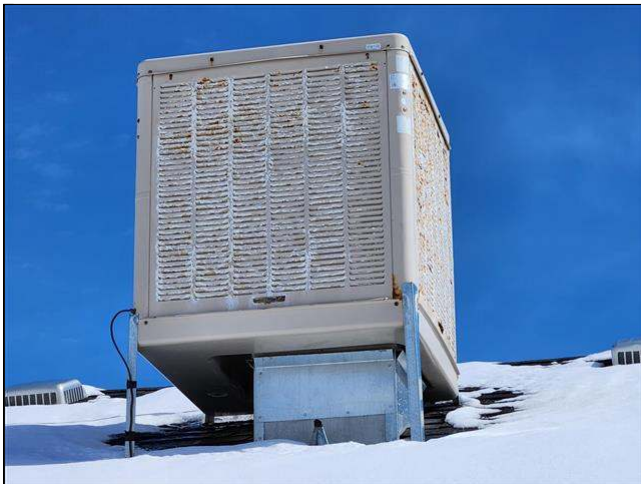
The home uses an Evaporative Cooler located on the roof. Cooler has been winterized, and could not be checked for proper operation.

10.5 Item 1(Picture) evaporative cooler on roof
