Home Inspection Report

PROPERTY INSPECTED:
1920 Plateau Road
Billings, MT 59105

Date of Inspection: 10/02/2024

Inspection No. 45957-1-1153

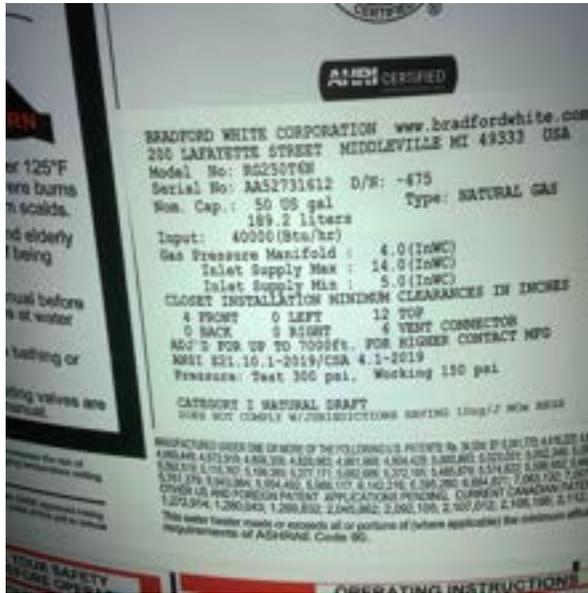
Data Plate:

10.4.4 Age: New this year
