Inspection Report

Property Address:
1844 Alpine St.
Carson City NV 89703

Clear Choice Home Inspection Services

Date: 6/14/2024	Time: 09:00 AM	Report ID: DAS184
Property: 1844 Alpine St. Carson City NV 89703	Customer: Barrett Dasenbrock	Real Estate Professional: Thomas Vander Laan Coldwell Banker

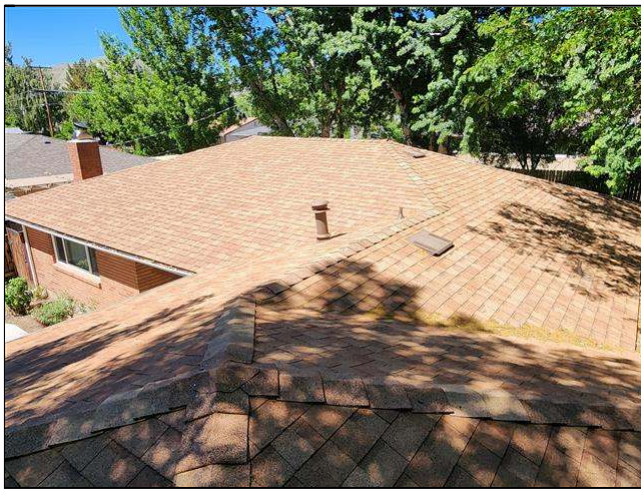
2.0 Item 1(Picture) view of roof

The roof, as seen at time of inspection. Inspected by walking the roof.

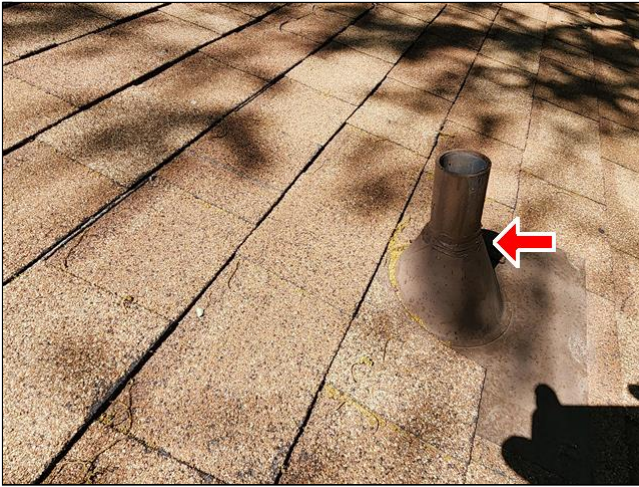
Plumbing and furnace vent pipes are sealed well against flashings to prevent moisture intrusion into attic framing areas.

2.3 Item 1(Picture) plumbing vent pipes sealed well

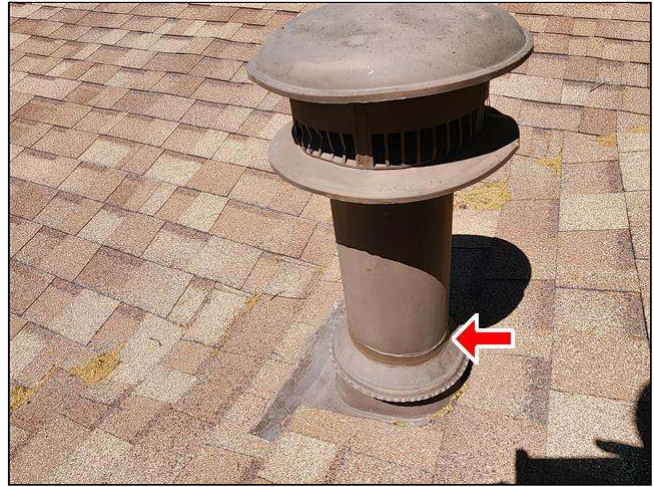
2.3 Item 2(Picture) flue pipes well sealed

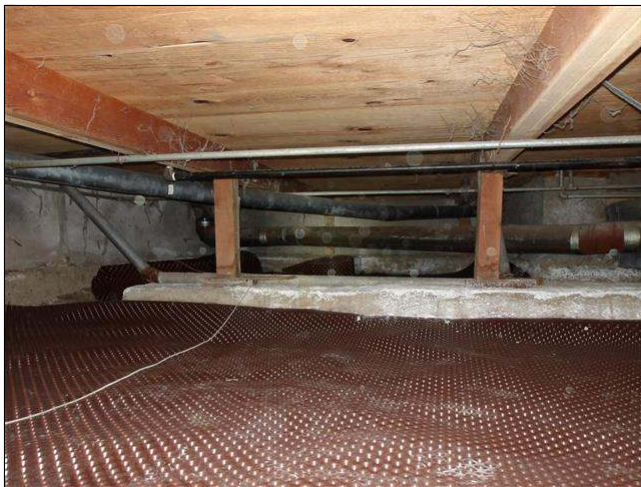
3.0 Item 1(Picture) view of crawlspace

Crawlspace, as seen at time of inspection.

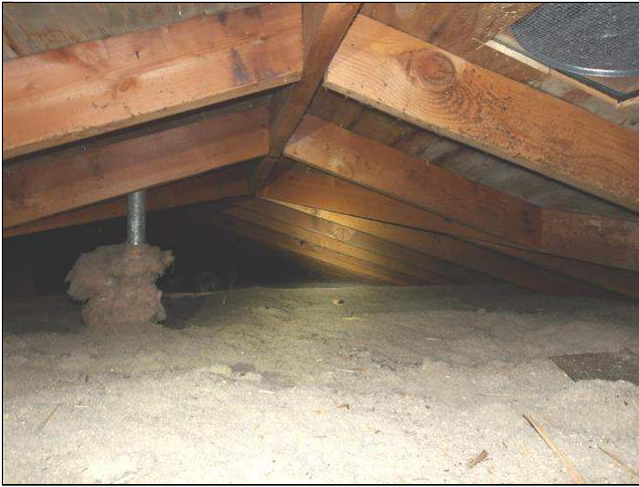
3.8 Item 1(Picture) view of attic

The Attic, as seen at time of Inspection.

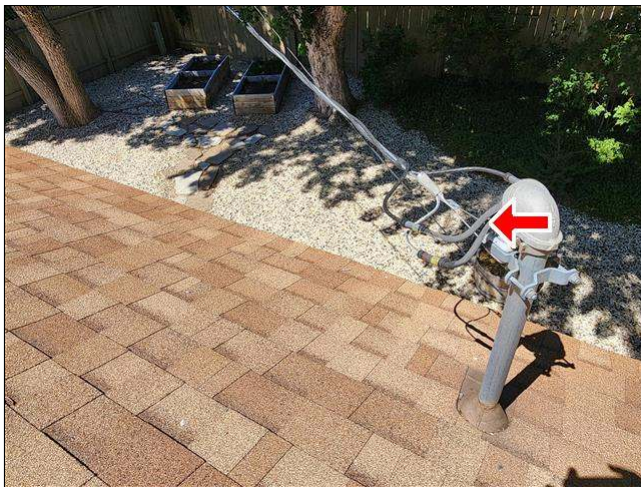
The Electrical Service Entrance is Overhead. Weather Bulkhead and connections appear in Serviceable condition. Conductors have proper clearance from ground, with "drip loop" noted.

4.0 Item 1(Picture) proper drip loop

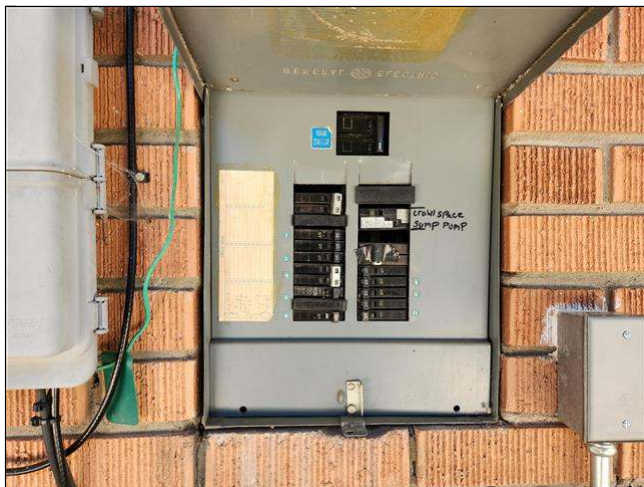
The Main and Distribution Panels are well labeled for circuit identification. "Dead front" cover appears serviceable. No problems noted.

4.1 Item 1(Picture) main electrical panel

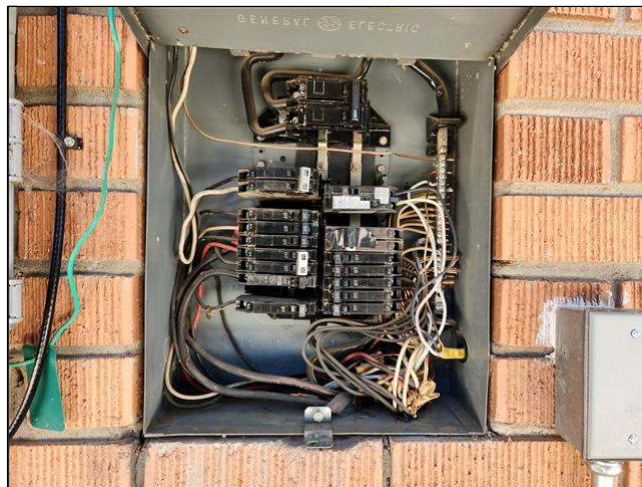
4.1 Item 2(Picture) main panel conductors

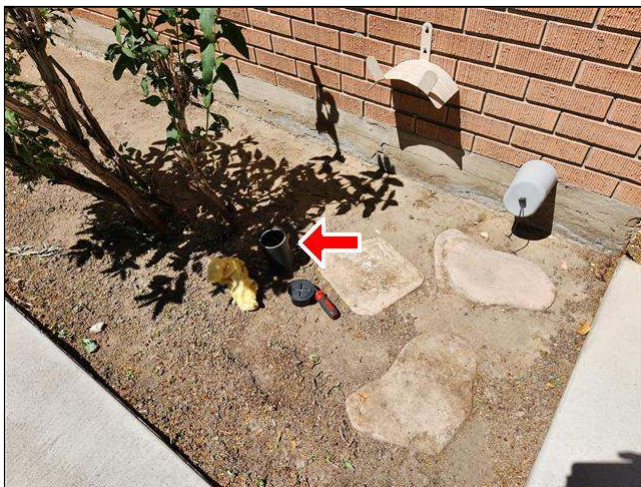
There are a couple main water shut-off locations. With the water meter at front of property (for emergencies), and at front yard to left of entry. Note: Both of these locations will require a water key tool to operate.

5.0 Item 1(Picture) main water shut-off valve location

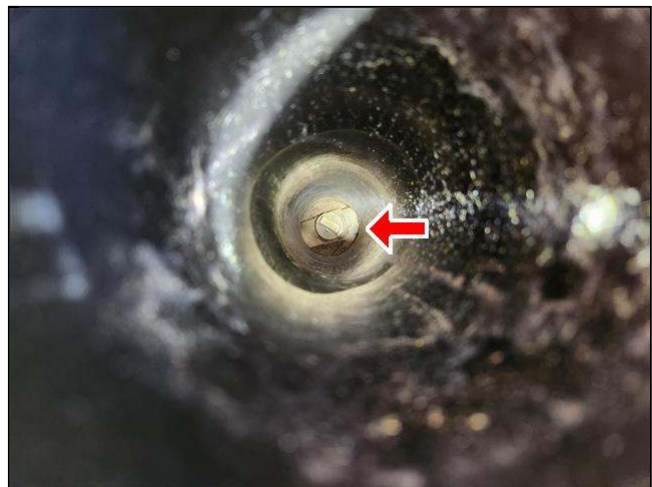
5.0 Item 2(Picture) main water shut-off valve

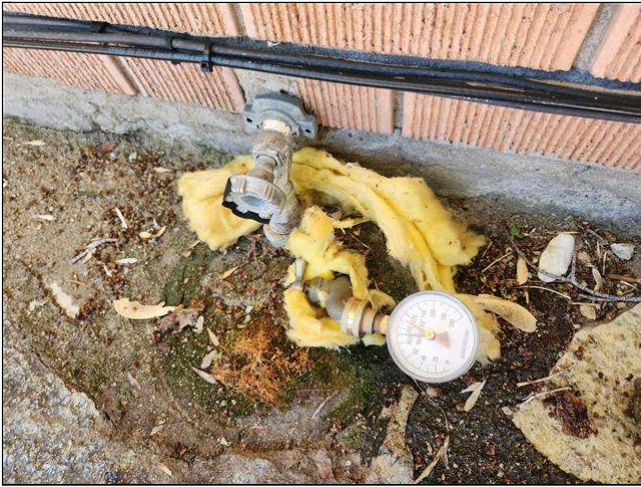
The water pressure was tested at the rear hose bib, pressure was 89 psi at time of inspection.

5.2 Item 1(Picture) water pressure at rear hose bib

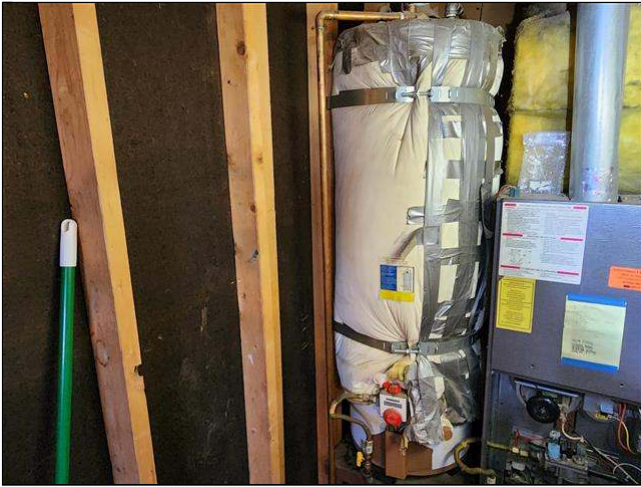
Temperature and Pressure Relief valve is piped to the exterior of the house, or within 6 inches of the floor (for safety). Water Heater is strapped with approved strapping material, and is setting on a pedestal minimum of 18" above the garage floor. Water and fuel shut-off valves are present. Water heater operated as intended with no abnormal noises or leaks noted. No problems noted at time of inspection... Manufacturer, Capacity and Age of the water heater are not visible due to being wrapped with an insulation blanket.

5.4 Item 1(Picture) water heater

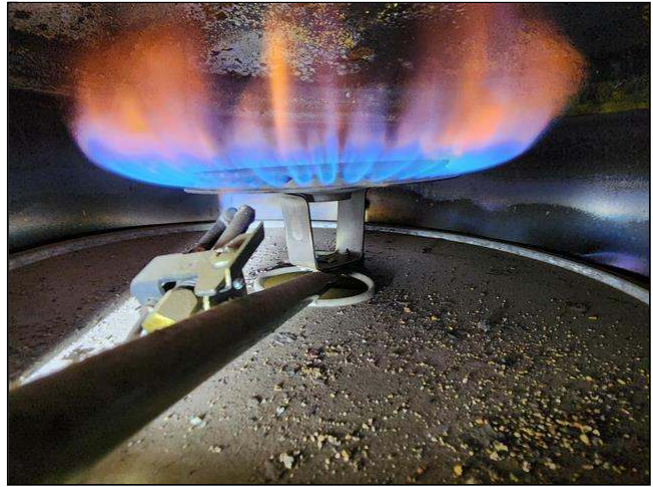
5.4 Item 2(Picture) water heater burner compartment

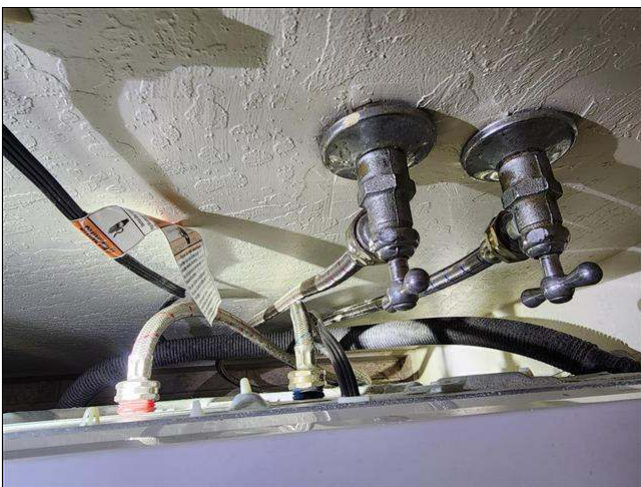
Washer and dryer hook-ups were inspected, with no problems noted. Dryer is electric powered with flexible aluminum venting installed. Washer drain is 1 1/2" diameter, Hot and Cold hook-ups with no problems noted.

5.6 Item 1(Picture) laundry hook-ups

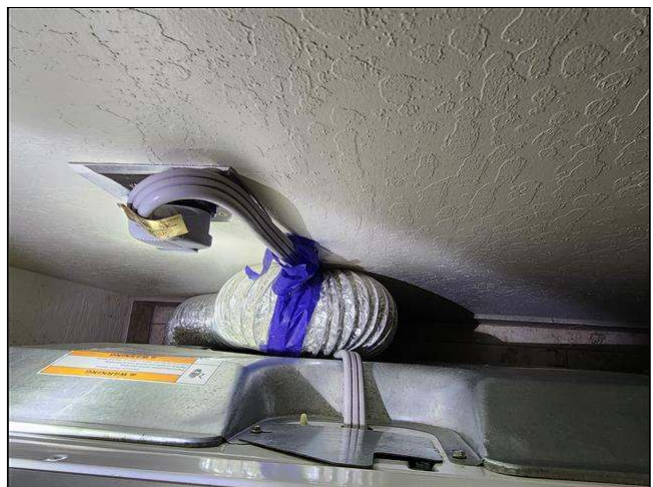
5.6 Item 2(Picture) laundry hook-ups

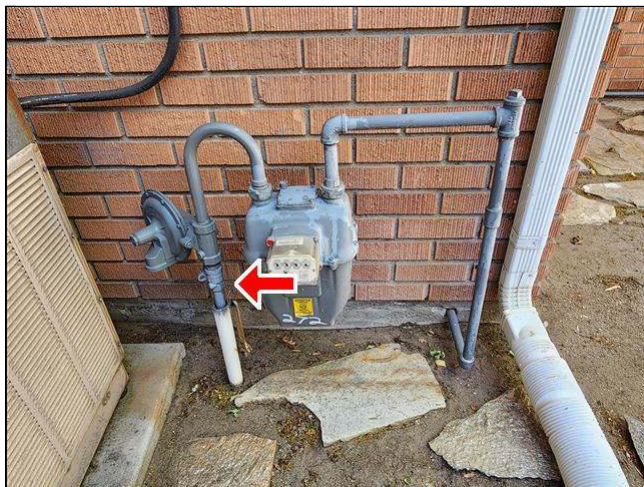
Located at the North side of the house with the gas meter. No problems noted.

5.11 Item 1(Picture) main fuel shut-off valve

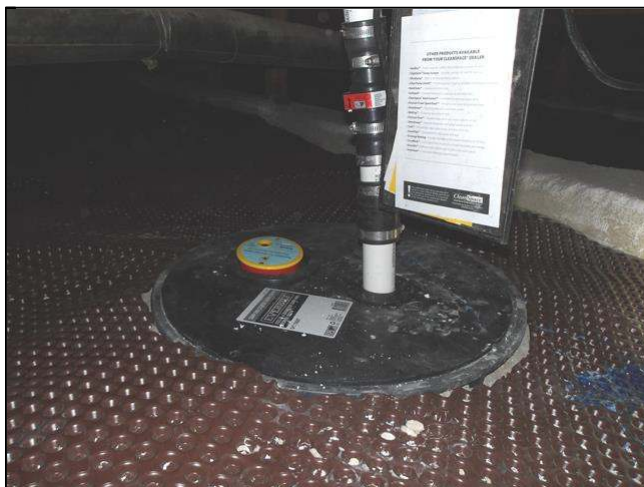
Sump Pump system was noted at the Southwest corner area of crawlspace. Pump was checked for proper operation by manually lifting the float, with no problems noted. Pump drains to the exterior of the building.

5.12 Item 1(Picture) sump pump in crawlspace area

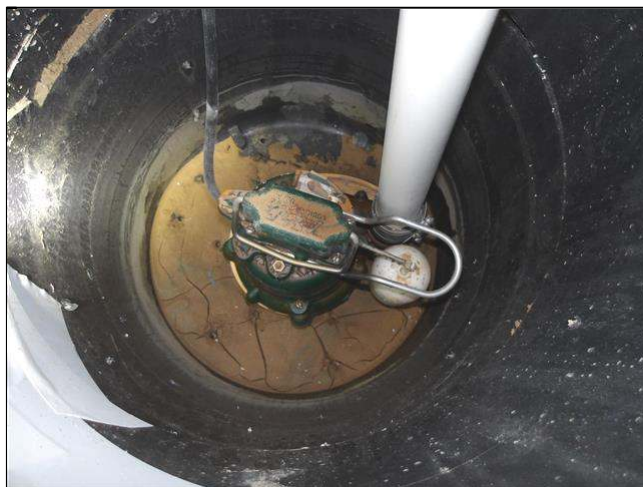
5.12 Item 2(Picture) checking operation manually

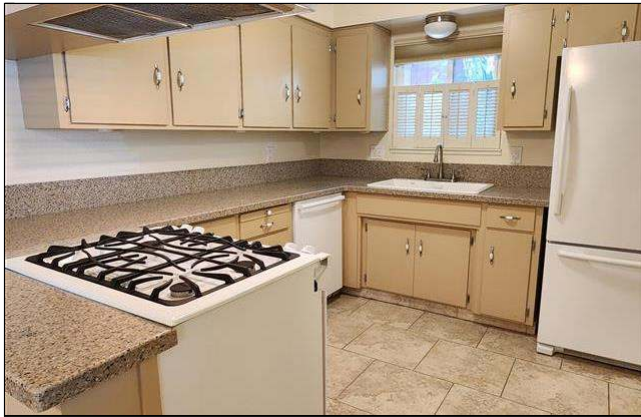
6.0 Item 1(Picture) view of kitchen

Kitchen, as seen at time of inspection.

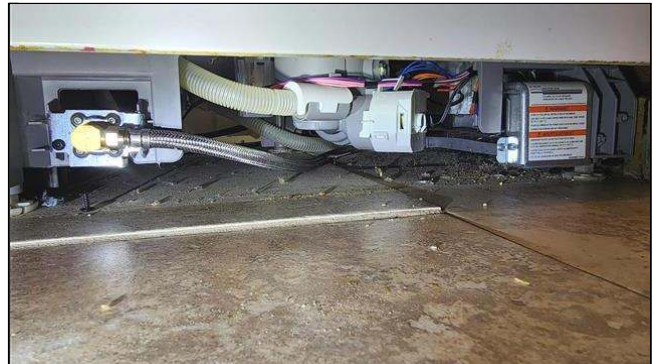
6.0 Item 2(Picture) dishwasher hook-ups

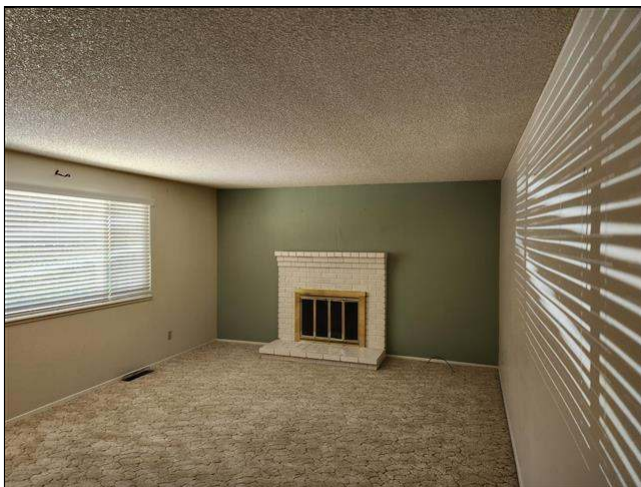
7.0 Item 1(Picture) view of interior

Interior, as seen at time of inspection.

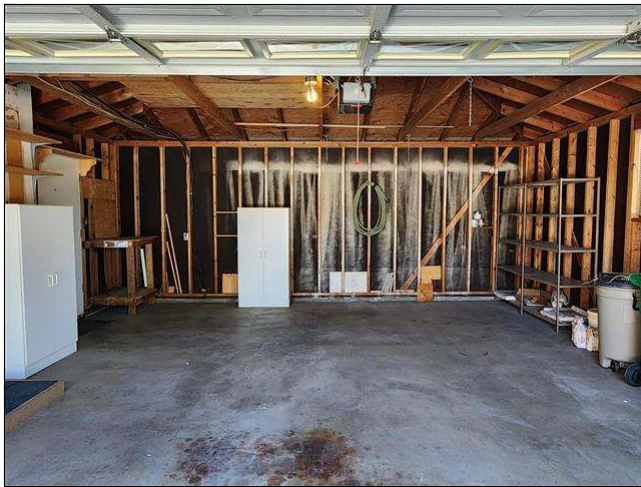
8.0 Item 1(Picture) view of garage

Garage, as seen at time of inspection.

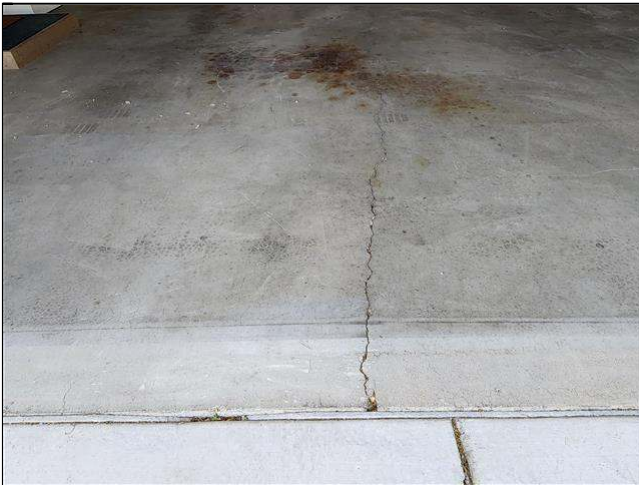
The Garage floors are poured concrete in serviceable condition, with normal settlement cracks.

8.4 Item 1(Picture) normal settlement cracks

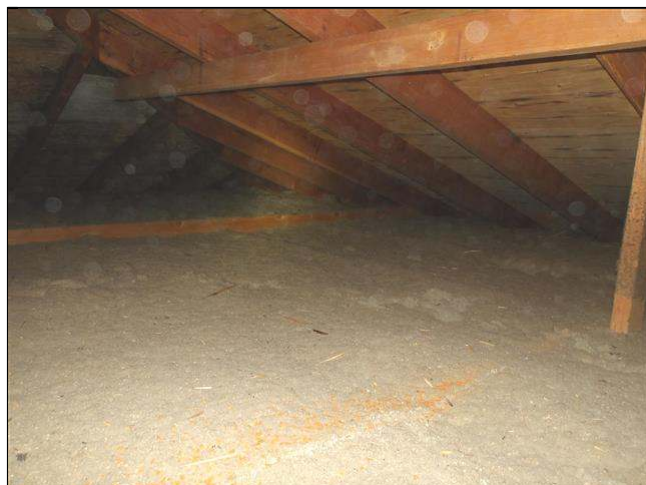
Attic insulation is Fiberglass Batt type approximately 3 inches thick (R13), with approximately 4 inches of Loose-fill Cellulose installed on top, giving the home's ceiling insulation about R30 value. No problems noted.

9.0 Item 1(Picture) view of attic insulation

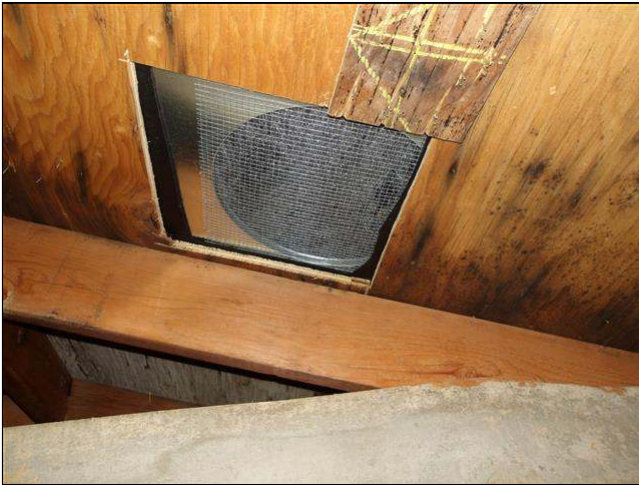
9.3 Item 3(Picture) roof vents recently installed

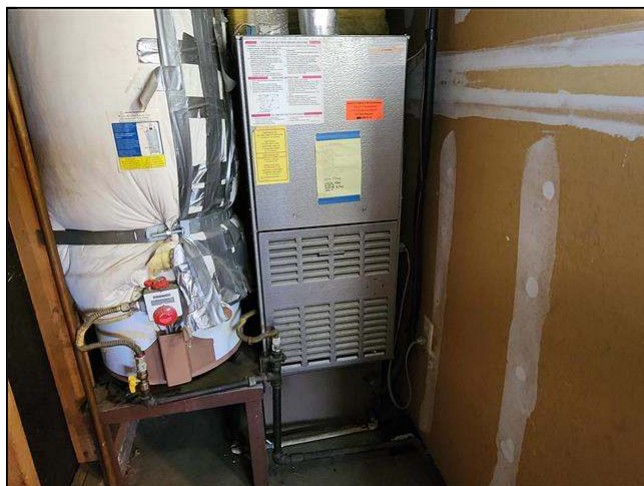
The heating equipment is NOT original (31 years). The furnace is a vertical downdraft natural gas fired forced air unit, Rated at 92,000btu's, that operated as intended with normal operating controls. The burners have an even blue flame. Manufactured in 1993 by BDP heating.

10.0 Item 1(Picture) forced air furnace

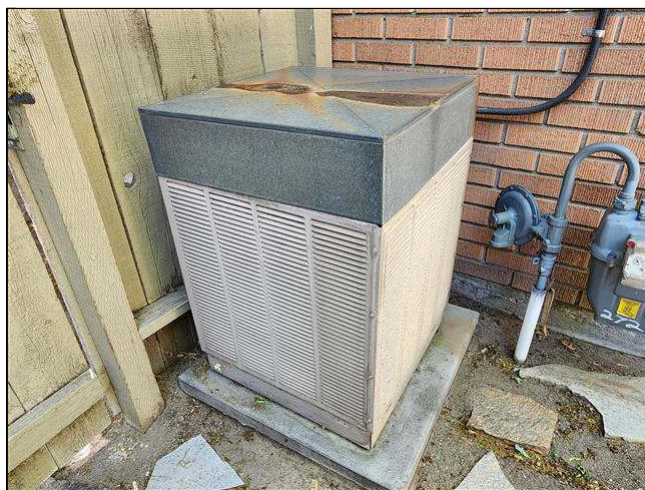
10.5 Item 1(Picture) condensing unit

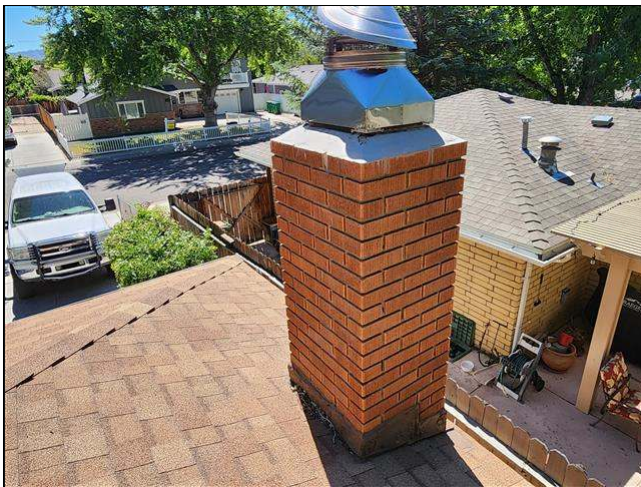
Chimney is brick and appears to be in good overall condition, with proper base flashings installed, and recent concrete chimney cap resurfacing. NOTE: touch-up is needed at a few locations at the chimney cap.

11.1 Item 1(Picture) brick chimney

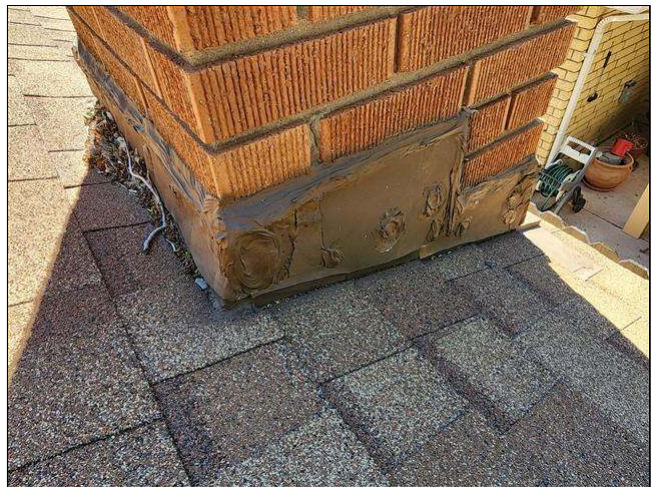
11.1 Item 2(Picture) proper flashings

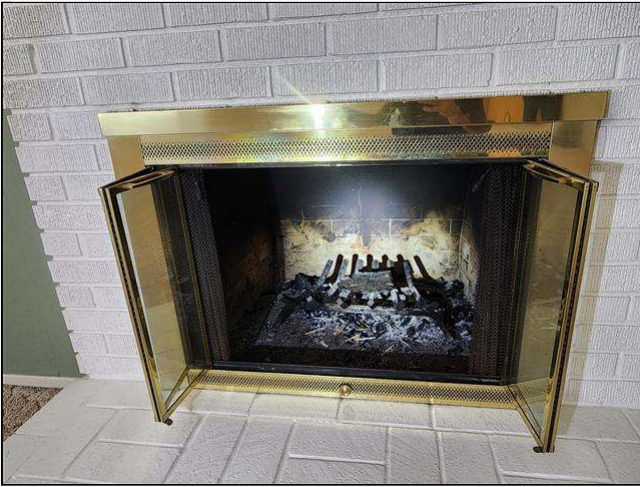
Fireplace appears in good operating condition. Damper operates freely, firebrick appears in good condition, with minimal cracks. Note: Recommend consulting a licensed fireplace contractor for a more thorough examination of the fireplace, chimney and flue pipe systems, and code compliance, as needed.

11.3 Item 1(Picture) living room fireplace

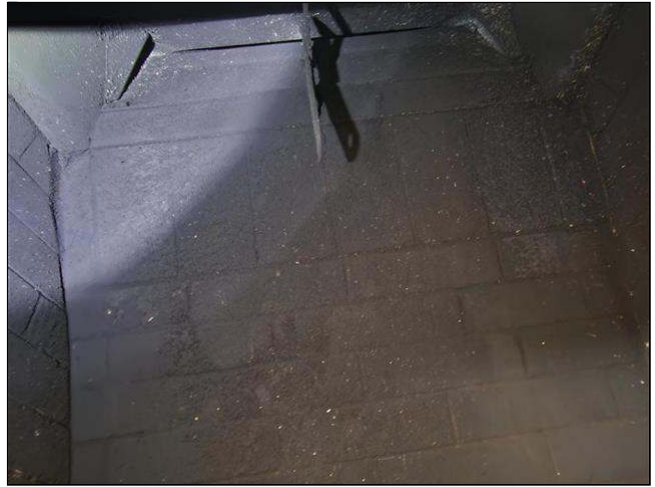
11.3 Item 2(Picture) fireplace damper
