Inspection Report

Property Address:
3115 Imperial Way
Carson City NV 89706

Clear Choice Home Inspection Services

Date: 6/1/2023	Time: 09:00 AM	Report ID: BRO311
Property: 3115 Imperial Way Carson City NV 89706	Customer:	Real Estate Professional: Thomas Vander Laan Coldwell Banker

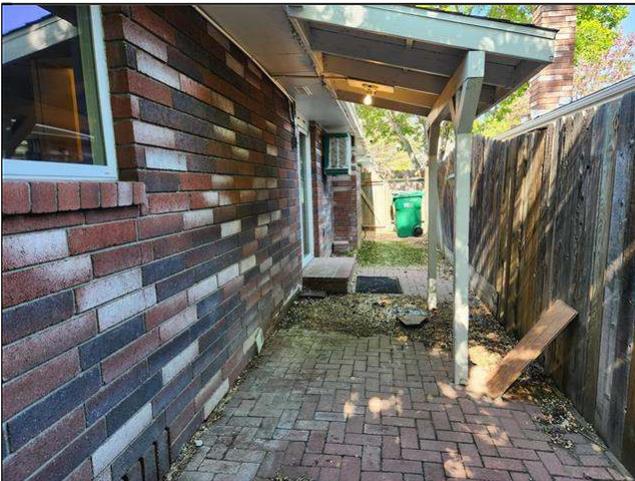
1.0 Item 1(Picture) view of north exterior

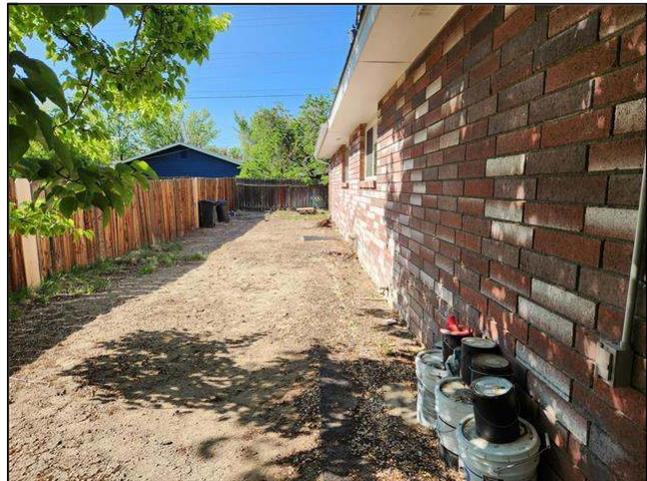
1.0 Item 2(Picture) view of east exterior

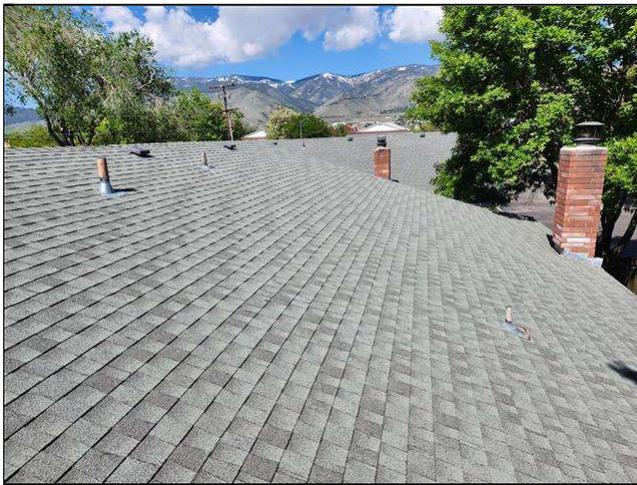
2.0 Item 1(Picture) view of roof

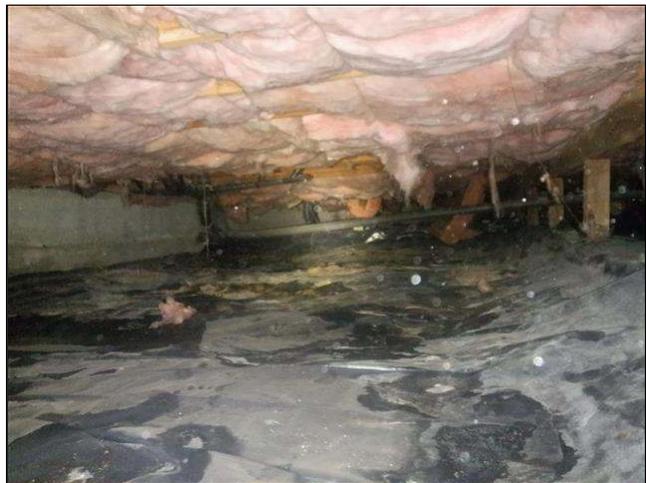
3.0 Item 2(Picture) view of crawlspace

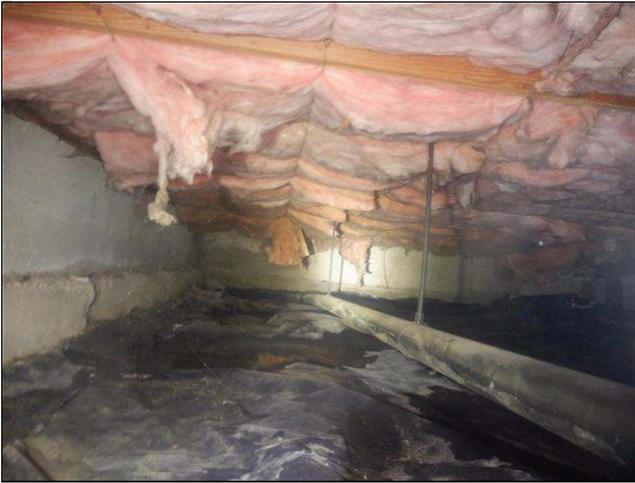
3.0 Item 3(Picture) view of crawlspace

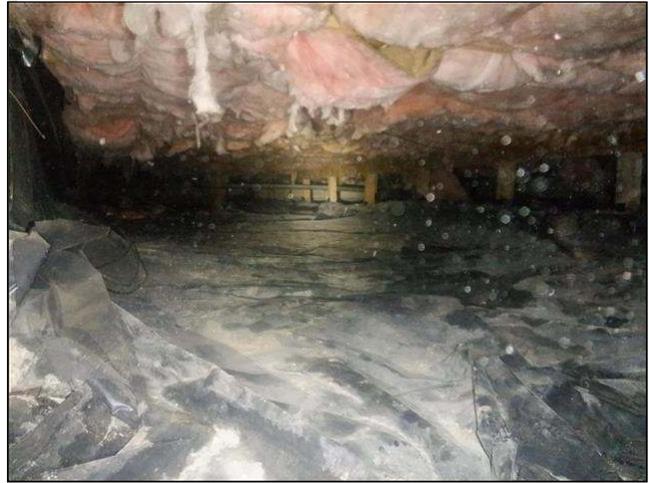
3.0 Item 4(Picture) view of crawlspace

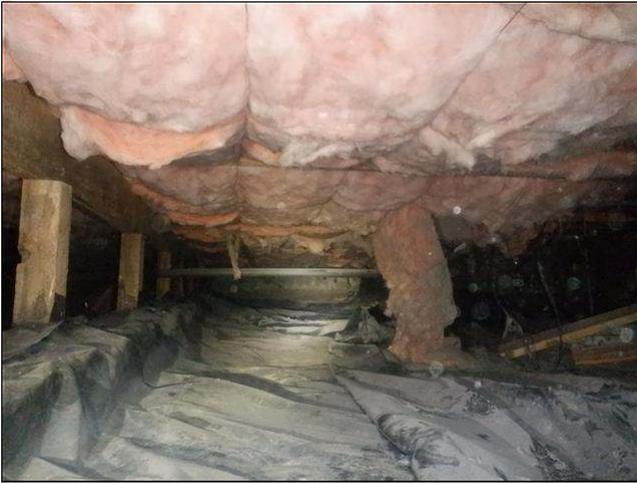
(1) NOTE: Subfloor area is NOT fully visually accessible for inspection, due to installation of floor insulation between the floor joists. Moisture Vulnerable areas such as adjacent to plumbing drain pipes, and exterior subfloor edges, were viewed by pulling back insulation.

3.6 Item 1(Picture) subfloor covered with insulation

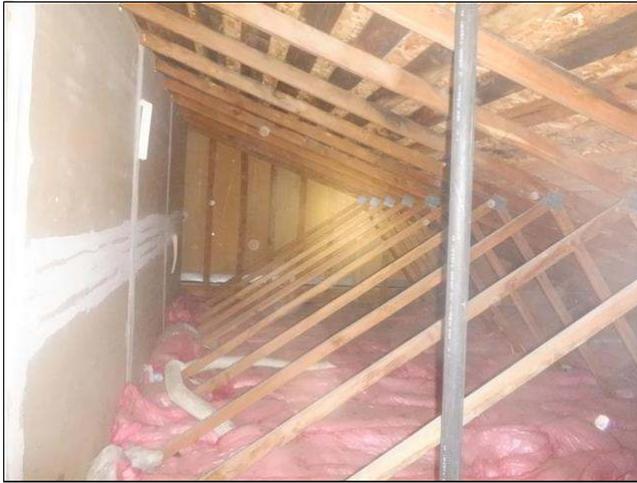
3.8 Item 1(Picture) view of attic

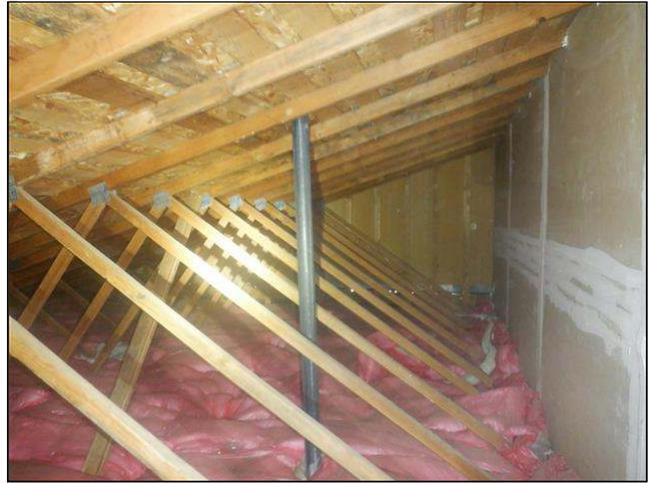
3.8 Item 2(Picture) view of attic

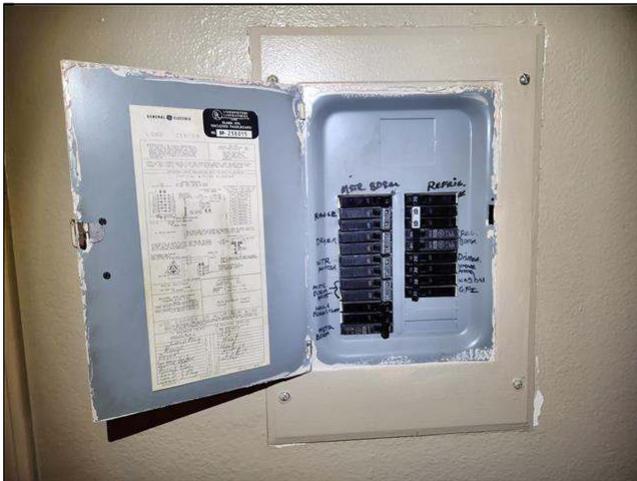
The Main and Distribution Panels are well labeled for circuit identification. "Dead front" cover appears serviceable. No problems noted.

4.1 Item 1(Picture) distribution panel

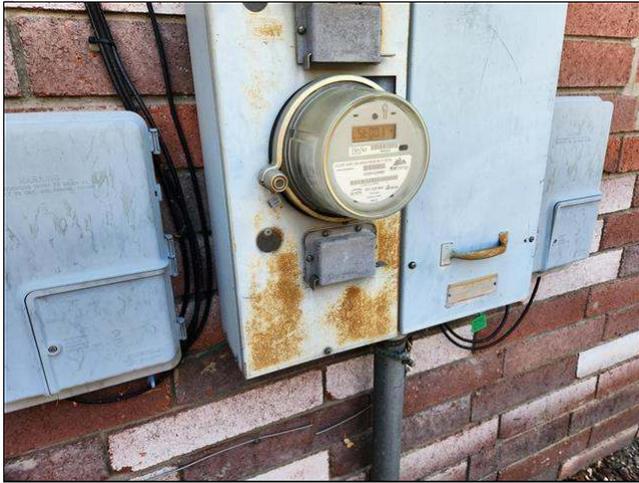
Main Panel and Disconnect are located at the West side of the home's exterior, The Distribution Panel is located in the master bedroom.

4.2 Item 1(Picture) main disconnect for home

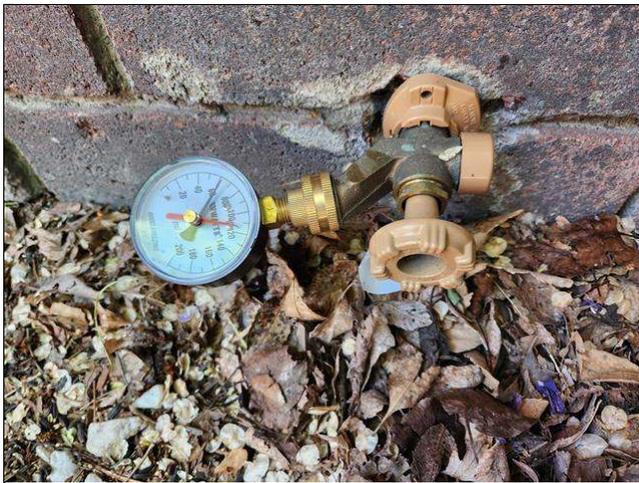
(2) The water pressure was tested at the North hose bib, pressure was 65 psi at time of inspection.

5.1 Item 3(Picture) water pressure at north hose bib

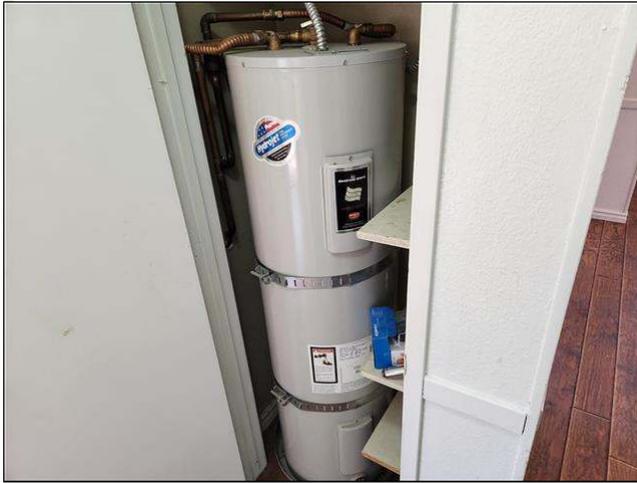
(1) Water heater is electric, and is located in the hall closet, and is strapped to current local codes. Temperature and Pressure Relief Valve is piped to the exterior of the home, or within 6 inches of the floor (for safety reasons). Water shut-off valve is present. Water heater operated as intended with no abnormal noises or leaks noted. Manufactured in 2011 by Bradford-White.

5.3 Item 1(Picture) water heater

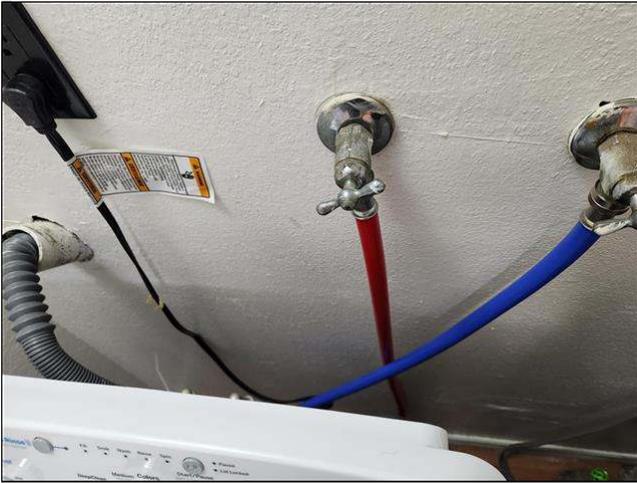
Washer and dryer hook-ups were inspected, with no problems noted. Dryer is electric powered with rigid metal venting installed in the crawlspace. Washer drain is 2" diameter, Hot and Cold hook-ups with no problems noted.

5.5 Item 1(Picture) laundry hook-ups

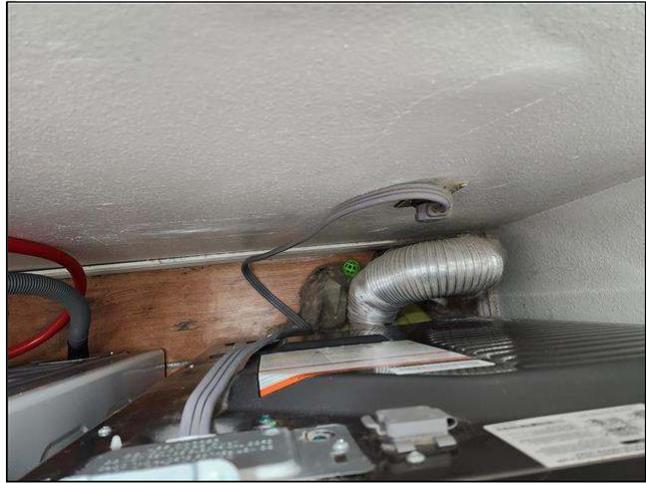
5.5 Item 2(Picture) laundry hook-ups

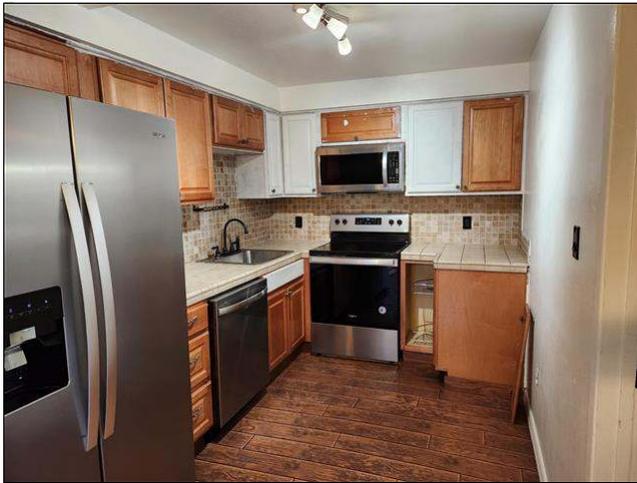
6.0 Item 1(Picture) view of kitchen

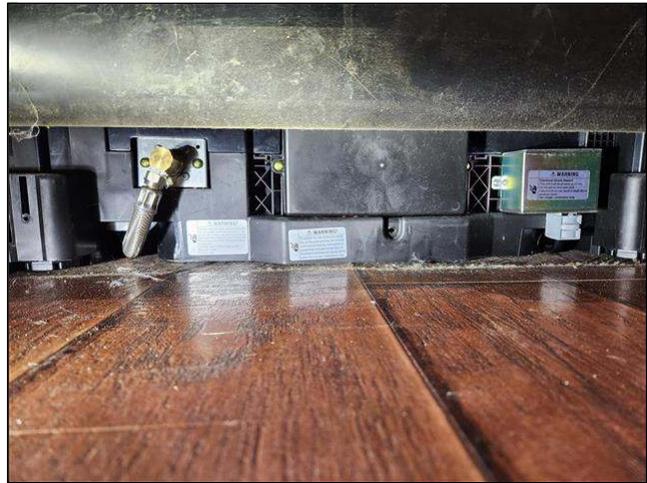
6.0 Item 2(Picture) dishwasher hook-ups

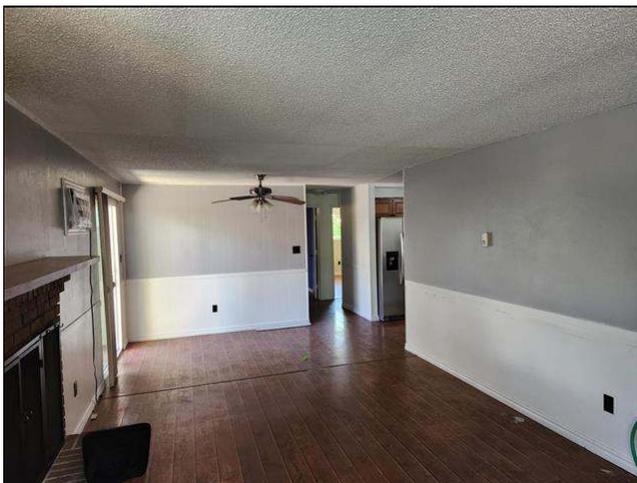
7.0 Item 1(Picture) view of interior

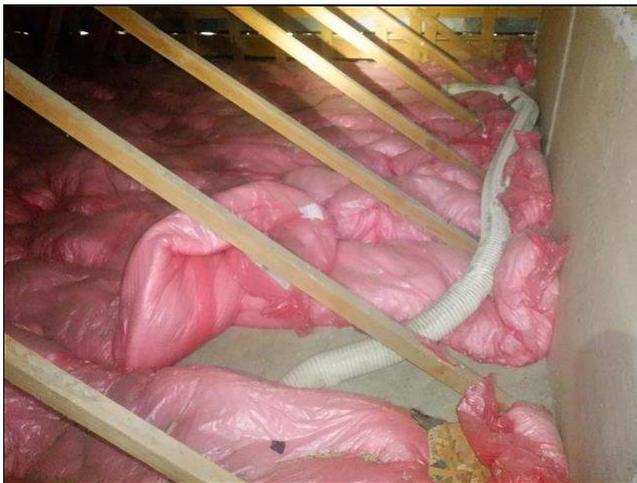
Attic insulation is Fiberglass Batt type approximately 6 inches thick (R19), installed over the original 4 inch thick Cellulose insulation, giving the home approximately R30 value. No problems noted.

8.0 Item 1(Picture) view of attic insulation

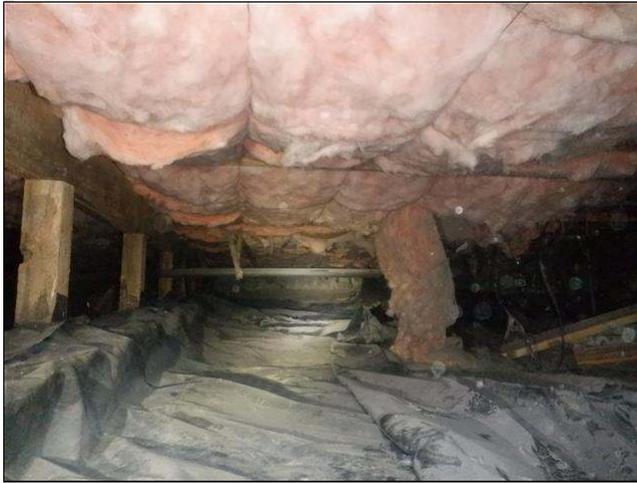
The subfloor area is insulated between the floor joists using R19 fiberglass Batts, with a couple areas sagging, no problems noted.

8.1 Item 1(Picture) view of subfloor insulation

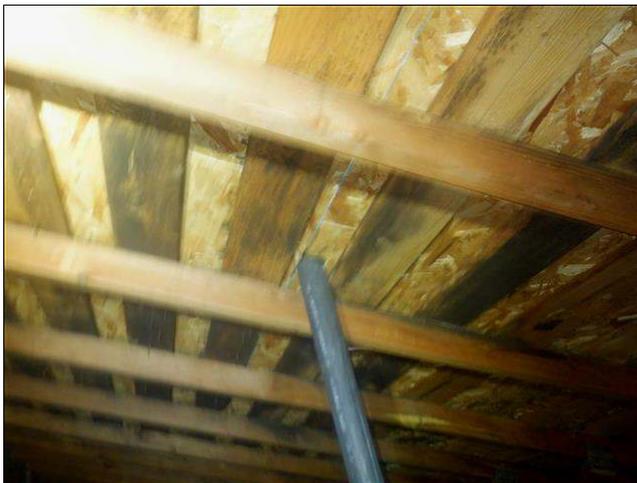
There are signs of past "poor ventilation" in the attic area, indicated by blackening of roof framing materials. There has since been roof vents installed, and appears the ventilation is now adequate.

8.3 Item 1(Picture) blackening of roof boards

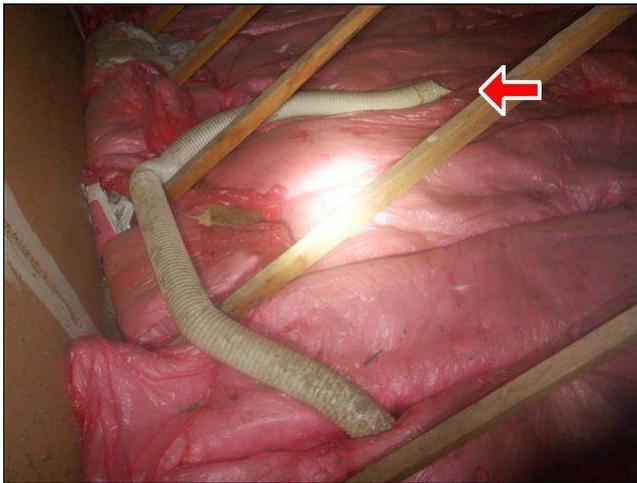
8.4 Item 3(Picture) master bathroom vents into attic

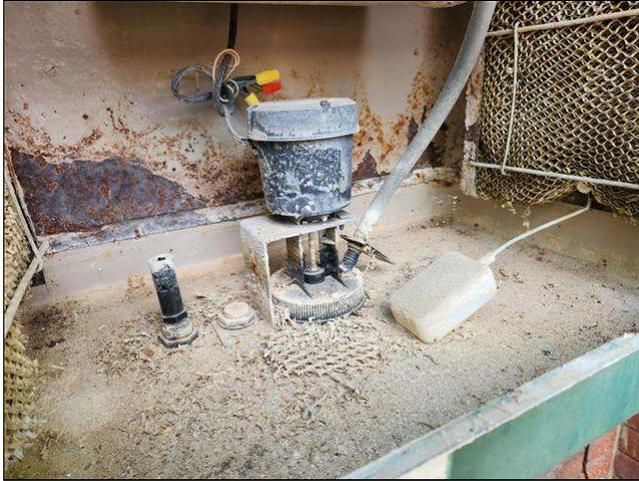
The home uses an Evaporative Cooler located in the Living room. Cooler has been winterized, and could not be checked for proper operation. Water pan appeared serviceable, pads need replacing. Could not determine if water pump functions properly.

9.5 Item 1(Picture) winterized cooler

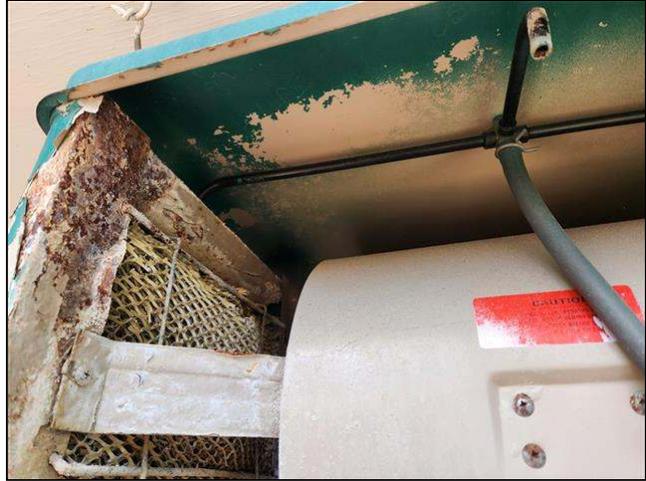
9.5 Item 2(Picture) winterized cooler

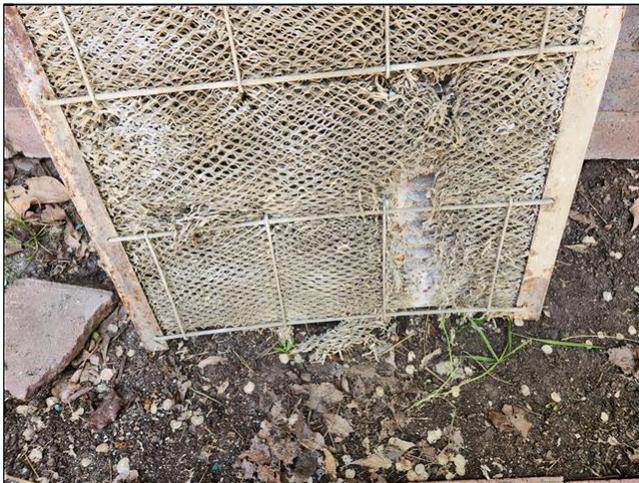
9.5 Item 3(Picture) winterized cooler pads

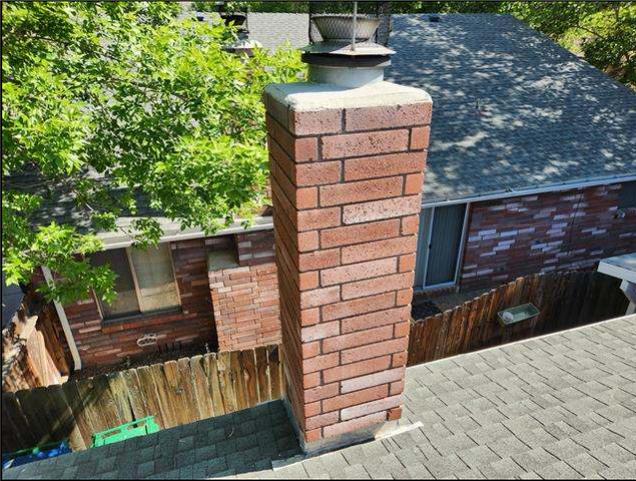
Chimney appears solid with good mortar joints and flashings. Concrete chimney cap is in good condition. No problem noted.

10.1 Item 1(Picture) block chimney structure

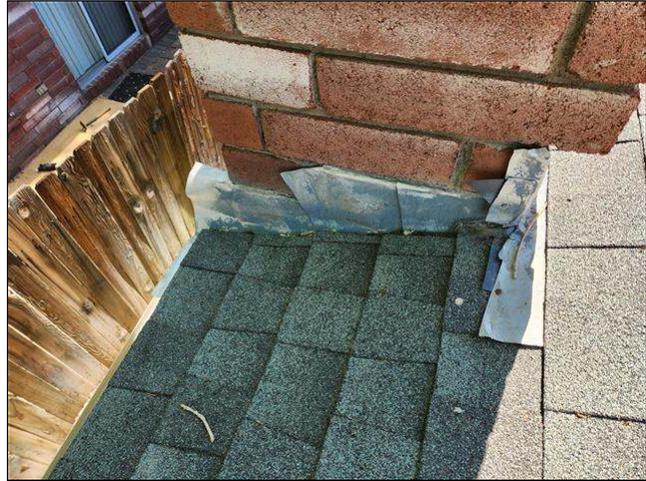
10.1 Item 2(Picture) chimney flashings

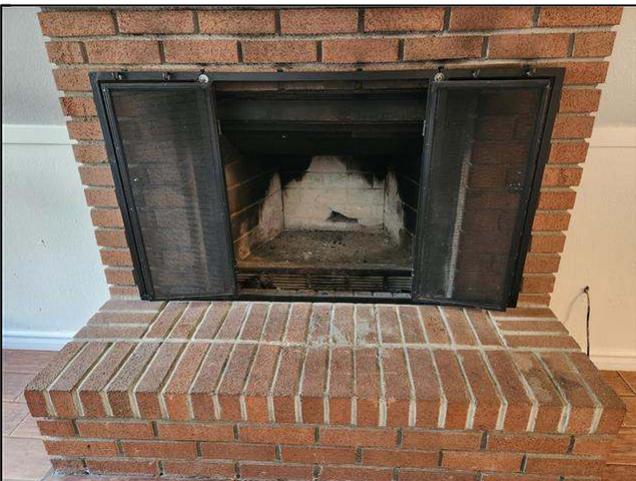
Fireplace appears in good operating condition. Damper operates freely, firebrick appears in good condition, with minimal cracks. Note: Recommend consulting a licensed fireplace contractor for a more thorough examination of the fireplace, chimney and flue pipe systems, and code compliance, as needed.

10.3 Item 1(Picture) living room fireplace

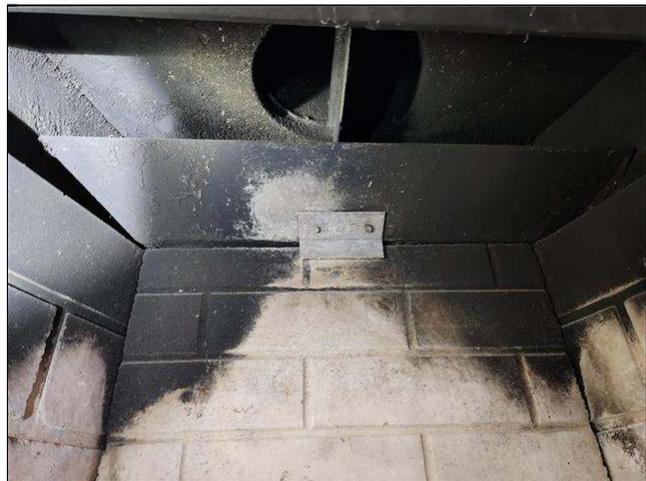
10.3 Item 2(Picture) fireplace damper
